# Opus 21 Condominium

## Structural Condition Survey Report

# **Opus 21 Condominium Condition Survey Report**

Re: Structural Milestone Building Inspection

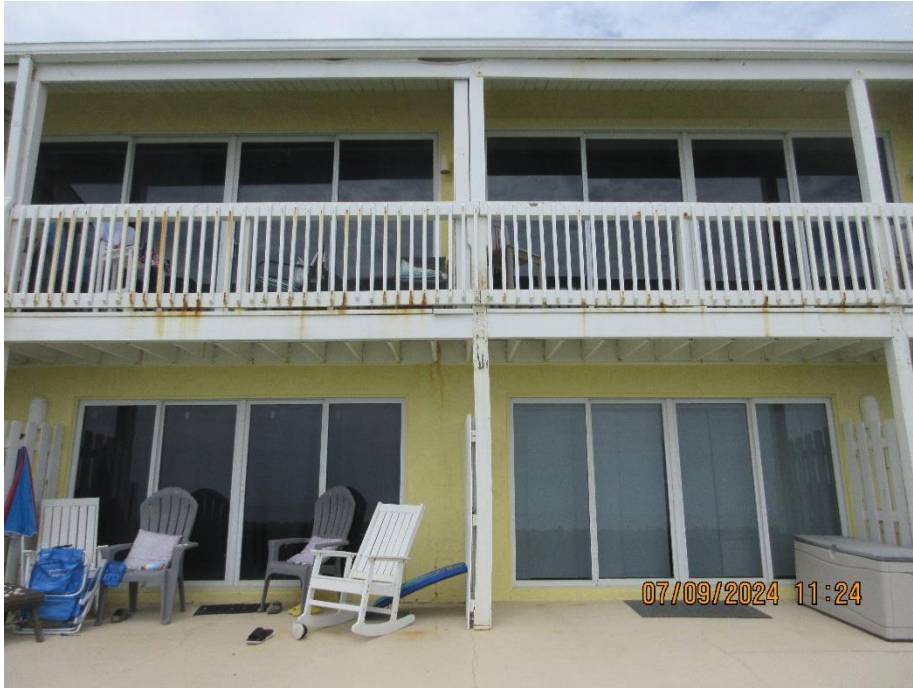
The existing railing system is a wooden picket system. Because of the corrosion staining, it is evident that stainless steel fasteners were not used.

**View of staining caused by corrosion of non-stainless-steel fasteners**

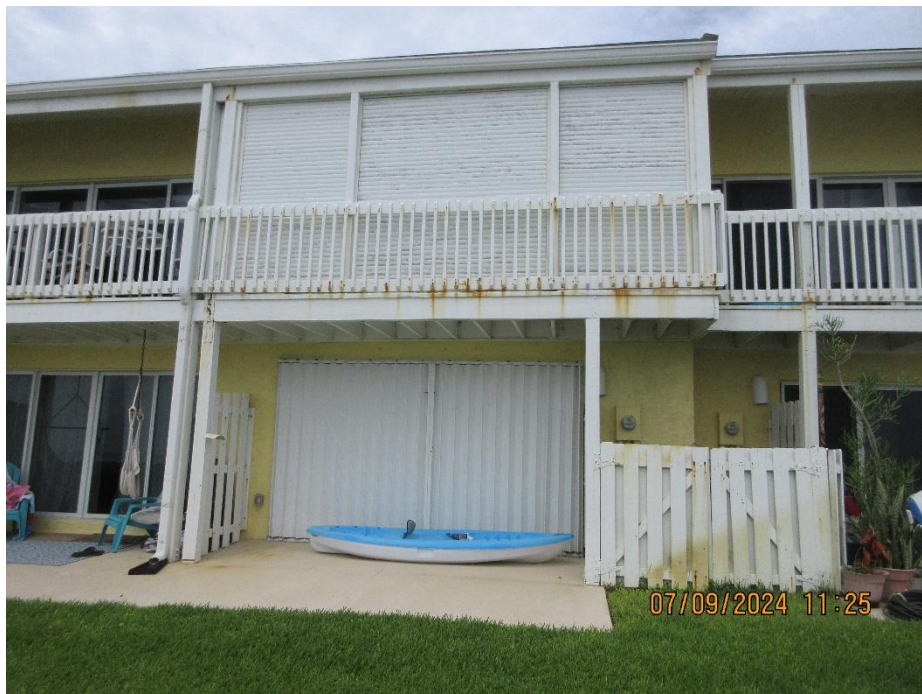
**View of staining caused by corrosion of non-stainless-steel fasteners**

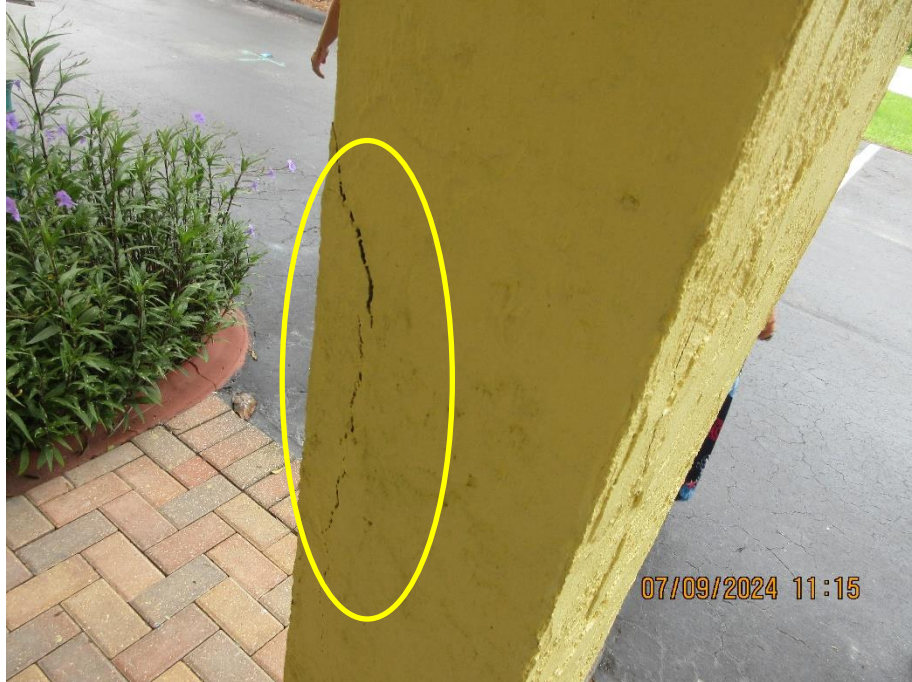
**View of stucco crack in west elevation column**

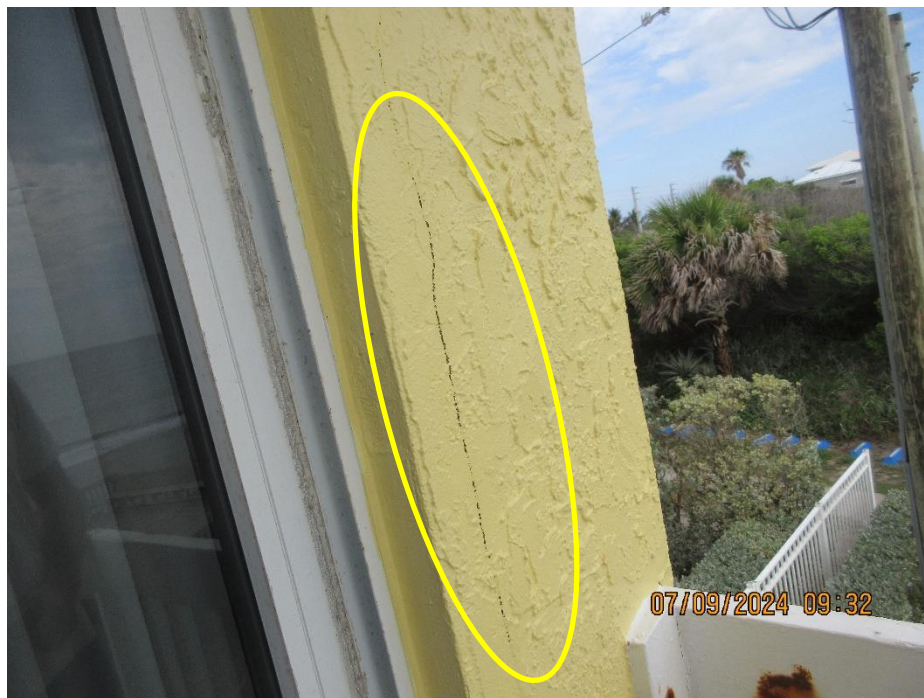
**View of stucco cracks near sliding glass door**

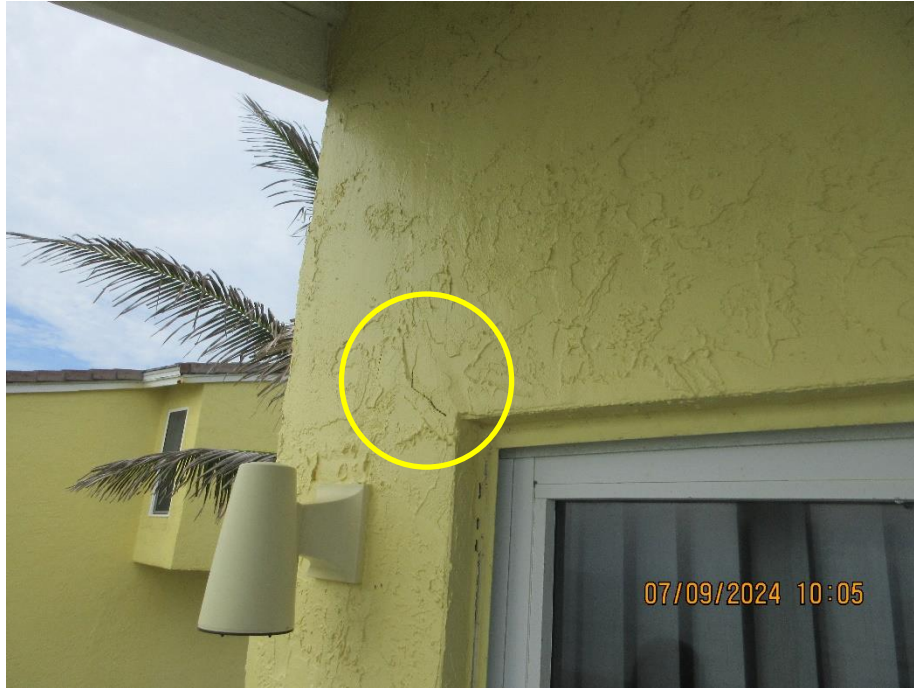
**View of stucco crack near balcony sliding glass door**

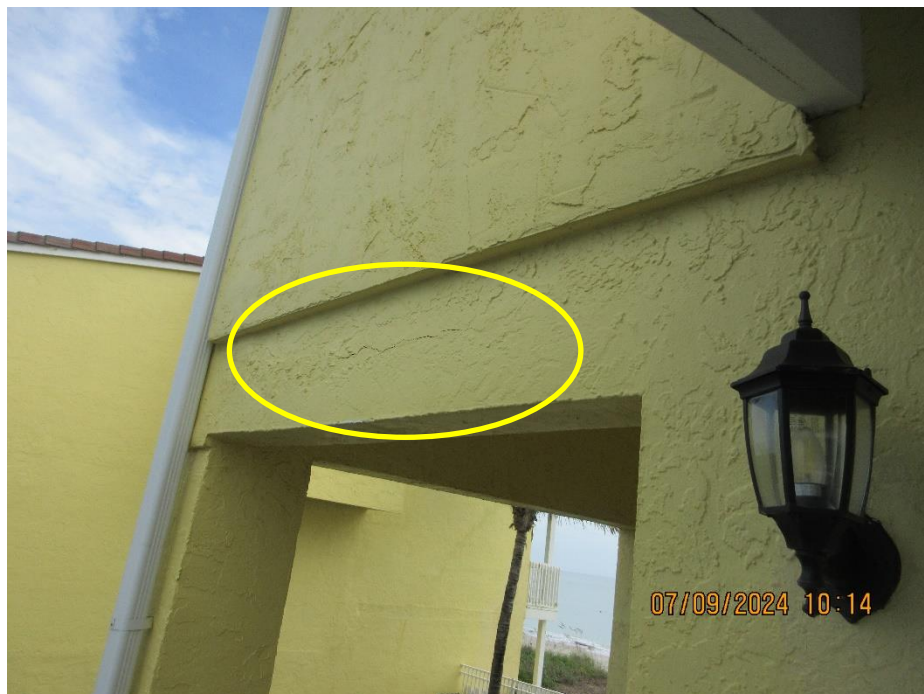
**View of stucco crack near unit entryway**

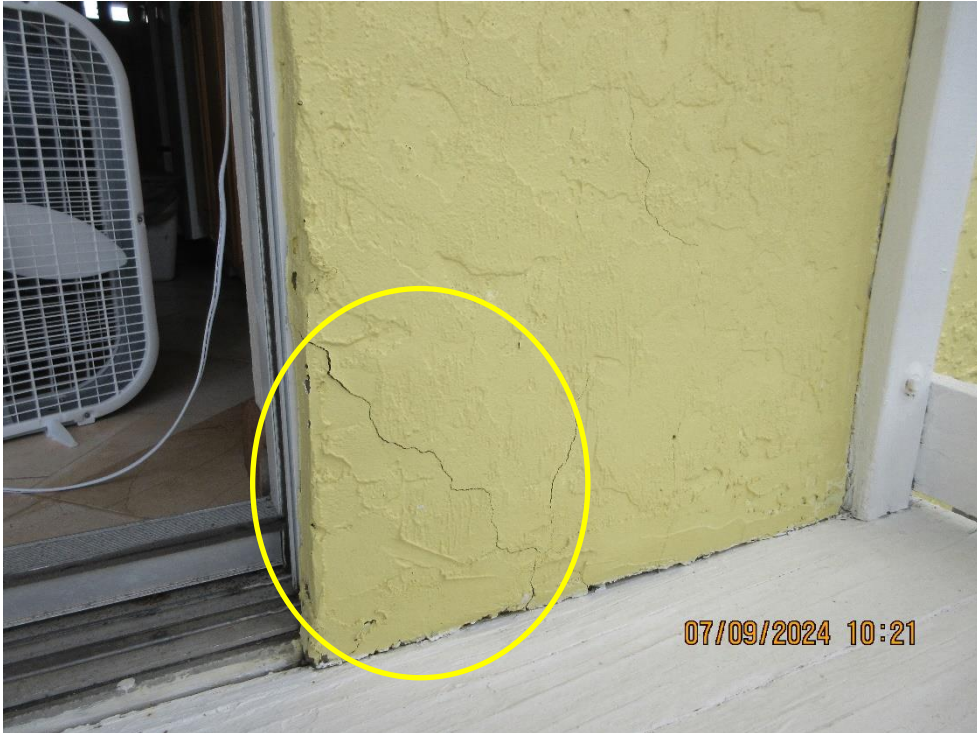
**View of stucco crack near sliding glass door**

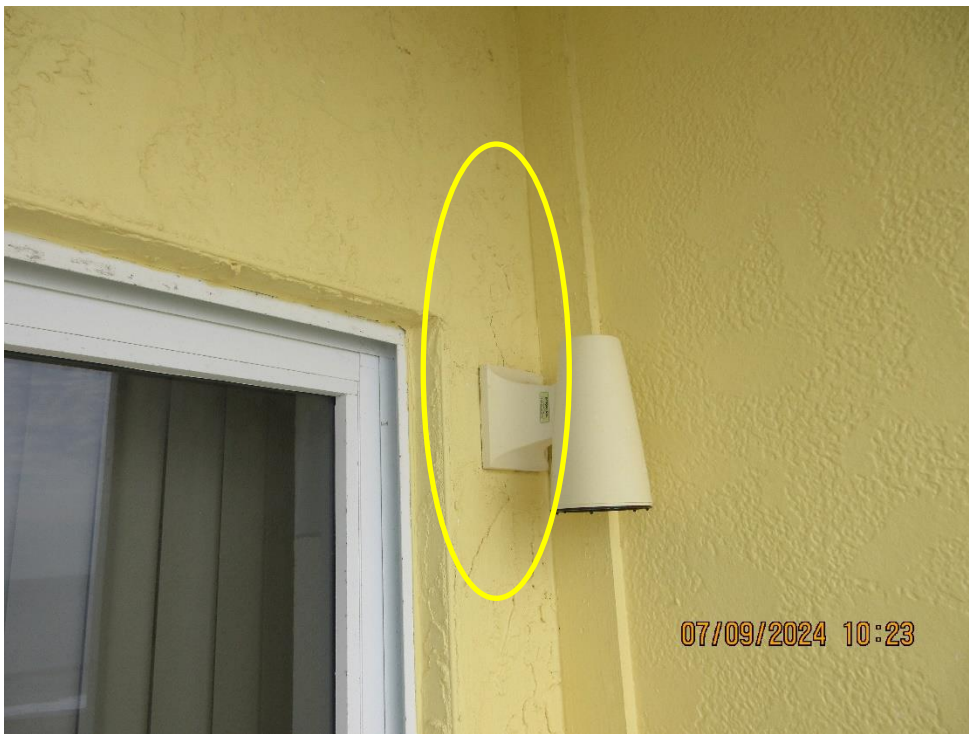
**View of stucco crack at light fixture**

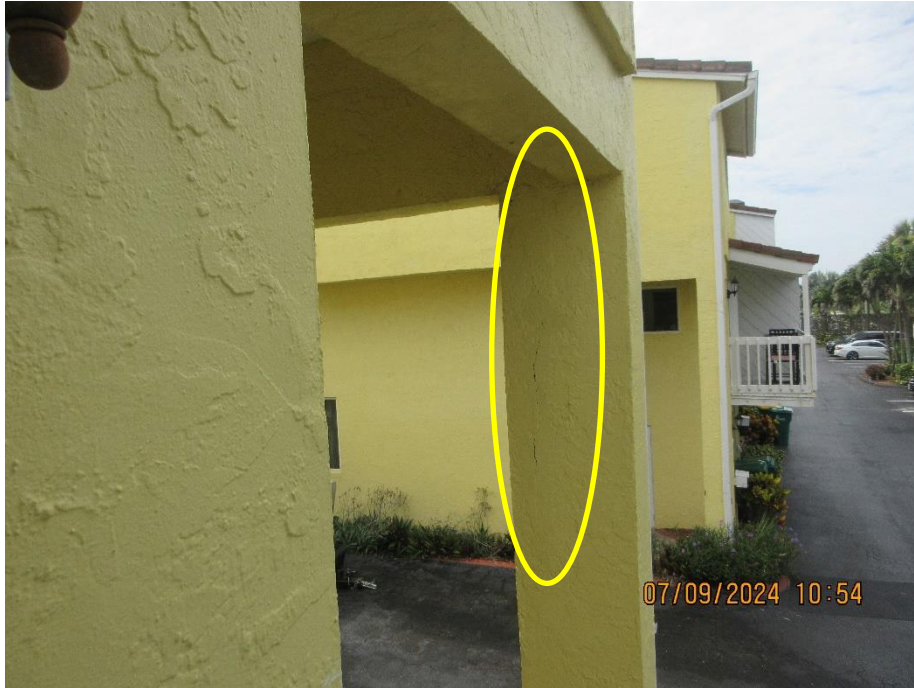
**View of stucco crack above unit entryway**

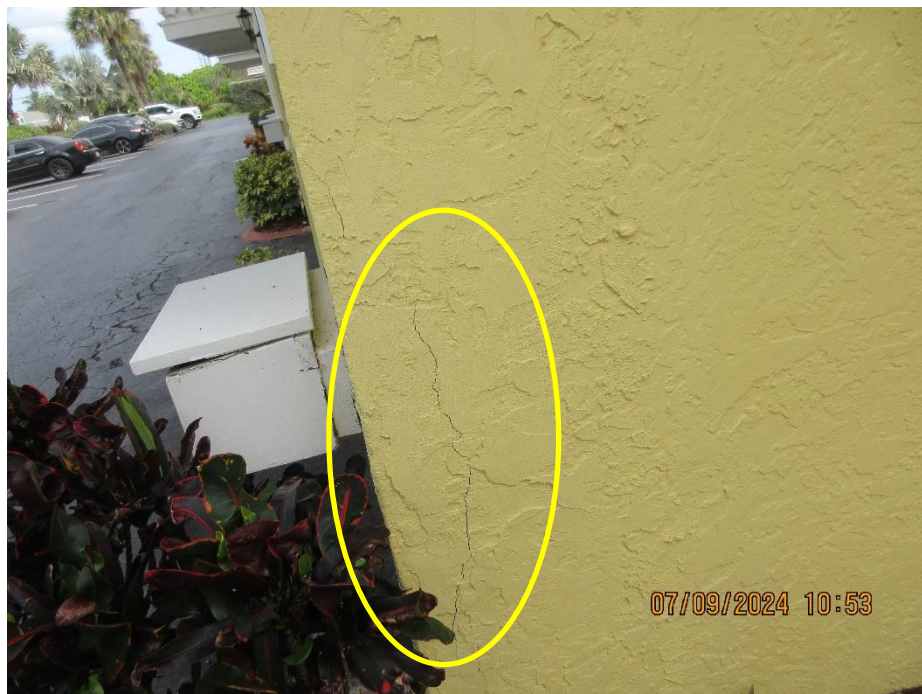
**View of stucco crack at unit entryway**

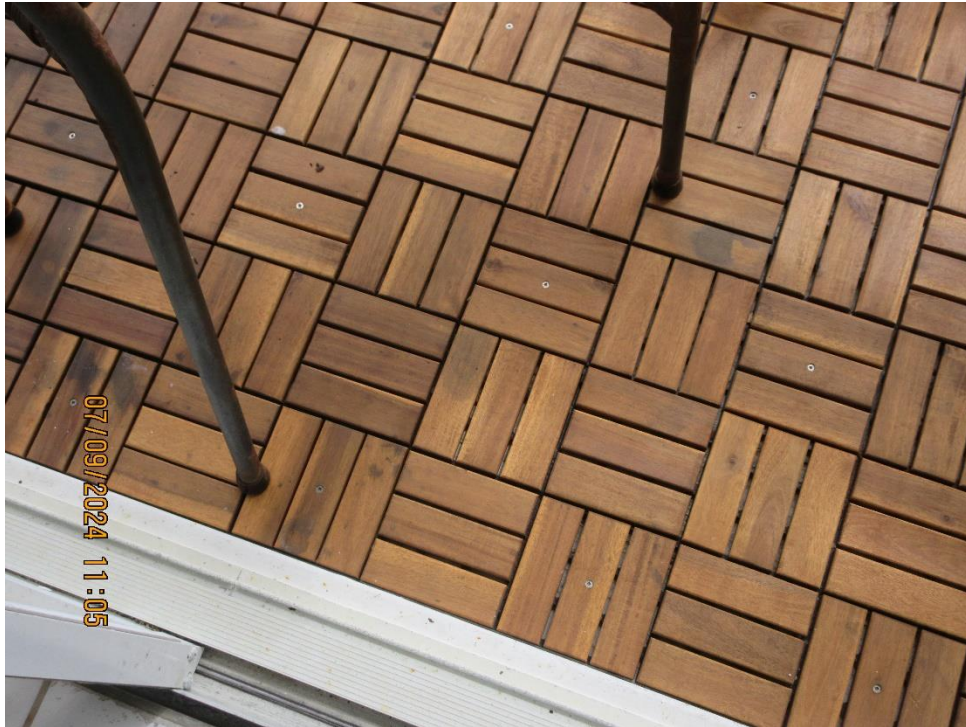
View of flooring installed over the original balcony structure

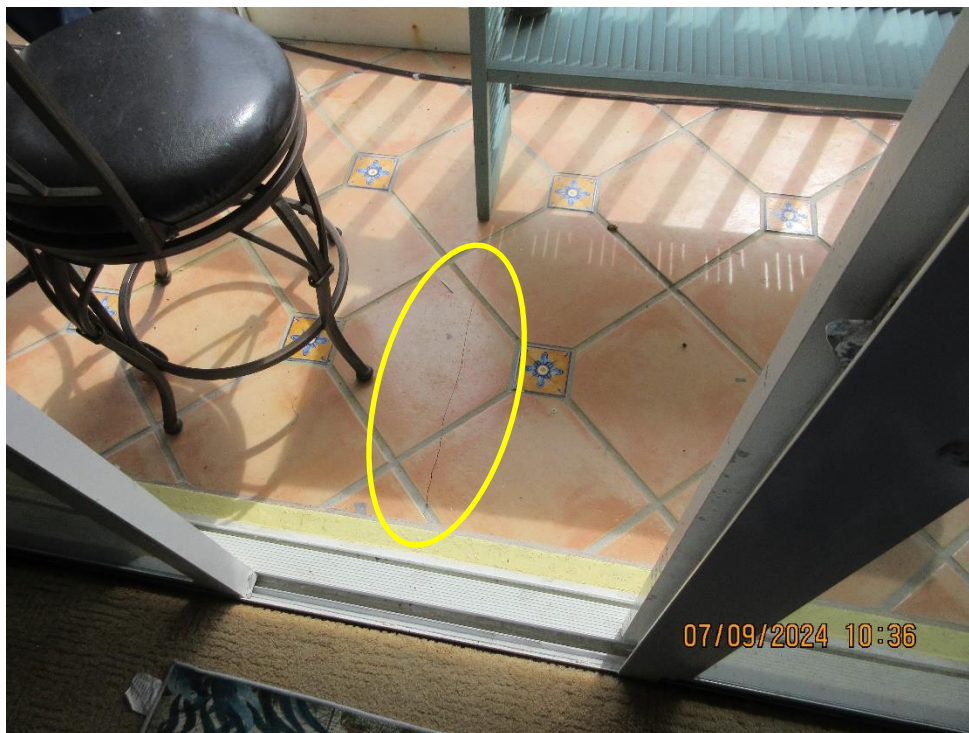
The balcony floor finish is the first line of defense against the corrosive elements of the water and salt air. The balconies have a poor to fair coating system and one unit has tile on its east and west balconies. Tile provides little to no protection and allows the balcony surface to remain wet and exposed to saltwater nearly continuously.

View of tile installed over the original balcony structure. Note crack in tile

**Possible solutions include stripping all existing coatings and tile and installing an improved coating system over the wood decking. Alternates could be provided to replace the balconies with synthetic (Trex) material or prefabricated aluminum.**

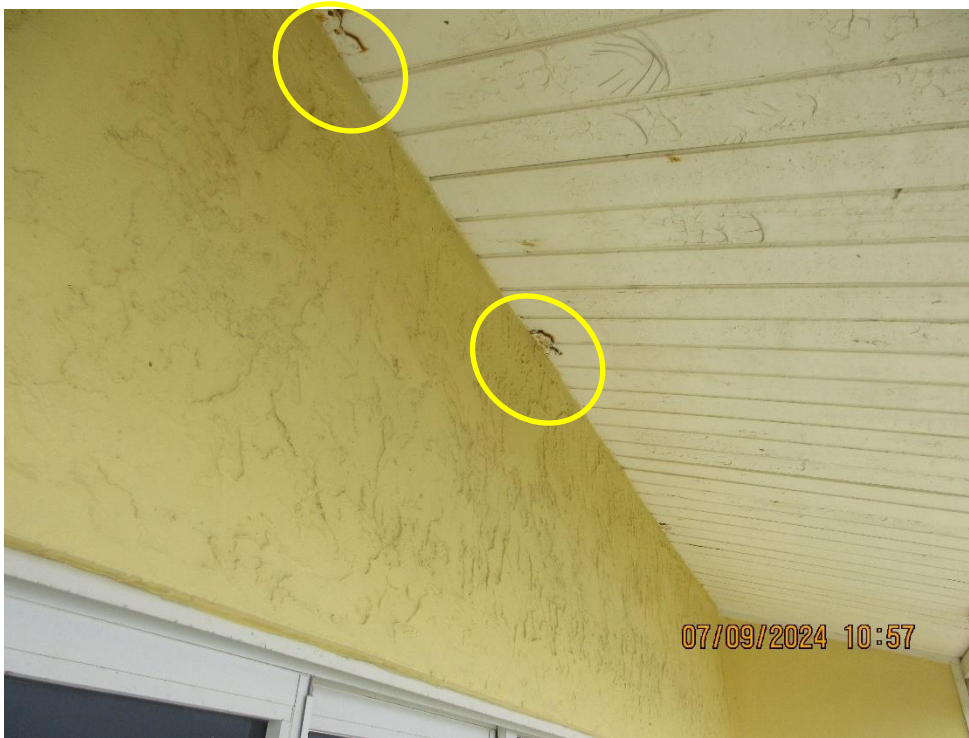
**View of corroded hurricane straps**

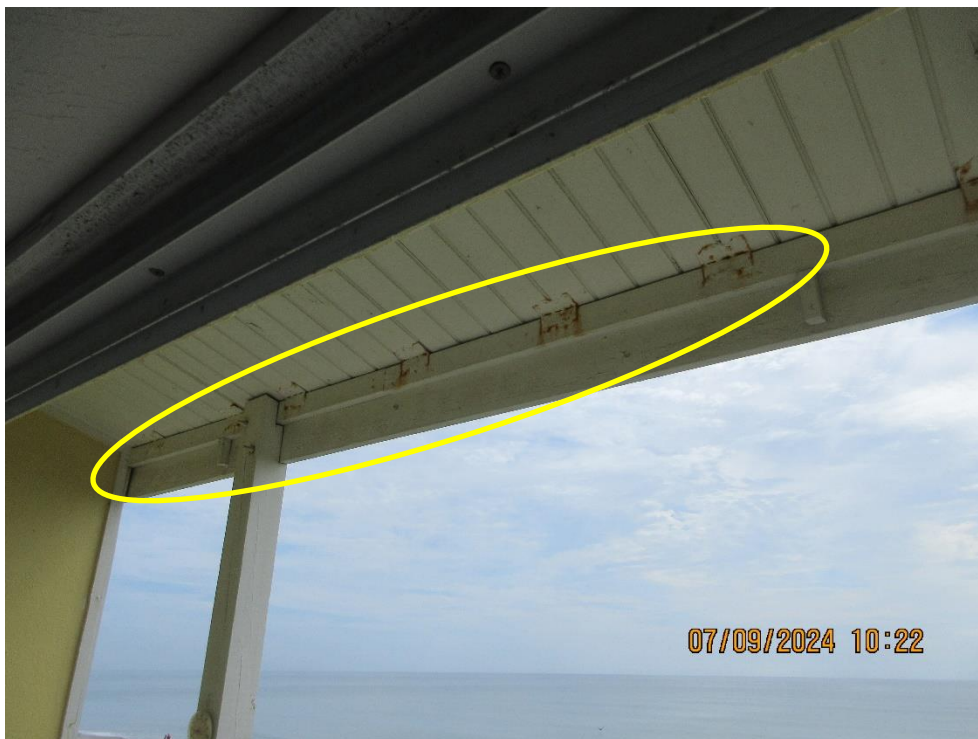
**View of corroded hurricane straps**

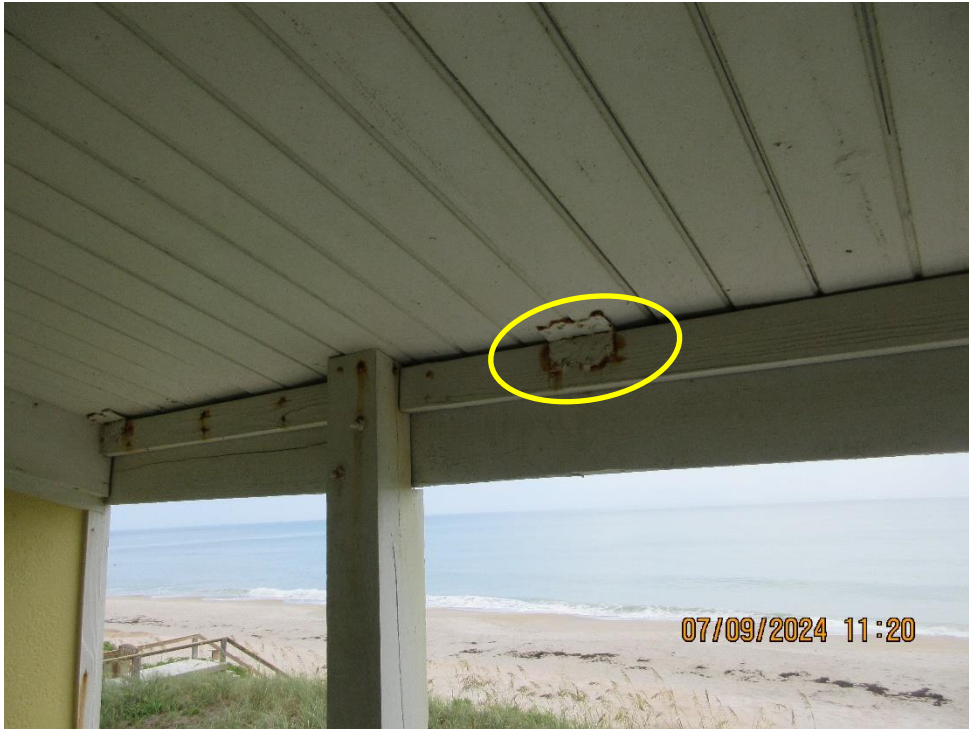
**View of corroded hurricane strap and fasteners**

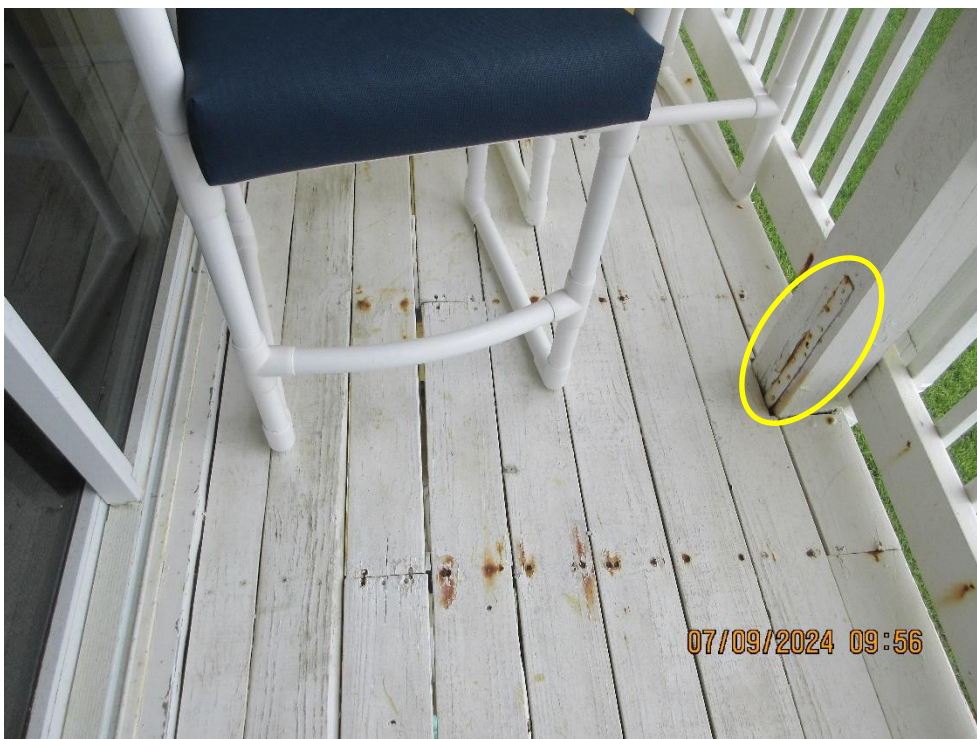
**View of corroded hurricane strap and deck fasteners**

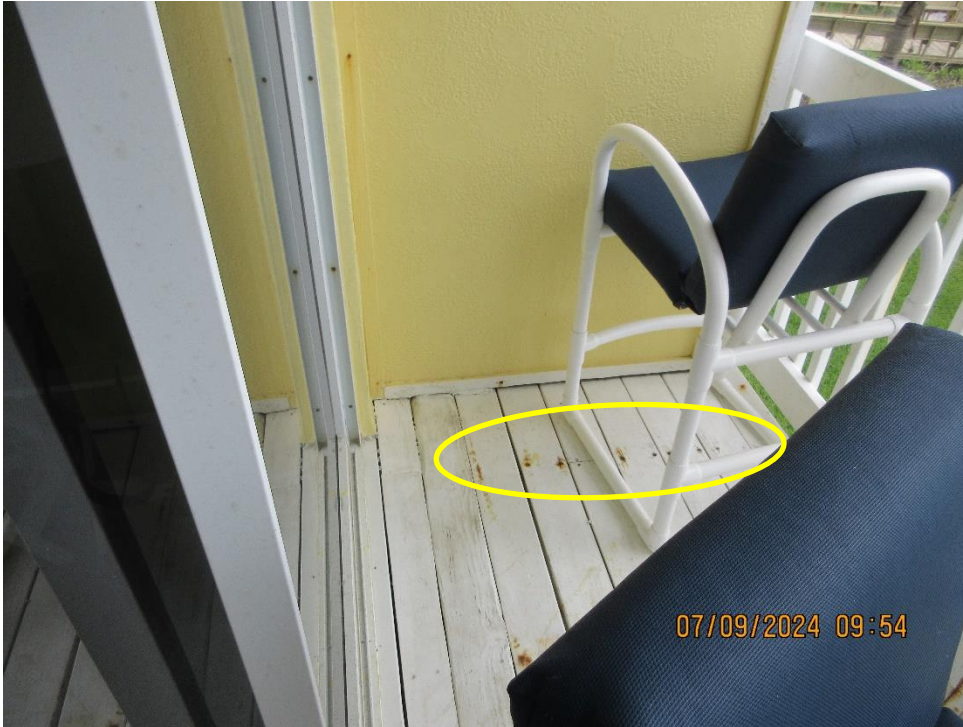
**View of corroded deck fasteners**

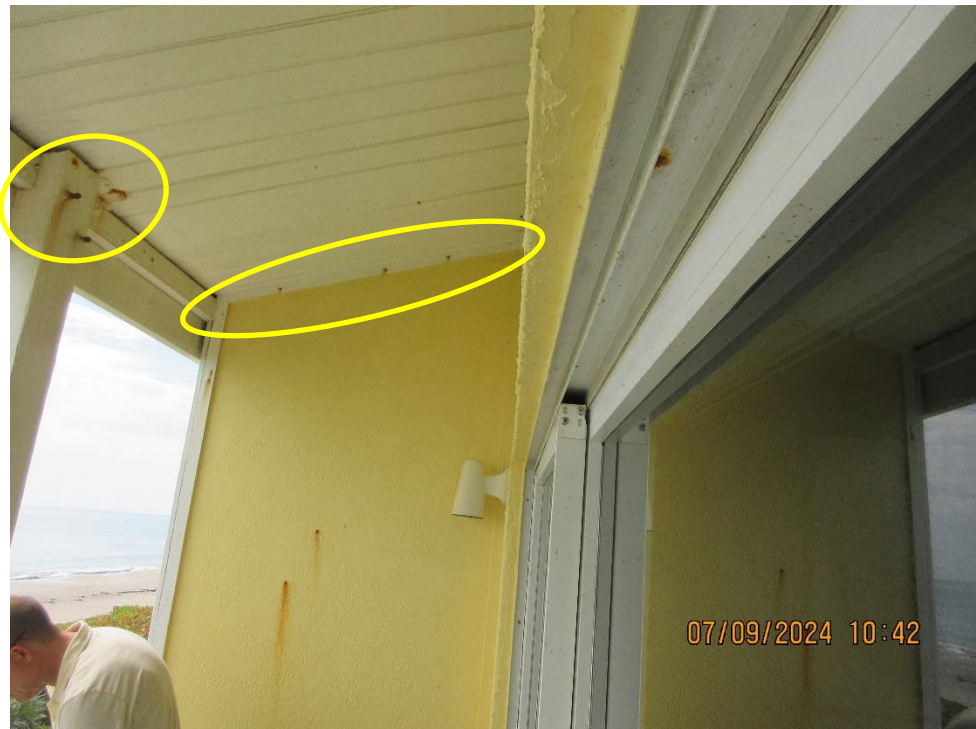
**View of corroded fasteners**

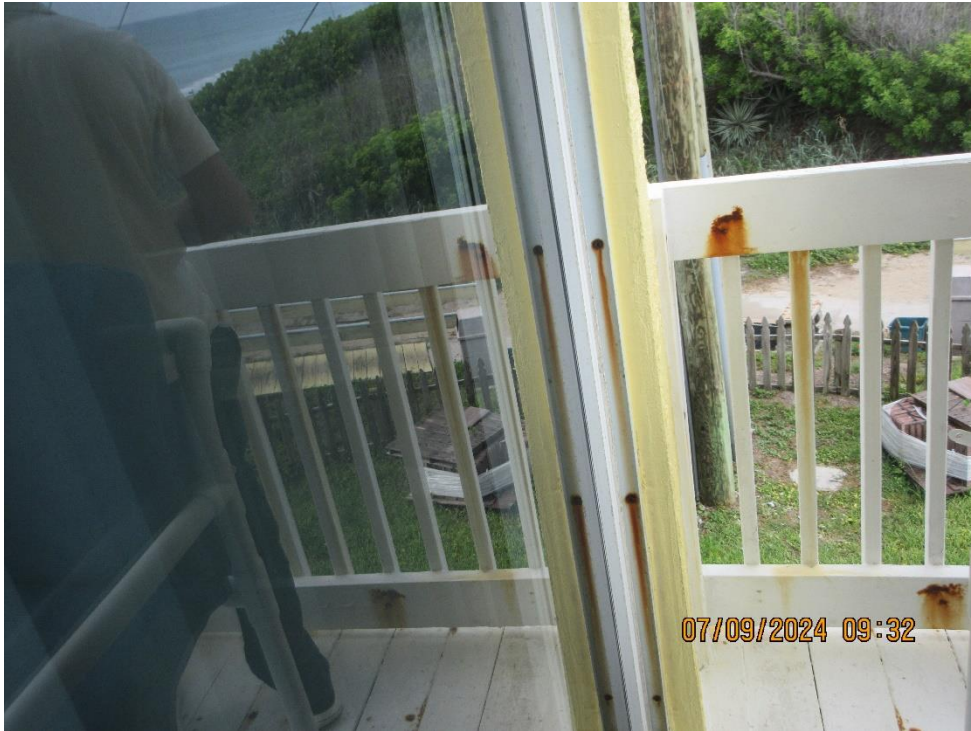
The sliding glass doors appear to be various ages and styles. A few have corroded fasteners, which can allow saltwater intrusion. An aged door, and/or a door in poor condition may be a candidate for replacement with a new code compliant model.

**View of corroding sliding glass door fasteners**

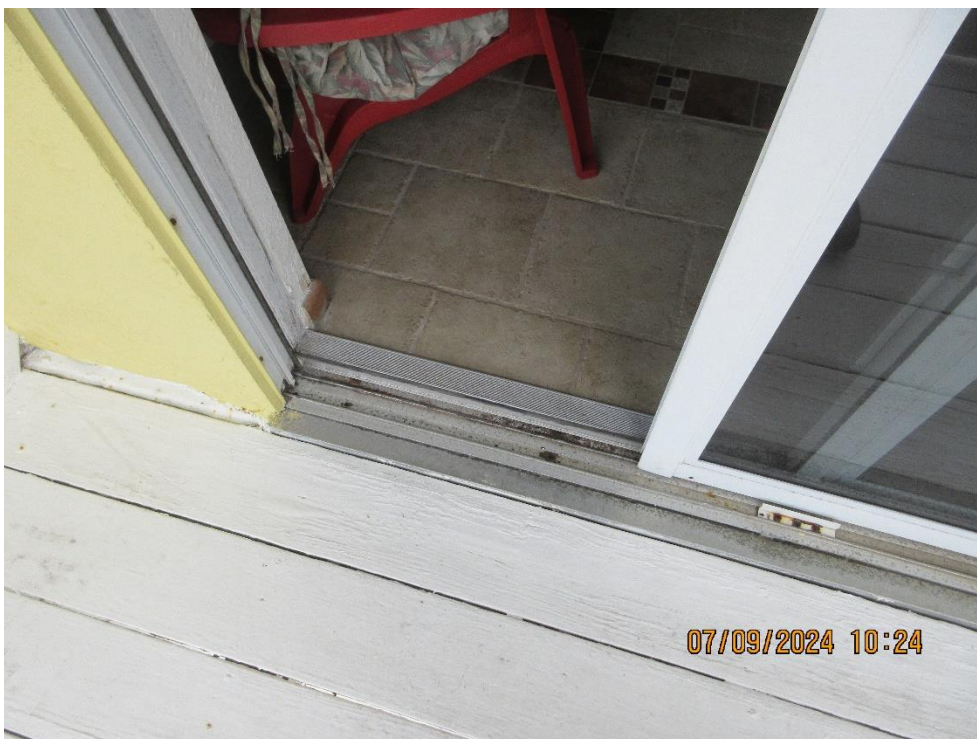
**View of corroding sliding glass door fasteners**

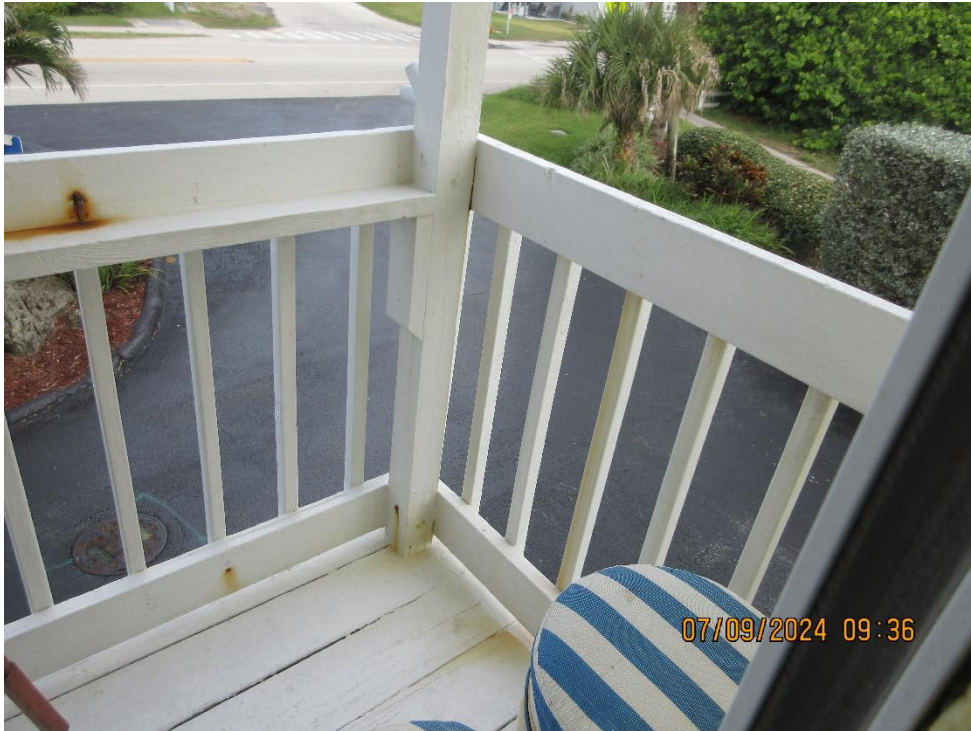
**View of corroded railing fasteners**

**Alternates could be provided to replace the railings with synthetic (Trex) material or prefabricated aluminum. New, properly installed railings and an improved protective floor coating system will greatly reduce future damage.**

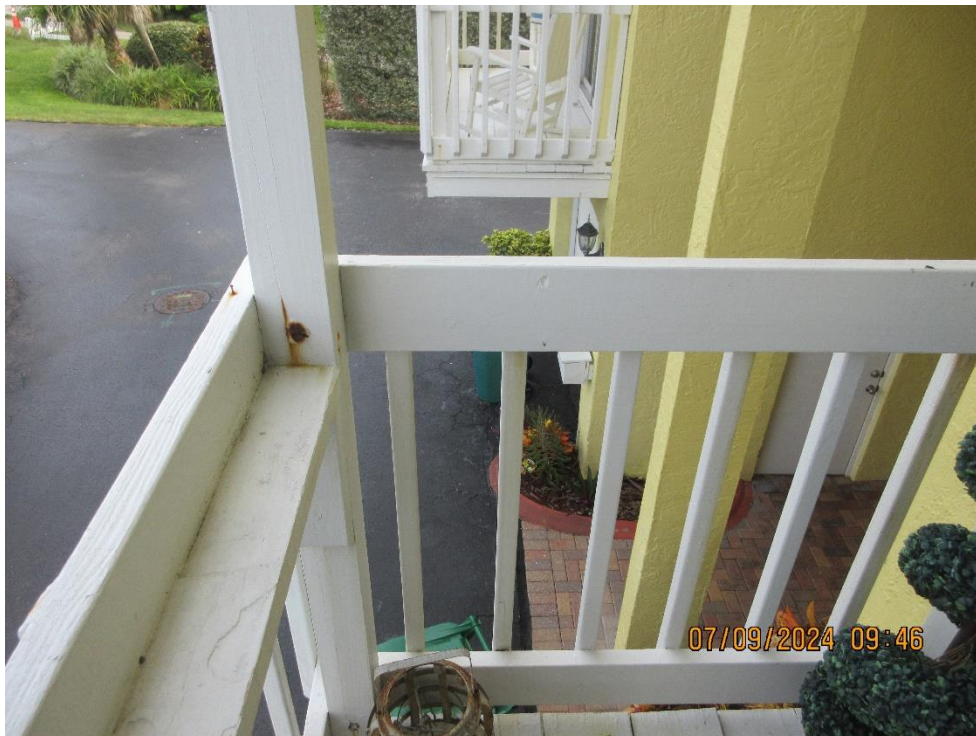
**View of corroded railing fasteners**

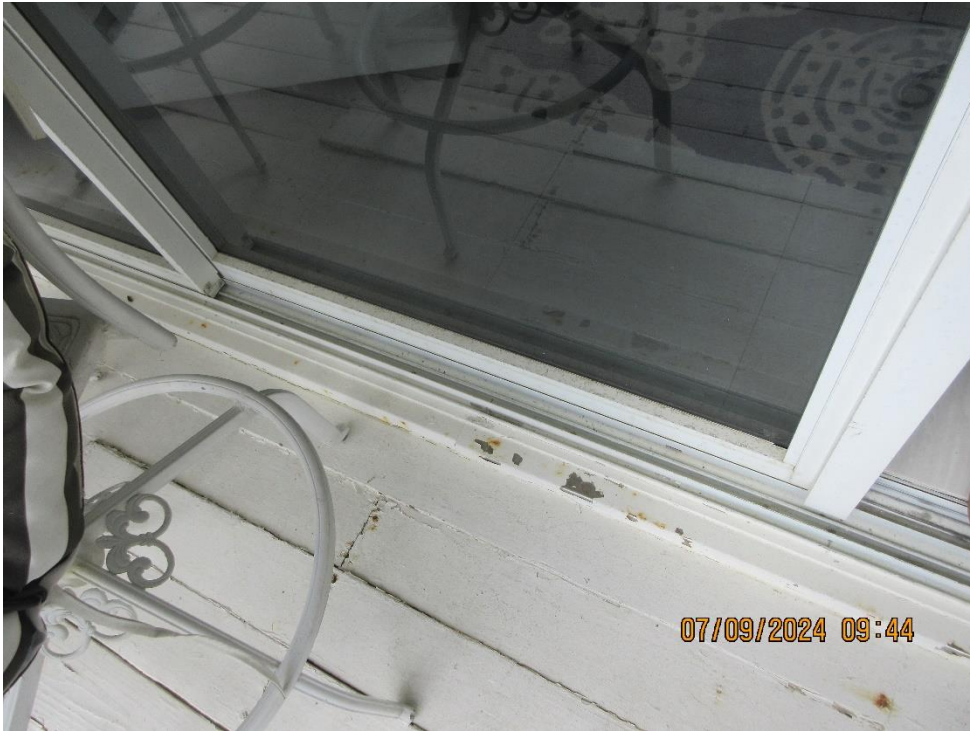
View of corroding sliding glass door track

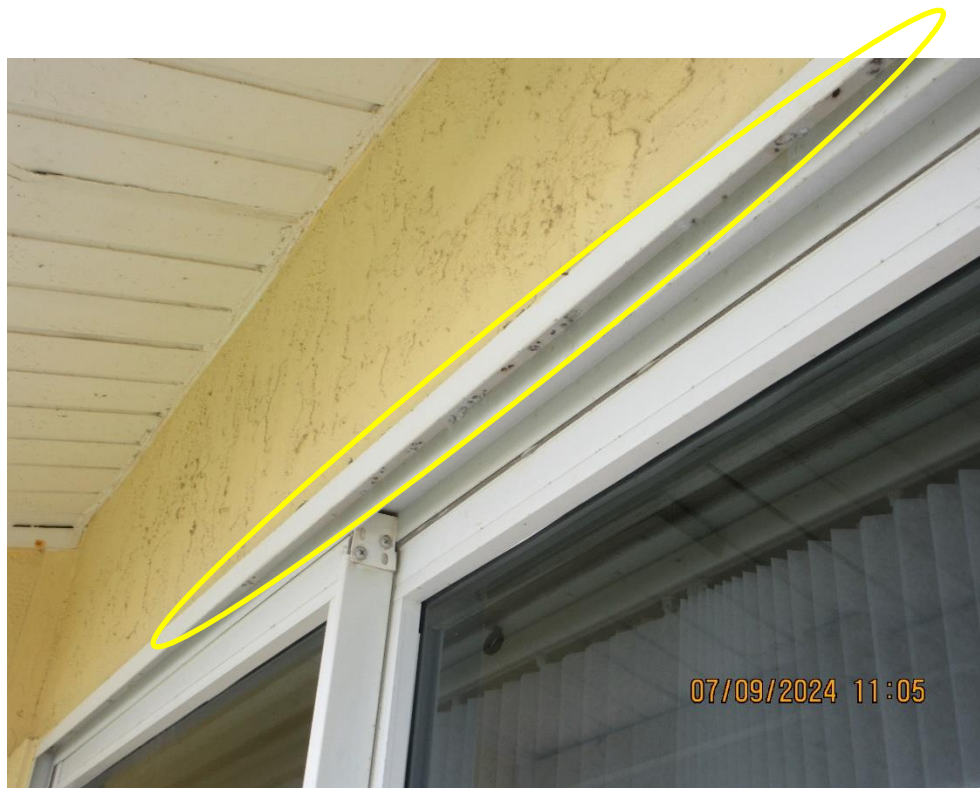
View of corroding sliding glass door track

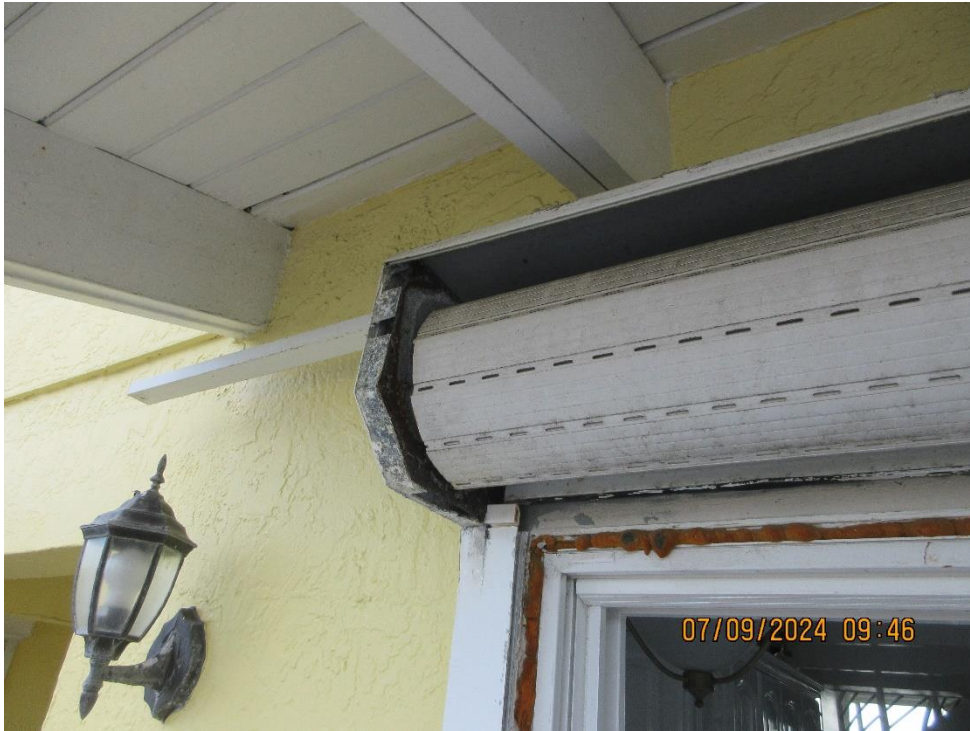
View of missing shutter box cover and Styrofoam sealant

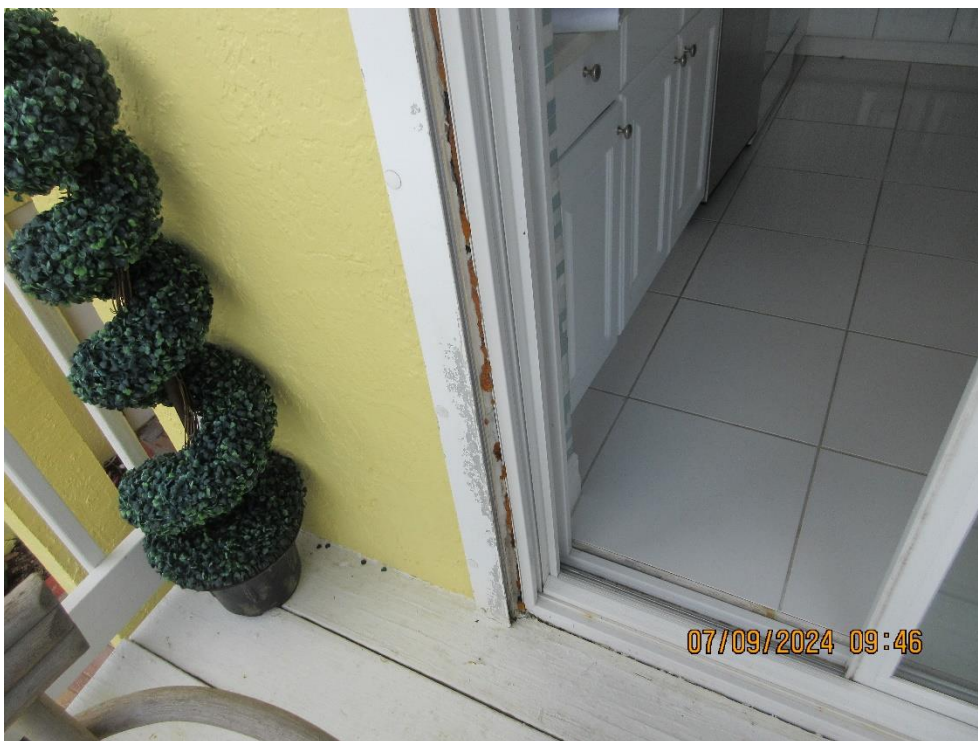
View of Styrofoam sealant along shutter track

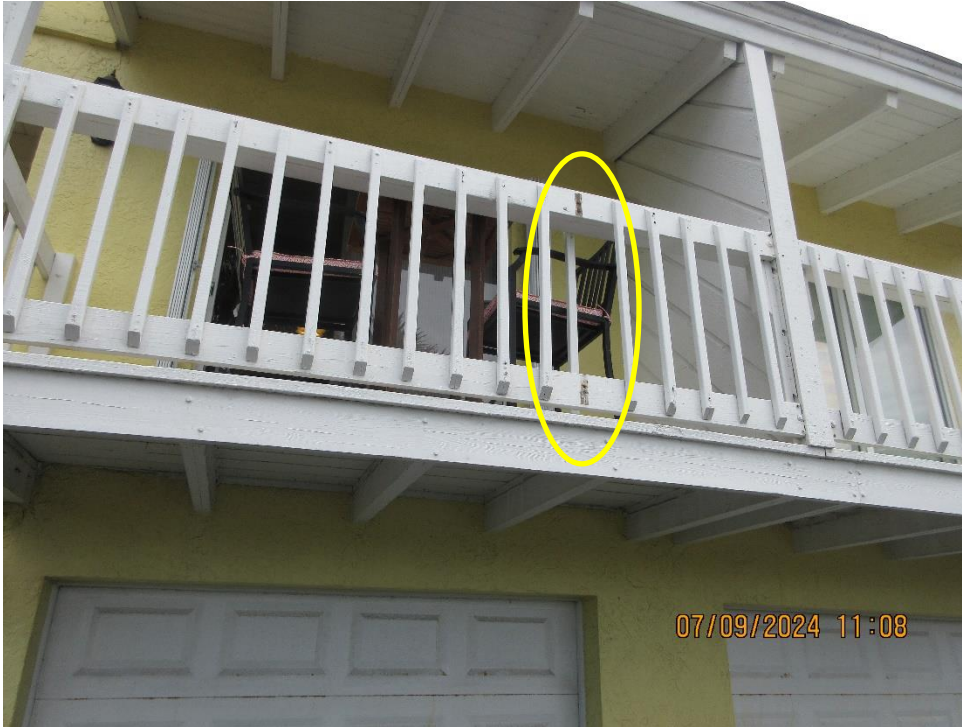
**View of loose/missing railing picket**

We recommend that all maintenance issues such as loose railing pickets and improper or missing railing attachments be completed as soon as possible. Considerations for the floor coatings repair or replacement should happen concurrently with the repairs.

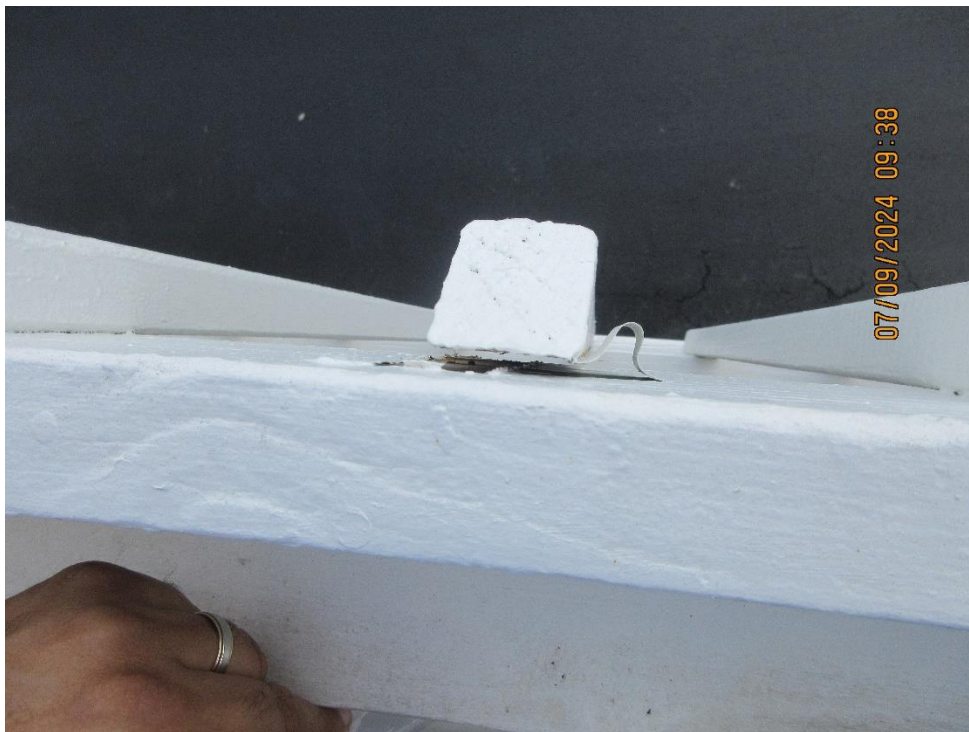
**View of loose railing picket.**

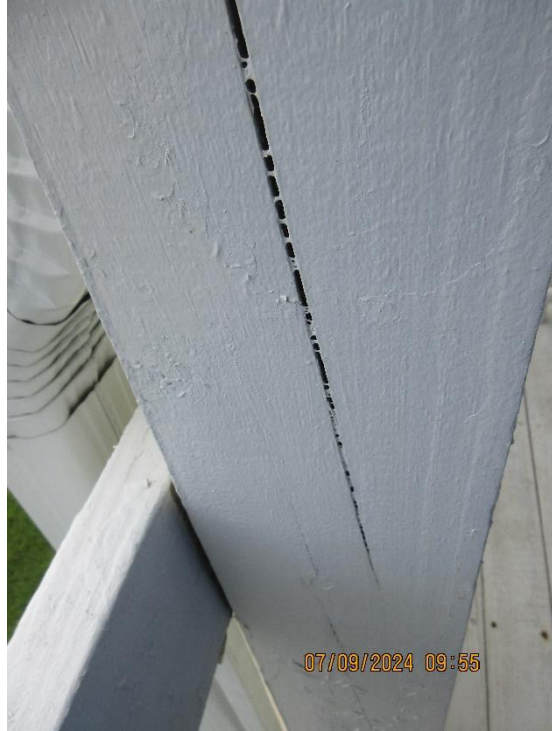
There is visible splitting on numerous floor and railing boards, including support posts. The cracks formed will also greatly increase the ingress of water and chlorides into the boards and cause the splitting and water damage to grow exponentially.

**View of splitting wood column**

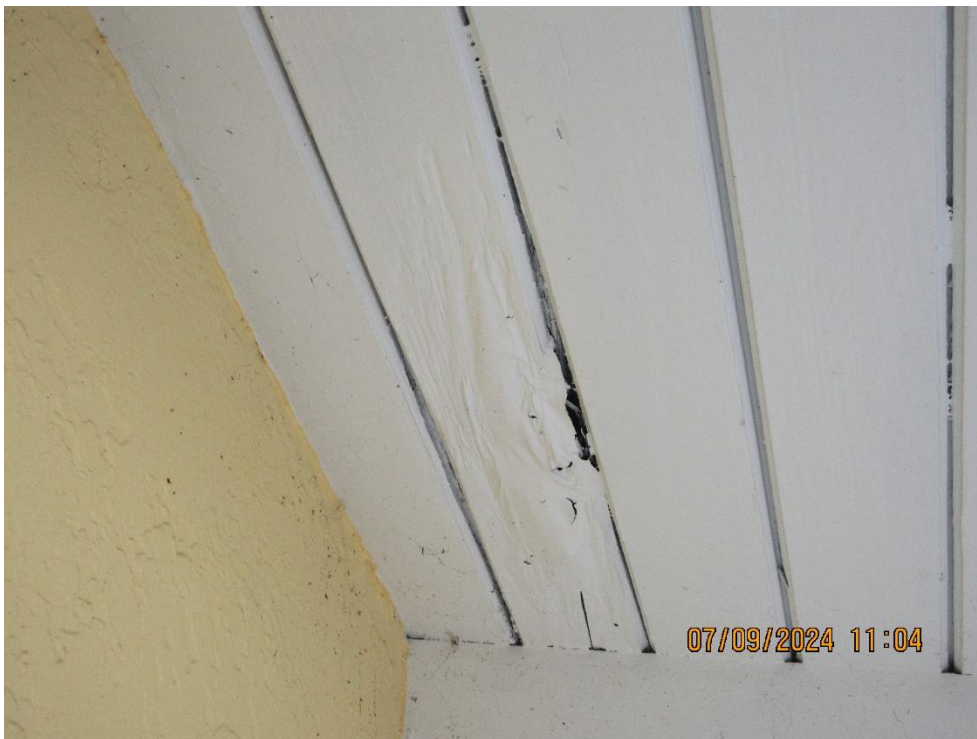
**View of deteriorated ceiling board**
