**Serena Shores Condominium Association**  
**SIRS Components**  
***Indian Harbor Beach, FL***

Report #: 36712-0  
Beginning: January 1, 2026  
Expires: December 31, 2026

**RESERVE STUDY**  
**"Full"**

June 30, 2025

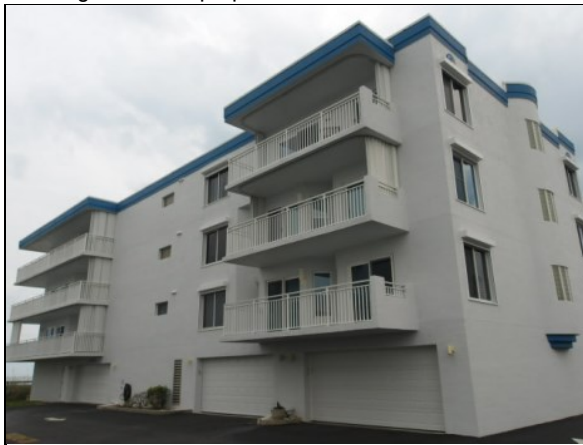
**Useful Life:**  
7 years

**Remaining Life:**  
5 years

**Lower Estimate:**

\$ 44,600

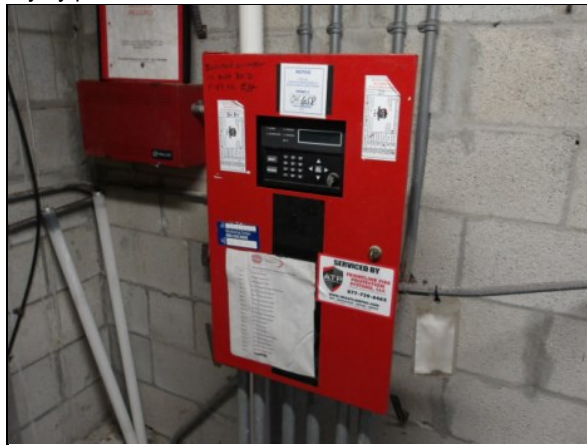
**Useful Life:**  
20 years

**Remaining Life:**  
10 years

**Lower Estimate:**

\$ 70,800

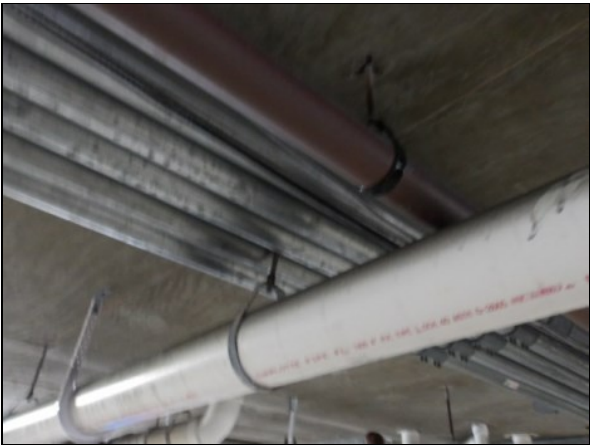
Useful Life:  
10 years

Remaining Life:  
7 years

| Lower Estimate: | \$ 14,900 | Higher Estimate: | \$ 18,200 |

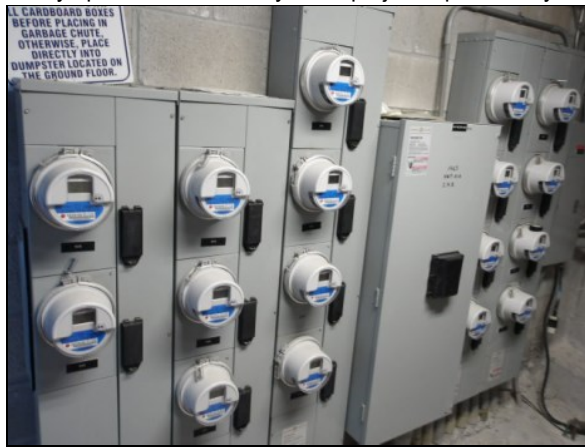
No major concerns or project history reported by the client during the current engagement. In accordance with Florida Statutes, a Structural Integrity Reserve Study is based only on a visual inspection. However, thorough analysis of electrical components requires testing beyond visual inspection (such as the use of infrared imaging equipment) in order to properly diagnose and detect problems which may require immediate repair or replacement. We recommend that the client consult with a qualified professional (i.e. electrician or other contractor) to more thoroughly evaluate the existing system(s) and to more accurately determine replacement timelines and cost estimates. Without further evaluation, it is our opinion an estimate of useful life and/or an estimate of replacement cost cannot be determined at this time, or that the remaining useful life of the equipment exceeds 25 years, and as such, that there is no recommendation for Reserve funding at this time. We recommend that the client treat any required repairs as an ongoing maintenance expense, and to track/report such expenditures during future engagements. Funding may be incorporated into future Reserve Study updates if dictated by client project/repair history and/or vendor recommendations.

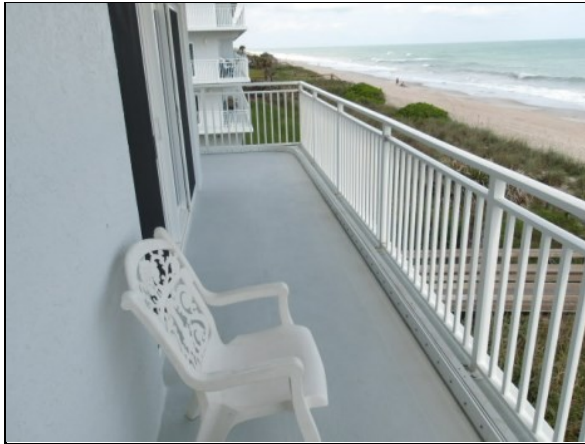
**Useful Life:**  
28 years

**Remaining Life:**  
20 years

**Lower Estimate:**

\$ 68,800

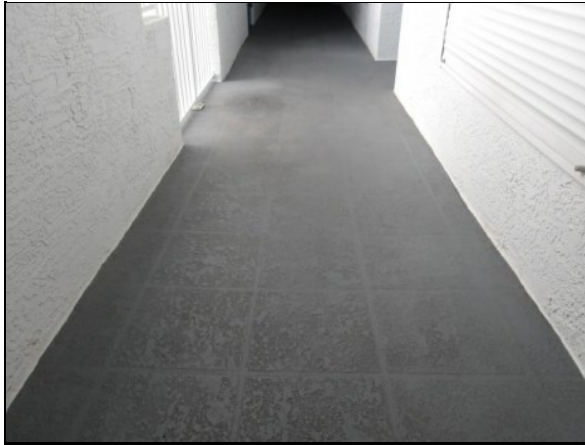
**Useful Life:**  
28 years

**Remaining Life:**  
20 years

**Lower Estimate:**

\$ 38,000

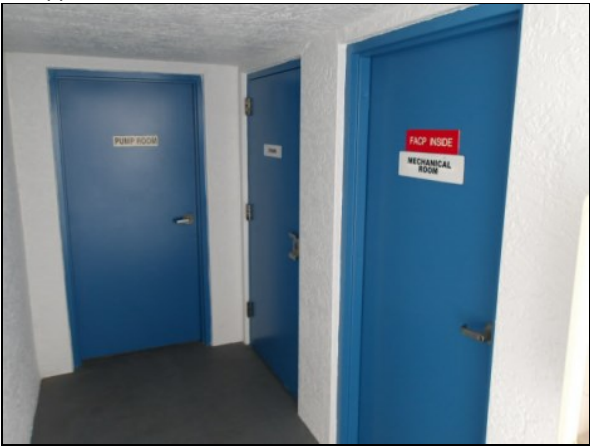
**Useful Life:**  
7 years

**Remaining Life:**  
5 years

| <b>Lower Estimate:</b> | \$ 28,400 | <b>Higher Estimate:</b> | \$ 34,700 |

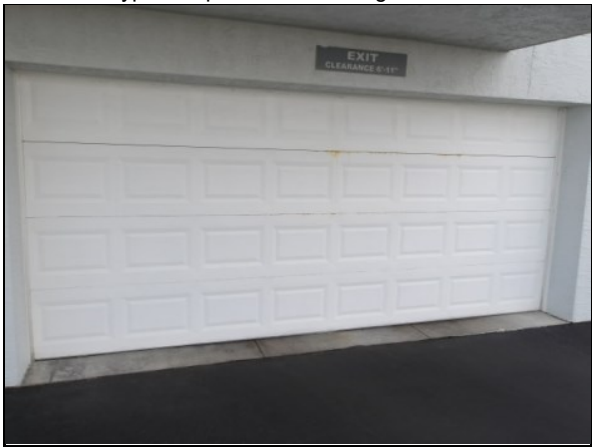
**Useful Life:**  
20 years

**Remaining Life:**  
15 years

| <b>Lower Estimate:</b> | <b>\$ 13,000</b> | <b>Higher Estimate:</b> | <b>\$ 15,800</b> |

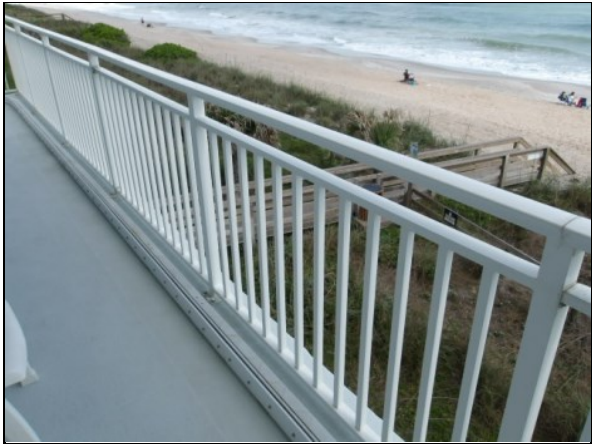
Useful Life:  
28 years

Remaining Life:  
20 years

Lower Estimate:

\$ 213,000

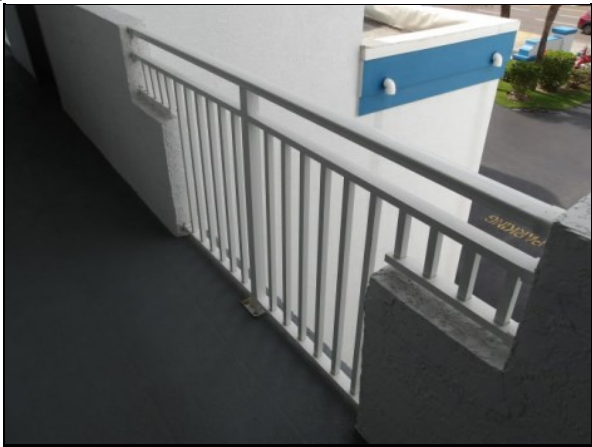
**Useful Life:**  
28 years

**Remaining Life:**  
20 years

| <b>Lower Estimate:</b> | \$ 11,700 | <b>Higher Estimate:</b> | \$ 14,300 |
