# **Pineapple House Condominium**

1437 Pineapple Avenue  
Melbourne, Florida 32935

## **Walkways and Exterior Condition Survey Report**

**September 23, 2022**

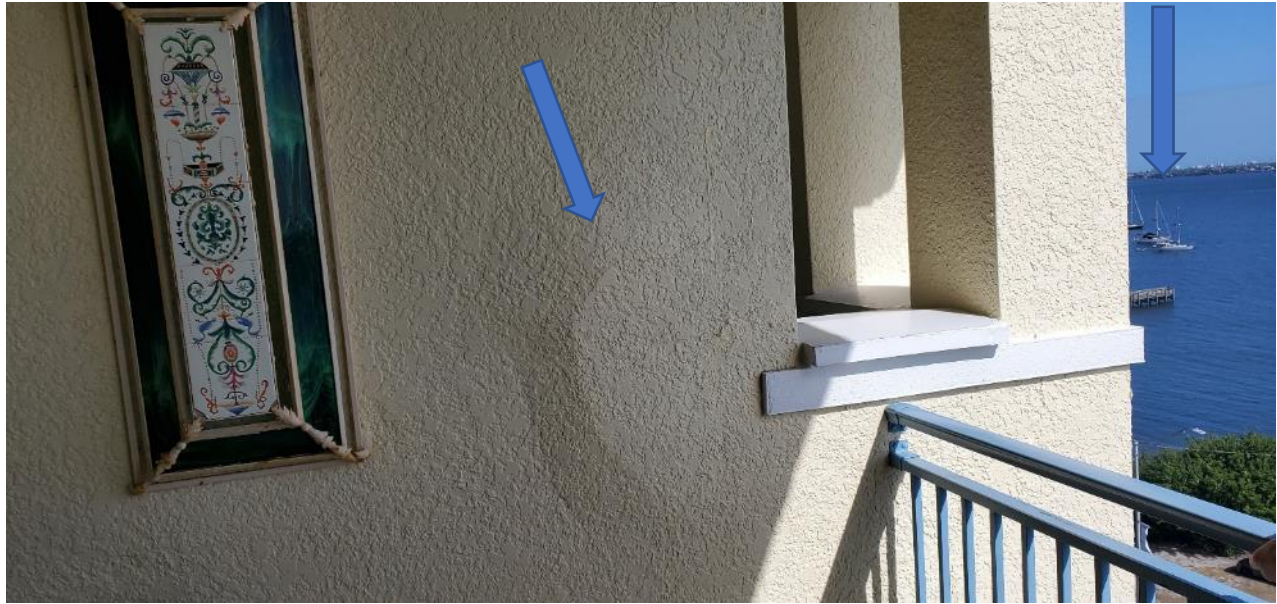
**Loose stucco on wall (Unit 801)**  
**Repair at next painting cycle**

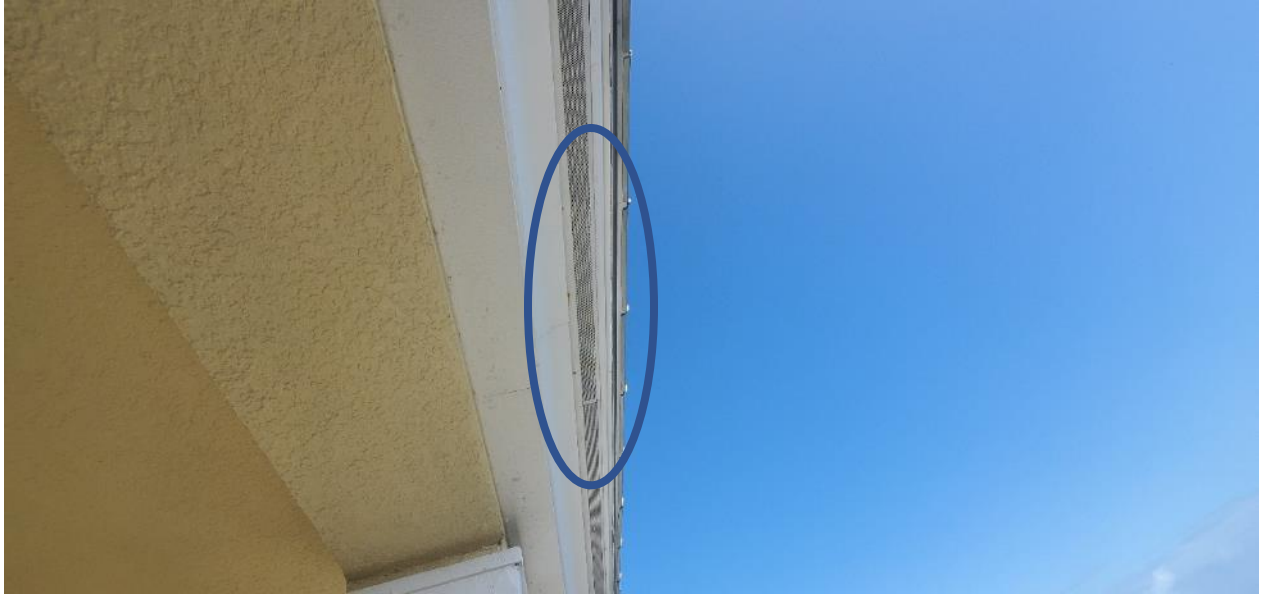
**Soffit separation and rust spots (Unit 802)**

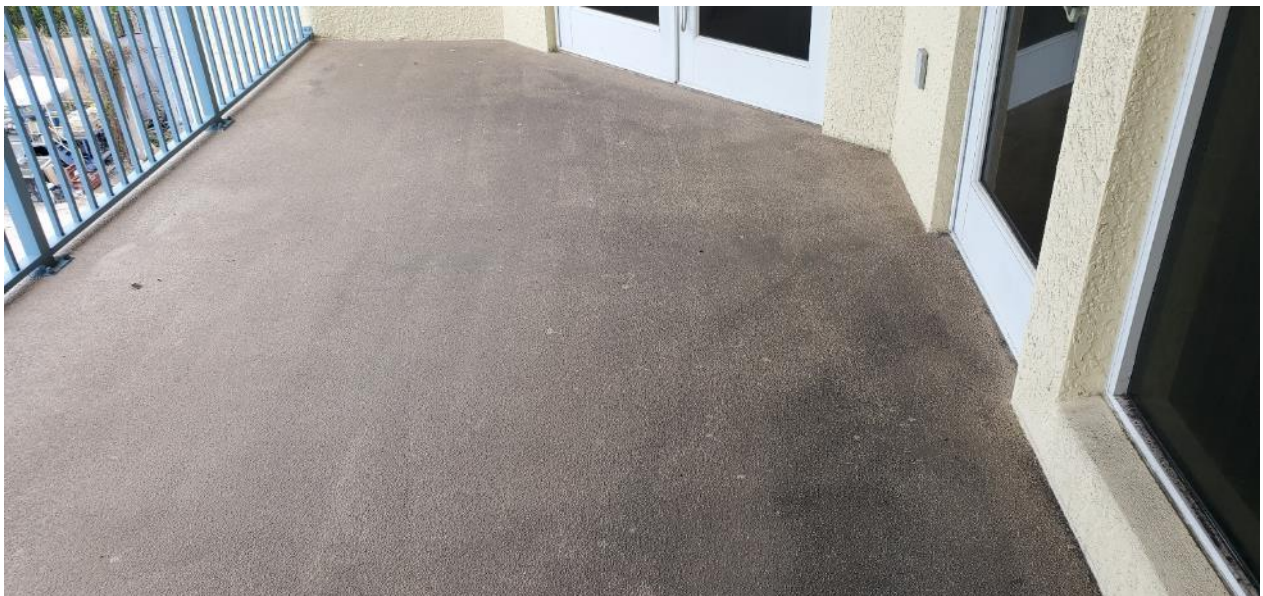
**Stained balcony surface. Possible candidate for cleaning and recoating as part of the next painting project. Drainage could be improved during a future restoration project.**

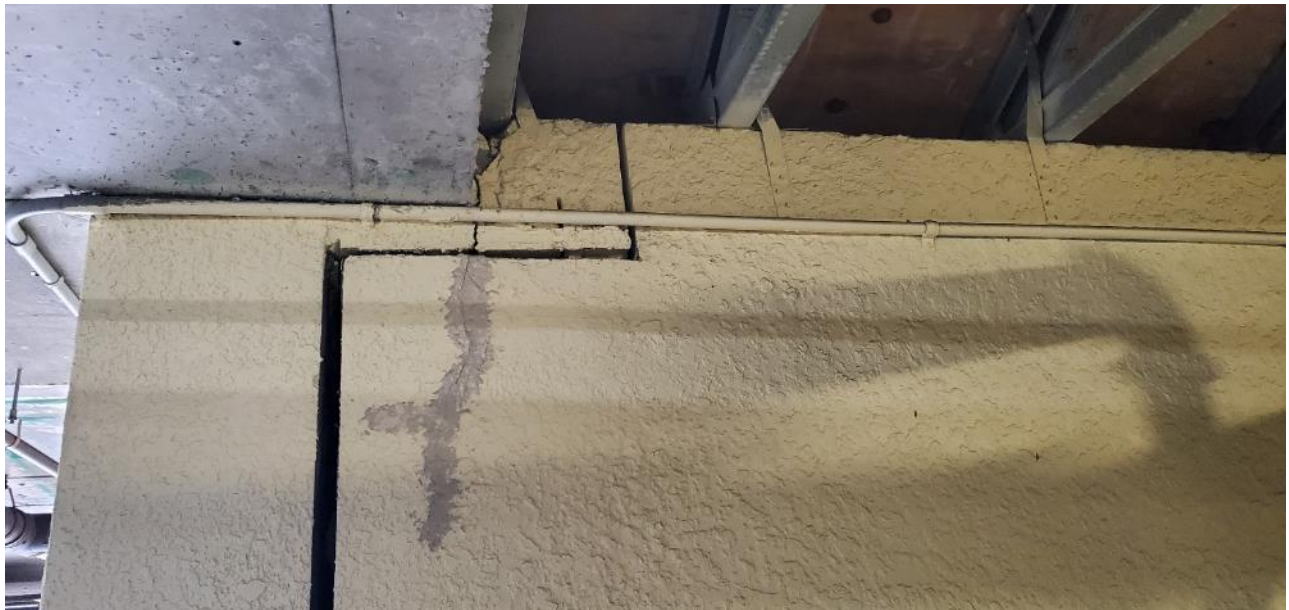
Concrete wall in garage with cracks  
Monitor for potential future concrete repair

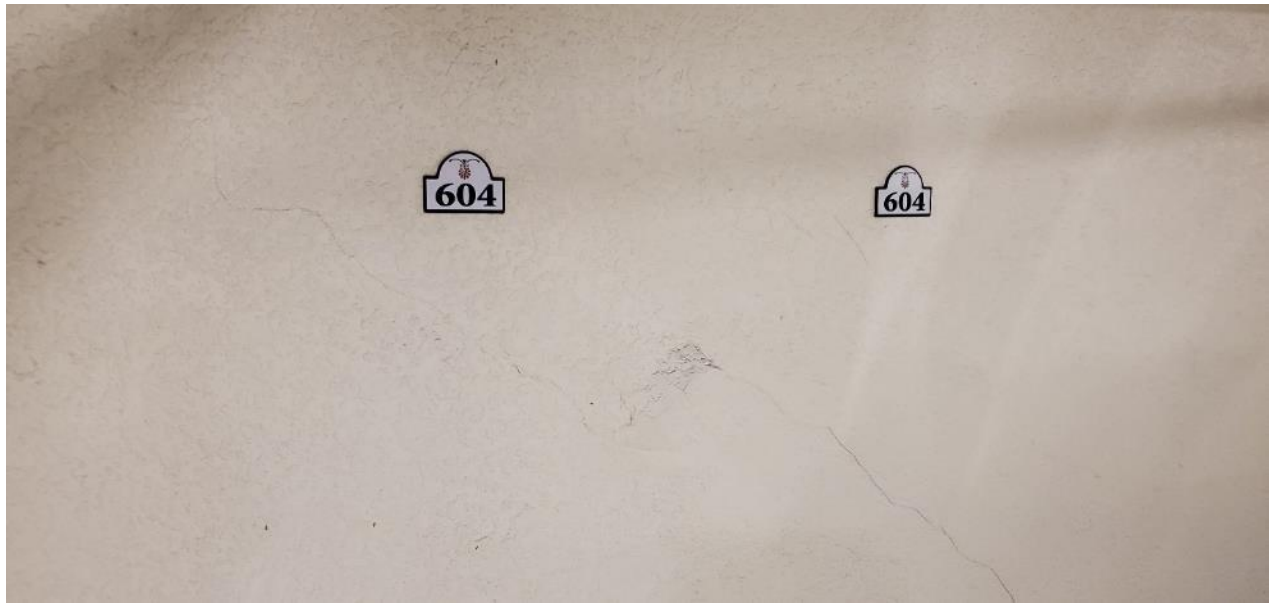
Concrete wall in garage with cracks and spalls  
Monitor for potential future concrete repair

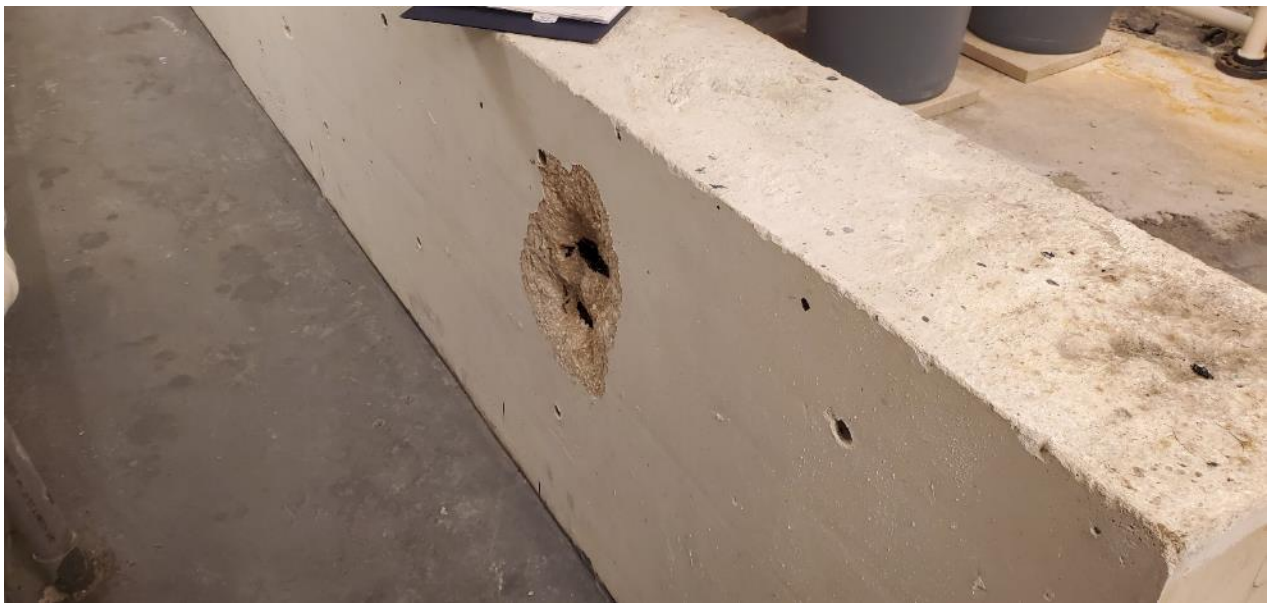
View of spalled knee wall in pool pump room (3<sup>rd</sup> Floor)  
Monitor for potential future concrete repair

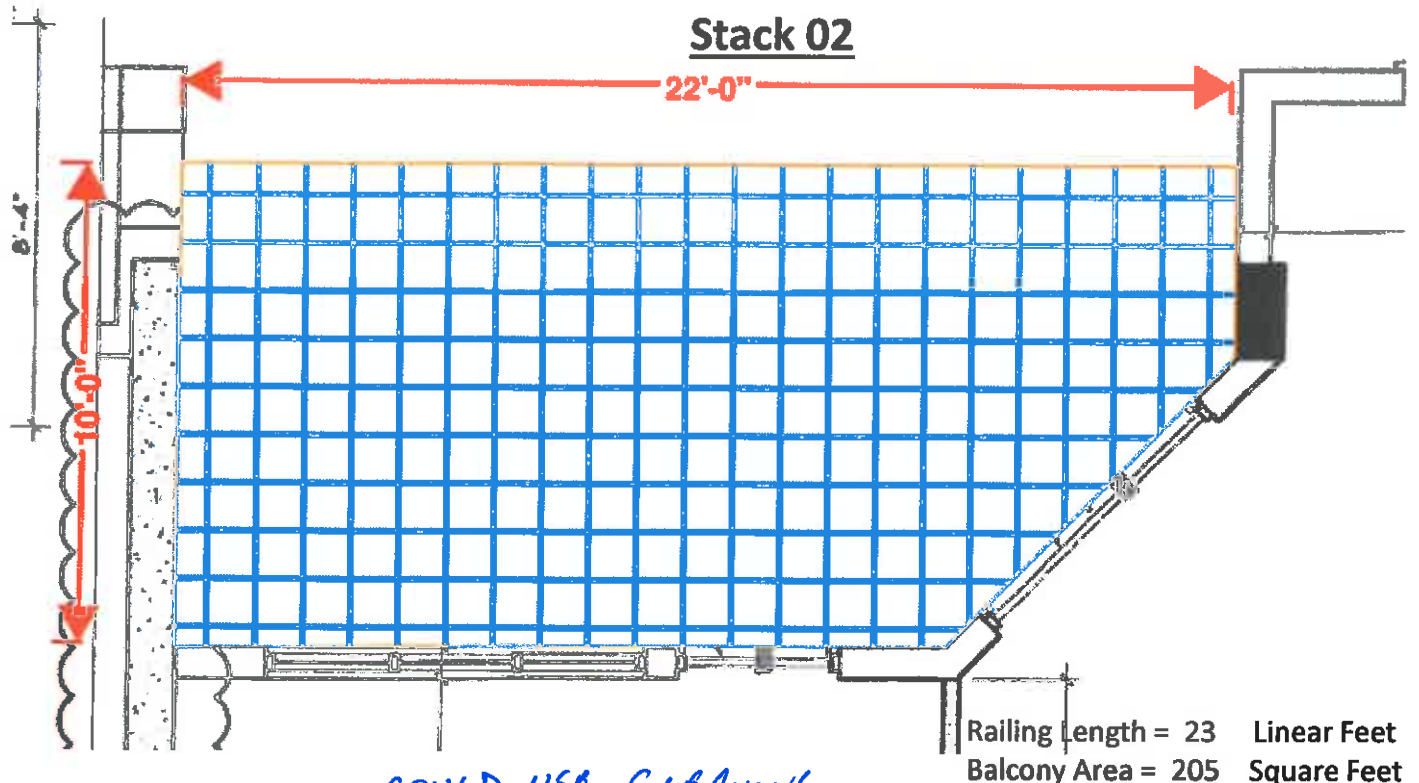
COULD USE CLEANING  
&  
RESURFACING

WINDOW SILL SPOT IN BR

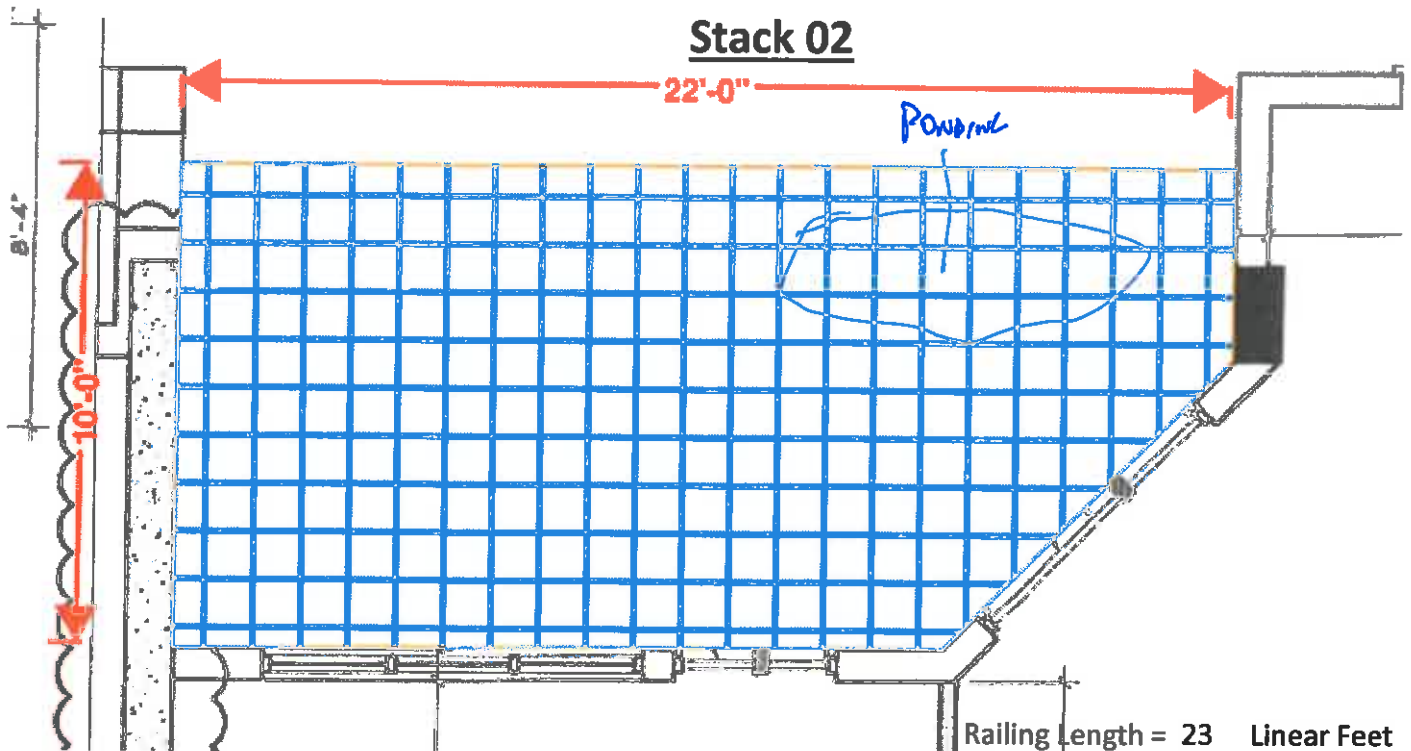
VIDEO SENT BY OWNER  
SHOWS PONDING DURING RAIN  
SHOULD DO FLOOD TEST  
AT SOME POINT.
