## Milestone Phase 2 Report RPO Condominium Association

Report Date: 🕒 🕒 2/24/2025

Inspection Date: 🕒 2/12/2025

1505 N Hwy A1A, Indialantic, FL, 32903

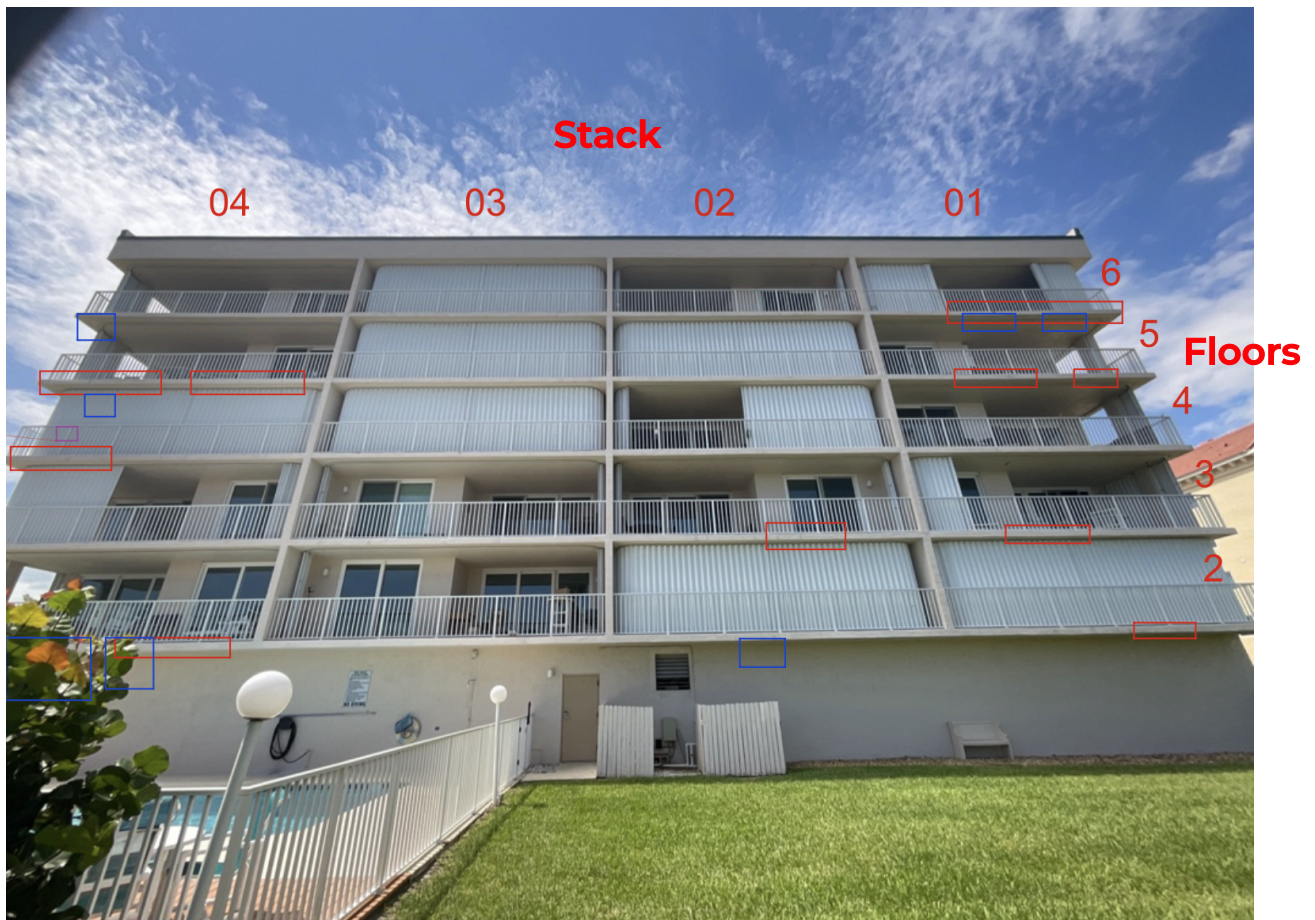
1. Concrete restoration is required for all balcony areas exhibiting face-of-slab cracks and soffit stucco delamination, due to the significant rebar deterioration identified at representative locations, including the Unit 504 balcony slab edge and the soffit below the Unit 204 balcony. Figure 1 below illustrates all identified areas with similar damage.

Figure 1. Areas of required remediation based on findings at representative areas during Phase II investigation. Areas in red signify slab edge cracks, areas in blue signify soffit damage, and areas in purple signify column damage.

During the remediation process, deteriorated concrete should be removed until sound material is reached and the exposed reinforcement is free of corrosion. Concrete should be chipped away around the full circumference of the rebar, providing sufficient clearance for thorough cleaning and treatment. The rebar should then be coated with a rust inhibitor before concrete patching. If more than 20% of the rebar's cross-sectional area has been lost—such as the severely corroded rebar observed at the Unit 504 balcony—it must be replaced. Additionally, all areas with excessively low reinforcement placement, such as below the Unit 204 balcony, should have the affected rebar replaced to ensure the slab maintains its intended strength.
