# Existing Structures

**River Club Condominium**

**1525 Minutemen CWSY**

**March 7, 2022**

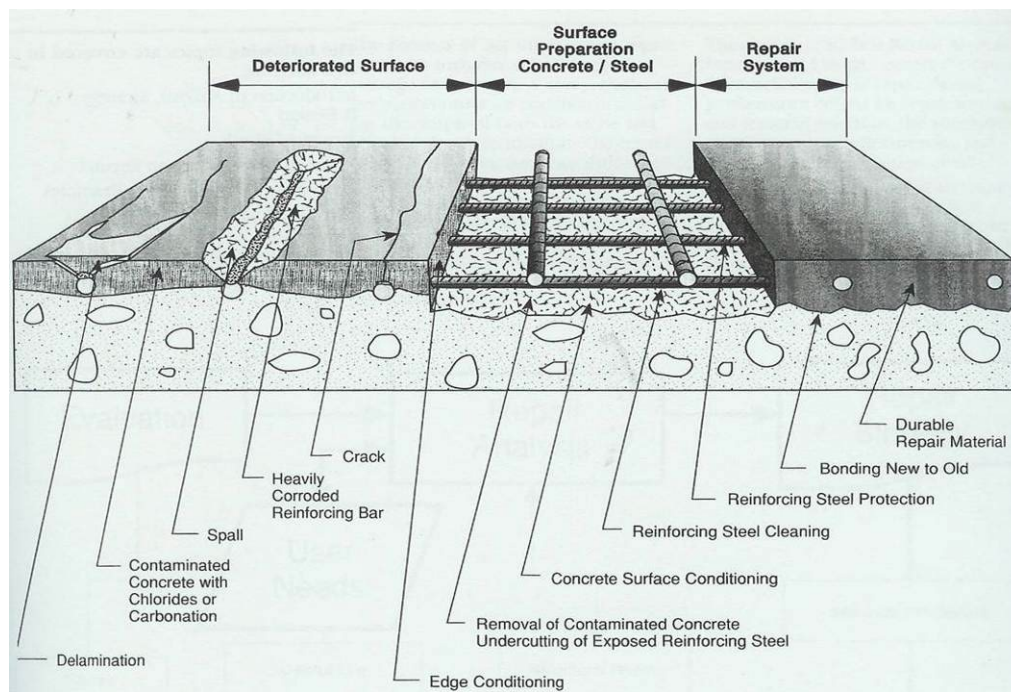
Figure 1: Deteriorated concrete proceeding to repair system

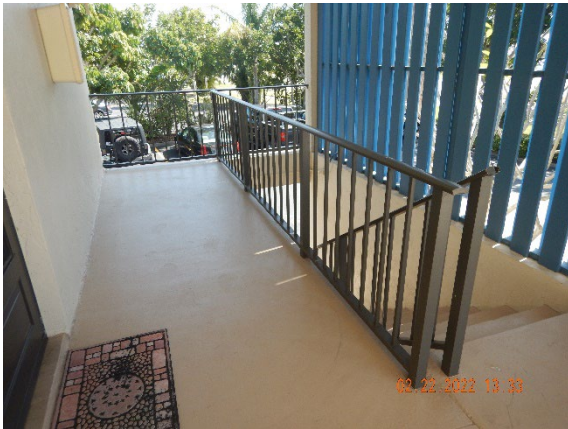
The stair treads themselves all appear to be in fair condition. It is recommended that the current coating be removed, and a new hybrid coating system with a knock down texture be installed. This is an asset preservation item as well as an aesthetic one.

Photograph 1: East stairway

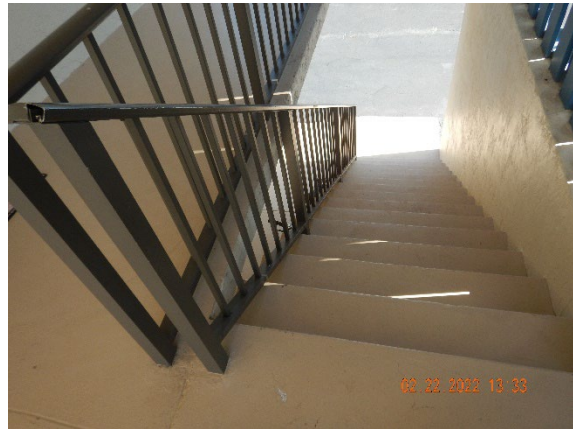
The stairway railings are of aluminum construction and are not compliant with current building code due to excessive rail spacing ( $>4"$ ) and not of minimum required height.

Photograph 2: Typical stairway railing

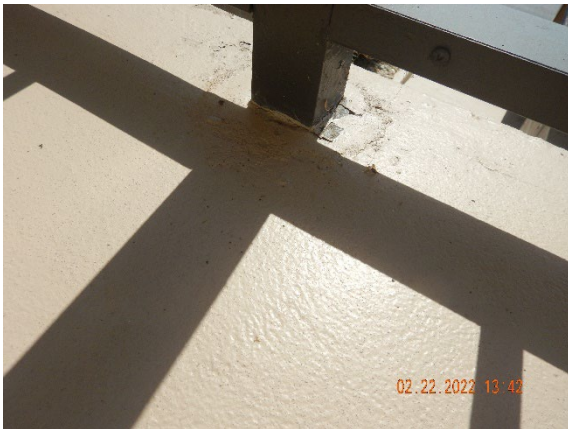
Photograph 3: Embedded post pocket

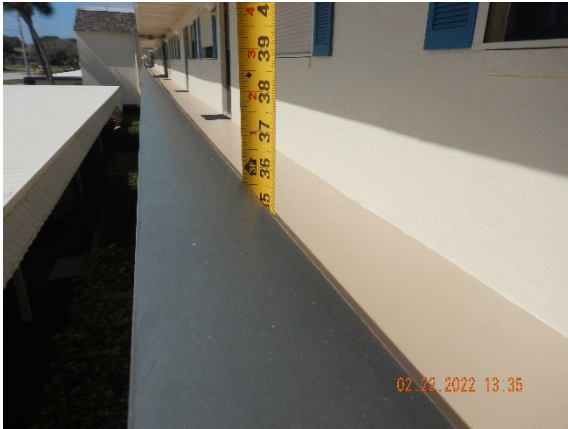
The walkway railings are of aluminum construction and are not compliant with current building code due to excessive rail spacing ( $>4"$ ) and not of minimum required height. The railings are in fair condition but are starting to show signs of corrosion. This is an asset preservation item as well as an aesthetic one.

Photograph 5: Aluminum guardrail **Not** to current building code

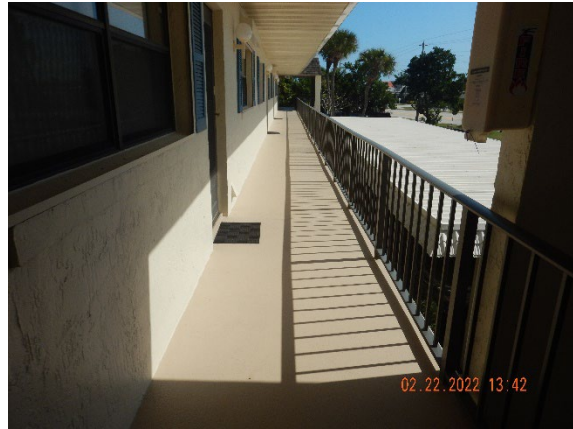
Photograph 6: Typical walkway guardrail

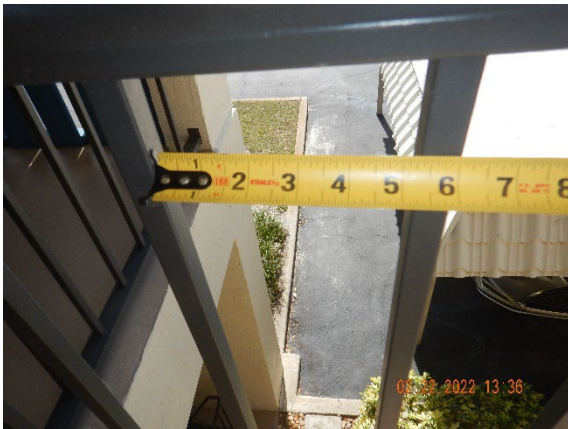
Photograph 7: Excessive rail spacing **Not** to current building code

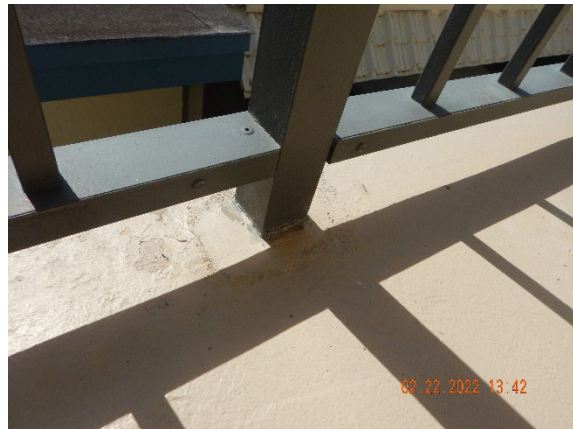
Photograph 8: Embedded rail post

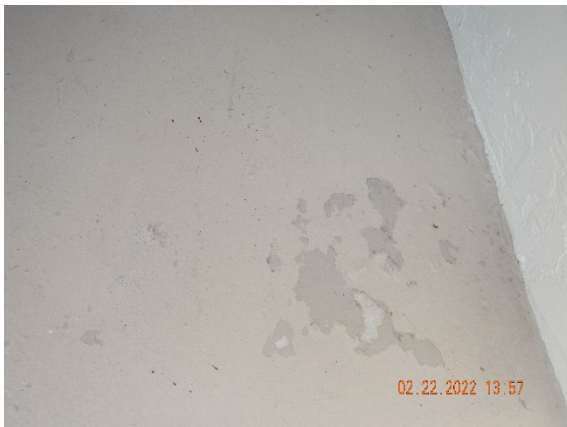
The walkways have a textured acrylic coating system throughout. The texture on the elevated walkway has been worn down or was never there to begin with. This could result in a slip hazard and injury. The coating is in fair condition but beginning to fail in a few areas. Besides the aesthetic reasons and a potentially slick surface, a failed coating provides no corrosion protective qualities. It is recommended that the current coating be removed, and a new hybrid coating with a knock down texture be installed on the elevated walkway.

Photograph 9: Chipped textured acrylic coating

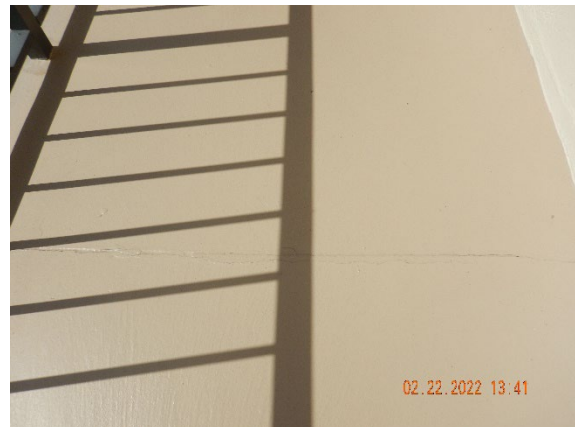
Photograph 10: Coating with very little texture

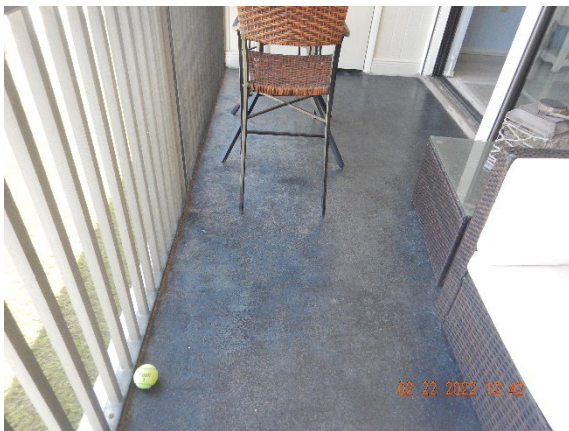
The elevated balconies are constructed of hollow core planks with CMU partition walls and wood frame storage sheds. The cracks that are telegraphing through the coating are likely to be where two planks come together. Temperature changes can cause these planks to move independently of each other causing the cracks. ESE recommends stripping the deck to bare concrete/overlay and installing a hybrid coating system with a urethane base coat and an acrylic topcoat. This system gives the most protection while also having some elastic characteristics to help bridge the panels and prevent some of the cracking. It also allows the ease of maintaining an acrylic topcoat system. This system should eliminate the issue with water leaking into the units below. This is an asset preservation item as well as an aesthetic one. Steel furniture, rugs and other floor coverings are NOT recommended on elevated concrete decks. Steel furniture rusts and damages the coating. Rugs retain moisture and hold water against the concrete and the rubber backings can also damage coatings.

Photograph 11: Some kind of stain & sealer

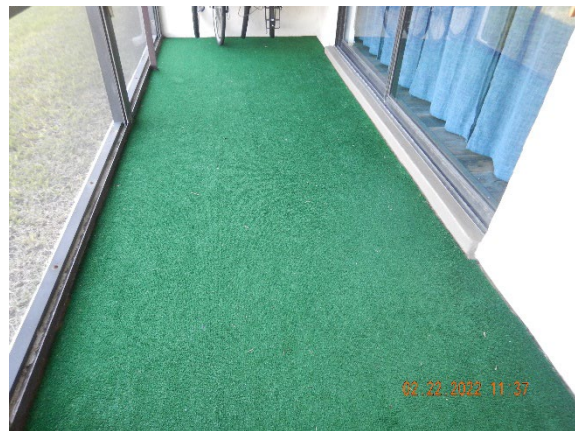
Photograph 12: 4 Carpet on the deck

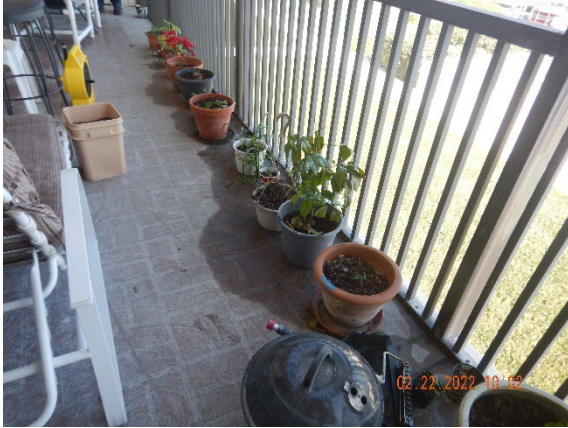
Photograph 13: Linoleum sheet with plants

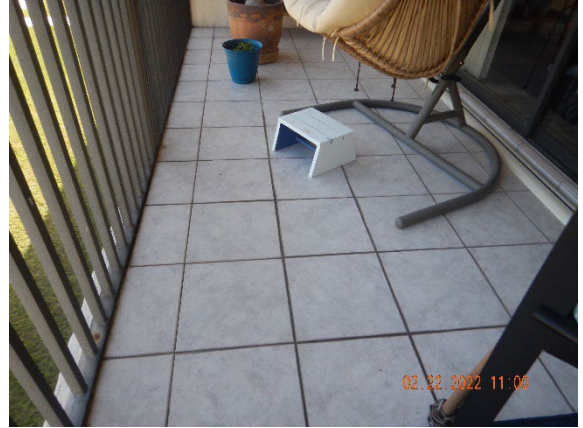
Photograph 14: Tile

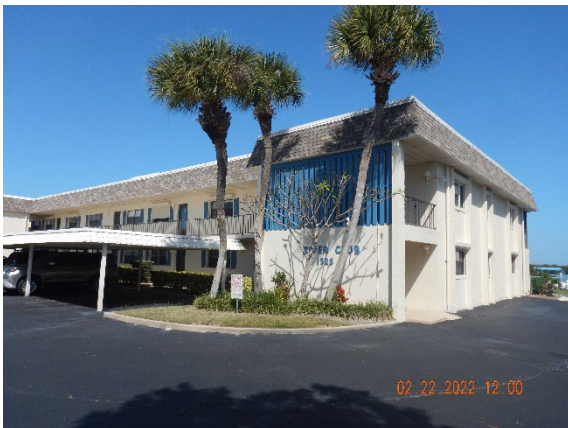
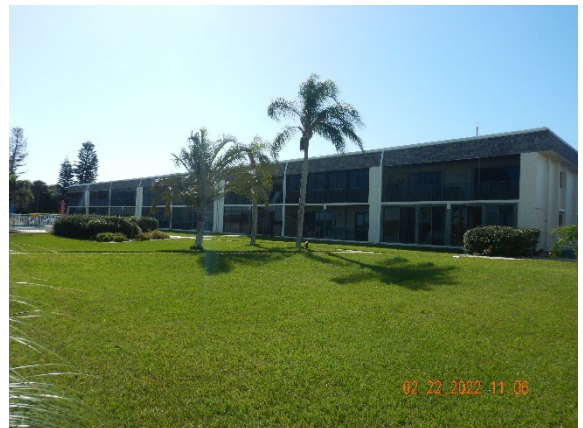
The building envelope is in good shape and only minor action is required at this time. There is delaminated stucco at the ends of the balcony beams where the planks meet. The water is coming through the seam and disbonding the stucco from the beam. The community should plan on a waterproofing/paint in the next five years. This is an asset preservation item as well as an aesthetic one.

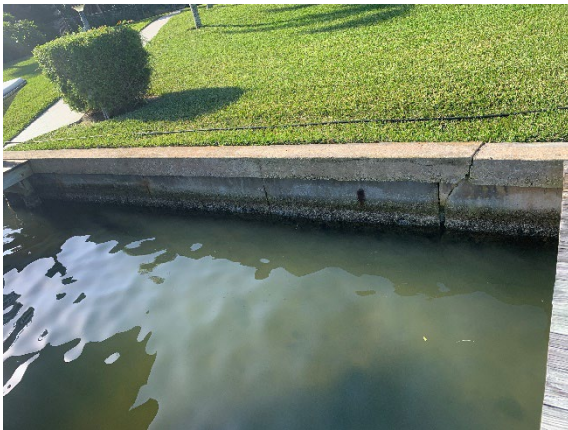
The reinforced concrete seawall cap and panels were reported installed during building construction in ~1977. The seawall is 287' long with expansion joints on 45' centers. The RC seawall cap is 9" d x 12" and resides on precast concrete panels. It is reasonable to expect a 30 year service life out of a traditional concrete seawall and this seawall is showing signs of aging and corrosion damage. The seawall exhibits several corrosion cracks from rebar spalling and soon these cracks will join at corner rebars and result in exposed rebar spalling. The seawall is still serviceable but we would expect corrosion spalling to cause unrepairable damage in less than five years. The CoA should plan on replacing the seawall in ~5 years. Discussion was entertained about replacing just the seawall cap but leaving 45 year old seawall panels under a new cap is not advisable.

Photograph 15: Seawall panel and cap

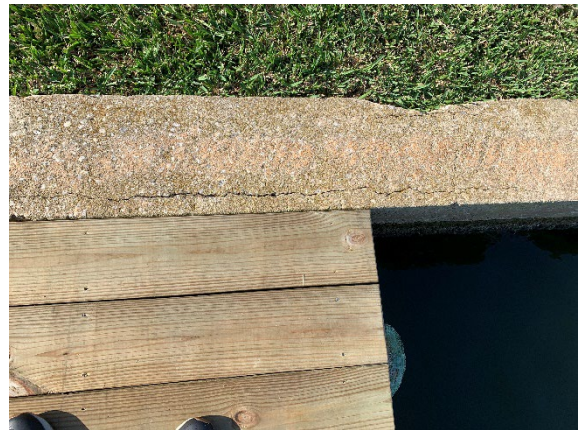
Photograph 16: Typical crack

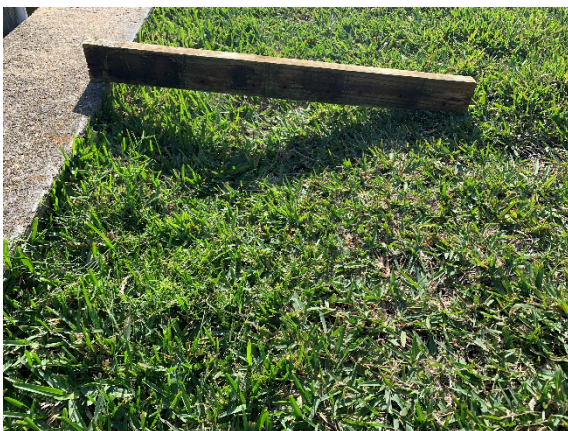
It was also noted that the sod next to the seawall exhibited “washout” or hidden erosion. This is normal and should be address by bringing in more earthen fill.

Photograph 15: Straight edge showing washout

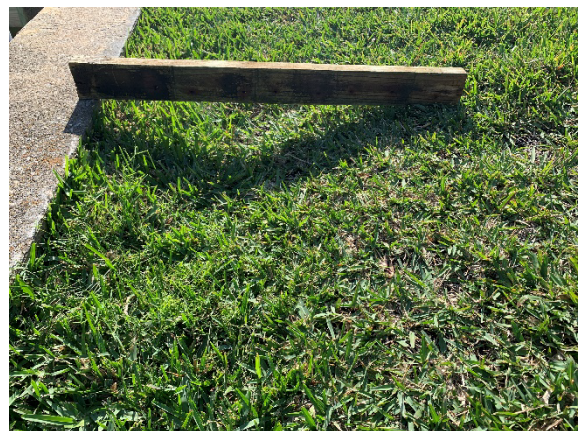
Photograph 16: Different location washout

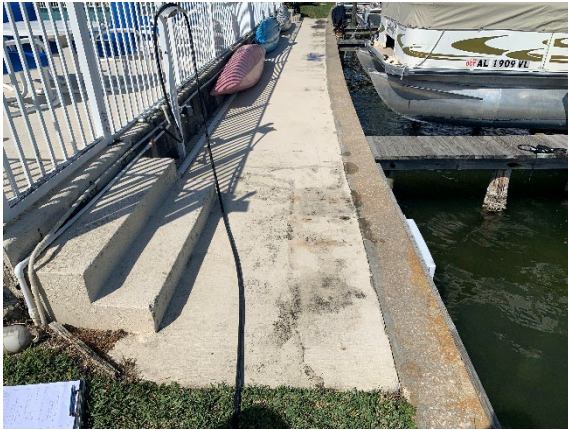
Photograph 15: Pool deck walkway

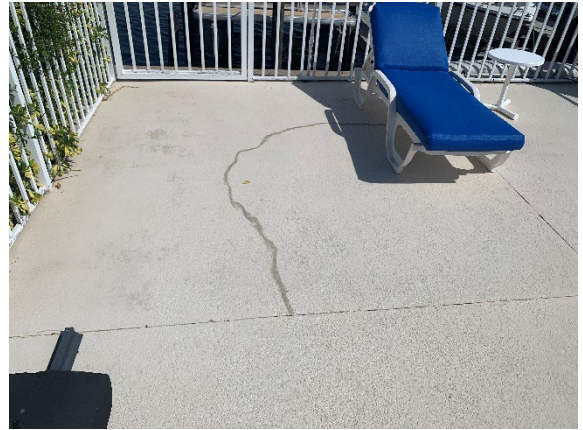
The pool deck walkway is a concrete 65' x 6' sidewalk between the pool and seawall and is unremarkable. The pool deck is ~45' x ~65' concrete with a textured acrylic coating. The pool deck exhibited some minor cracking which had undergone an attempted repair. Cracked concrete always “telegraphs” through “cool deck” and we are not aware of an adequate repair. We suggest maintaining the present coating and monitoring the cracking.

Photograph 16: Pool deck and crack
