**Milestone Phase I Report**  
**R.P.O Condominium Association, Inc.**

Report Date: 10/21/2024

Inspection Date: 9/19/2024

1505 N Hwy A1A, Indialantic, FL, 32903

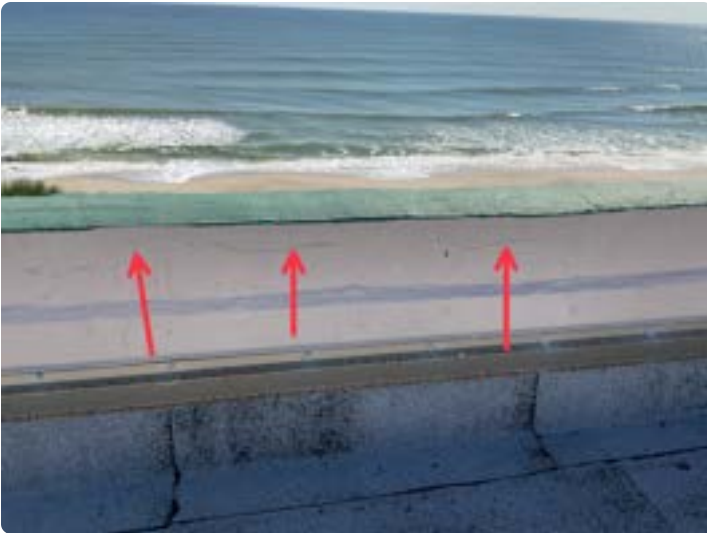
Hairline crack on roof parapet wall

| Maintenance | <ul style="list-style-type: none"><li>• Rout and reseal hairline cracks on roof parapet wall.</li><li>• Clean corrosion on metal roof with a wire brush. Coat with rust inhibitor before repainting.</li></ul> |

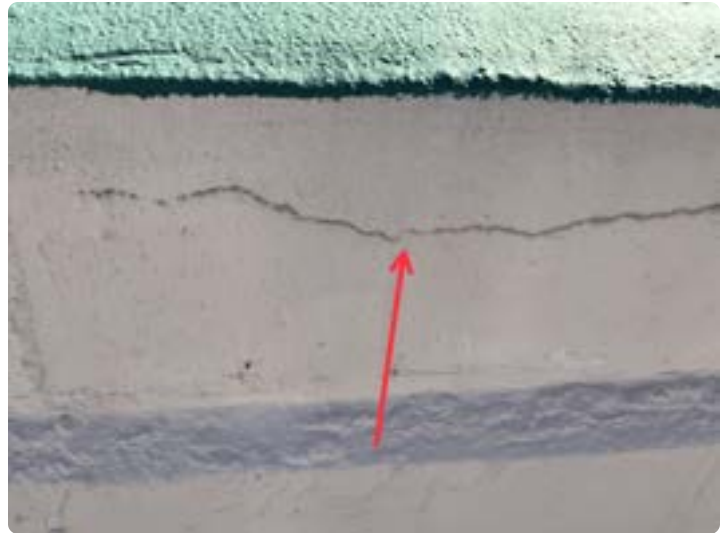
Zoomed photo of hairline crack on roof parapet wall

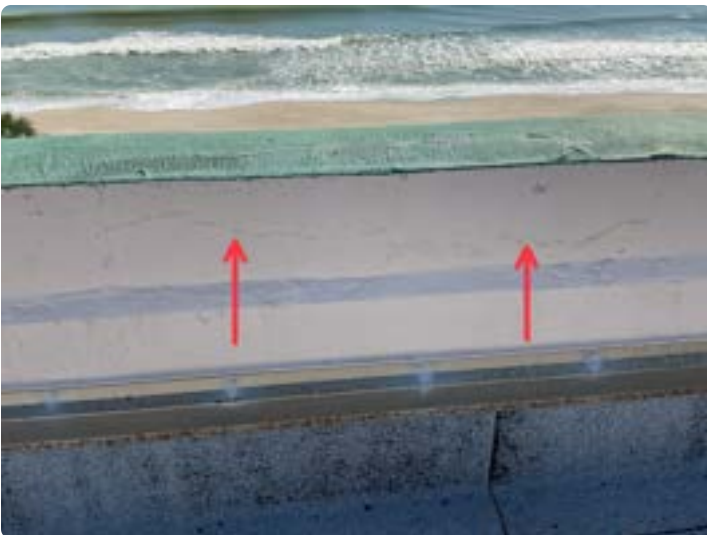
Hairline crack on roof parapet wall

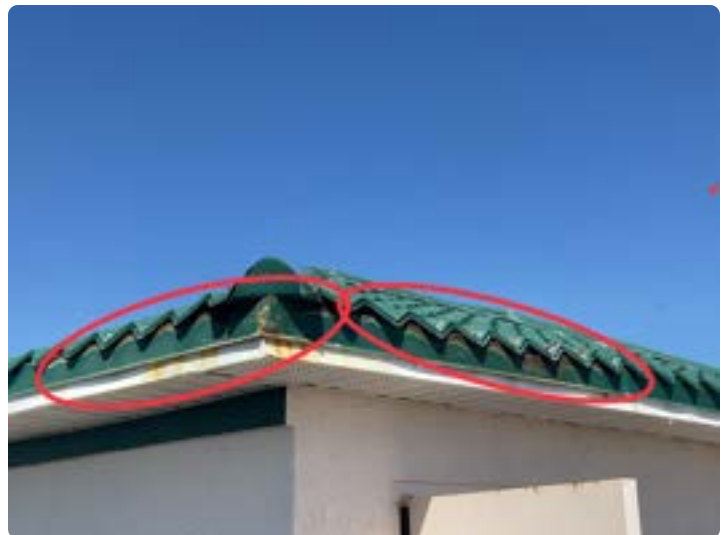
Corrosion on metal roof

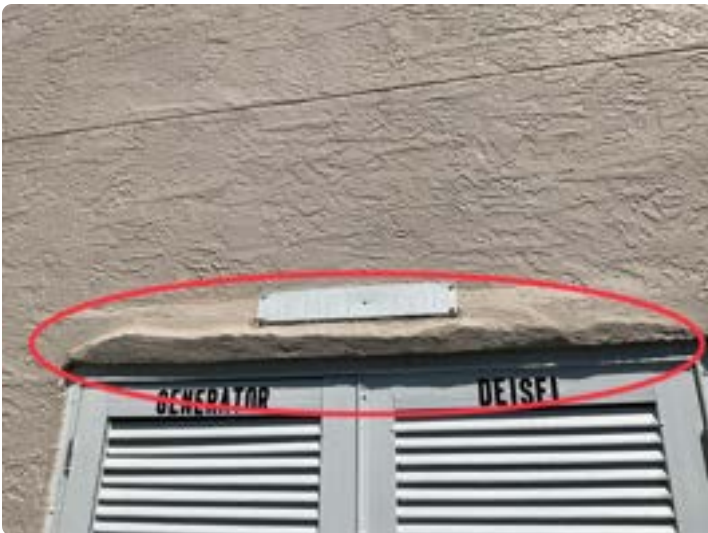
Failed previous remediation above generator room door

| Maintenance | Chip away concrete at area of failed remediation above generator room door. Re-patch area ensuring it is flush with the existing wall. |

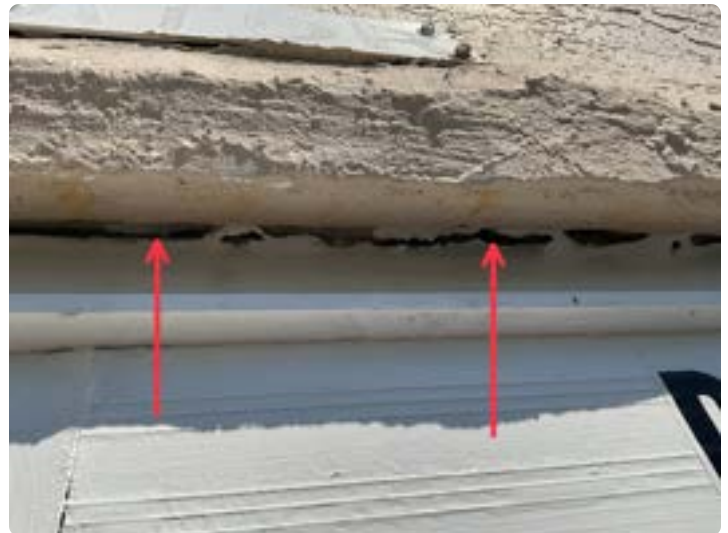
Failed previous remediation above generator room door

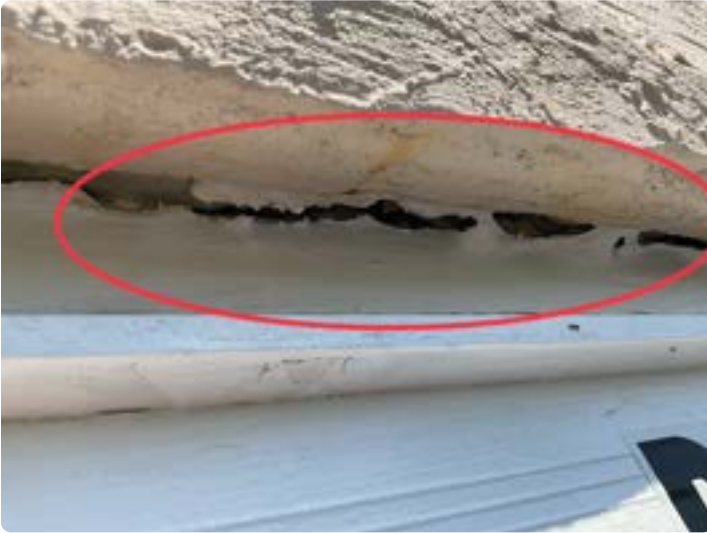
Failed previous remediation above generator room door

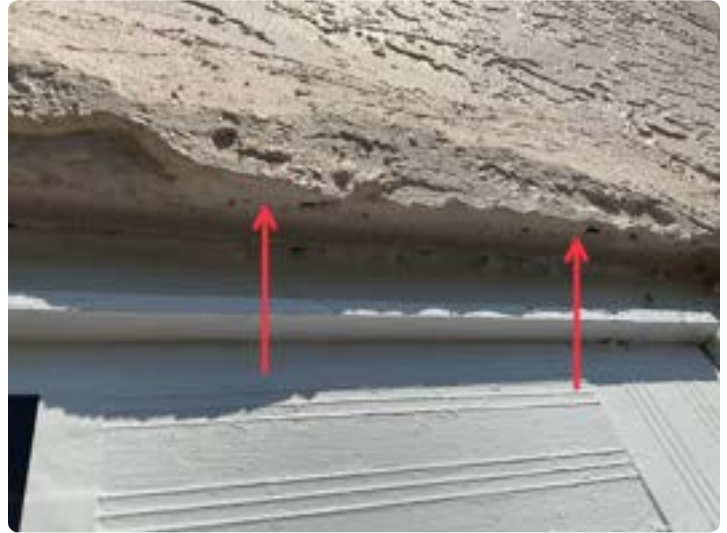
Failed previous remediation above generator room door

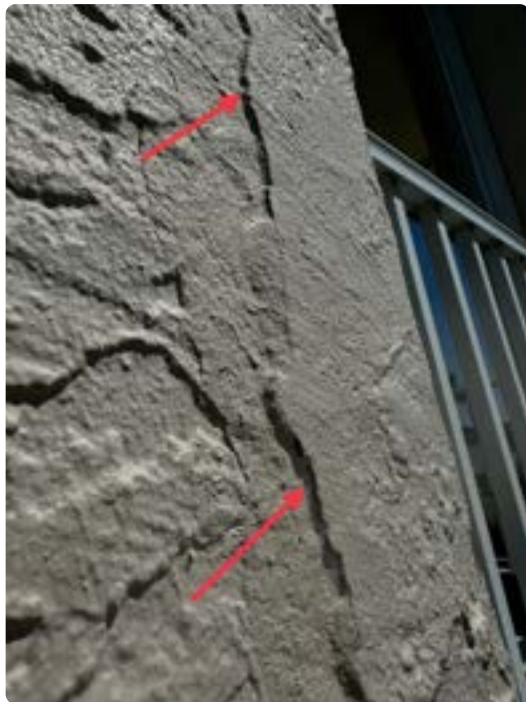
| Deficiencies | <p>Cracks were identified on the right elevation wall, near the balcony edges, for four out of the five floors. The cracks are occurring at a corner near where the CMU block exterior walls meet the metal stud-framed sliding glass door wall on the balconies. The building plans indicate that the CMU blocks in the area are filled with rebar. The fifth floor unit and the third floor unit were accessed to view the interior damage caused by the cracks. The fifth floor unit did not have an obvious crack on the exterior of the building, but had some drywall damage on the interior. The third floor unit did contain cracks on the exterior of the building and, when entering the unit, water damage was identified in the wood sheathing, metal studs, and carpet near the area. The unit owner removed the drywall and the area was still open during the inspection.</p> <p>The cracks on the exterior of the building appear to have had some previous remediation. This previous remediation was not sufficient as the cracks are resurfacing. Additionally, the unit owner in the third floor unit indicated to SIG during the inspection that water intrusion is still a current issue.</p> <p>A Phase II investigation with destructive testing is required to examine the mortar joints and condition of the CMU block at the areas with cracks.</p> |

Failed previous remediation on first floor, far-right side of right elevation

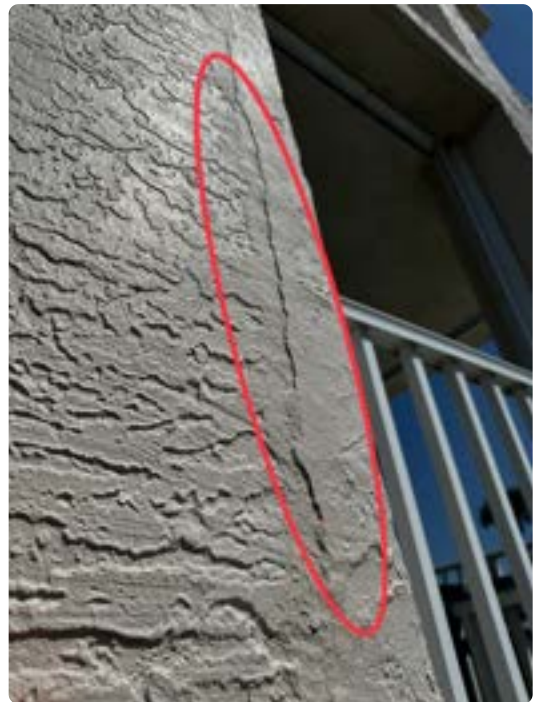
Failed previous remediation on first floor, far-right side of right elevation

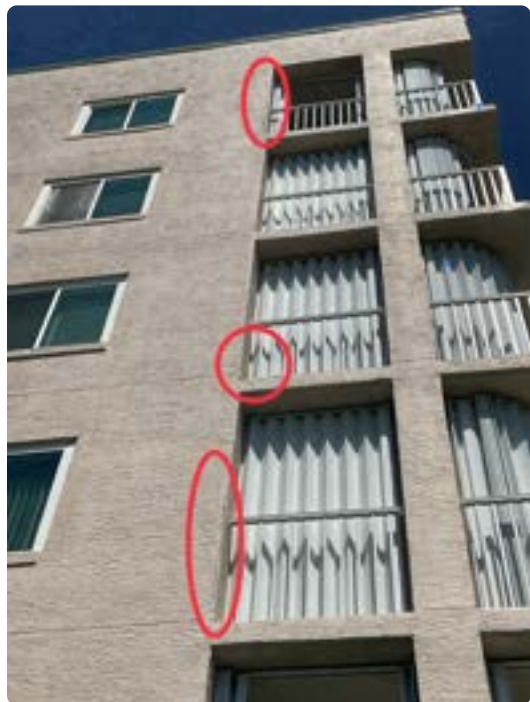
Similar damage identified on 3rd, 4th, and 6th floors on far-right side of right elevation

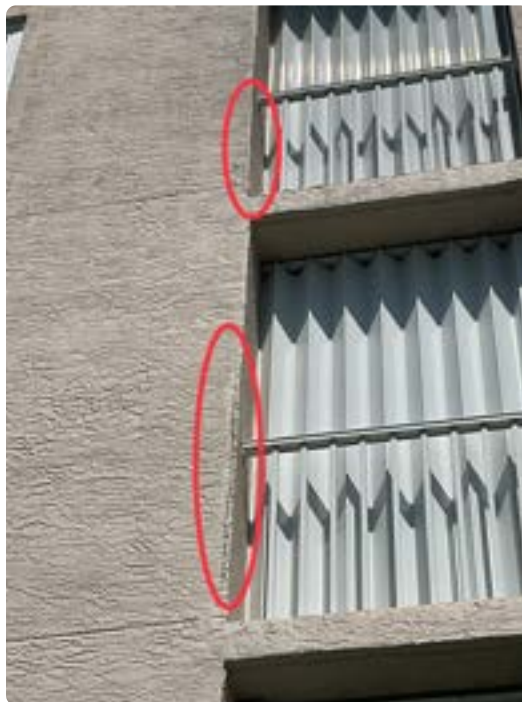
Zoomed photo of 3rd and 4th floor

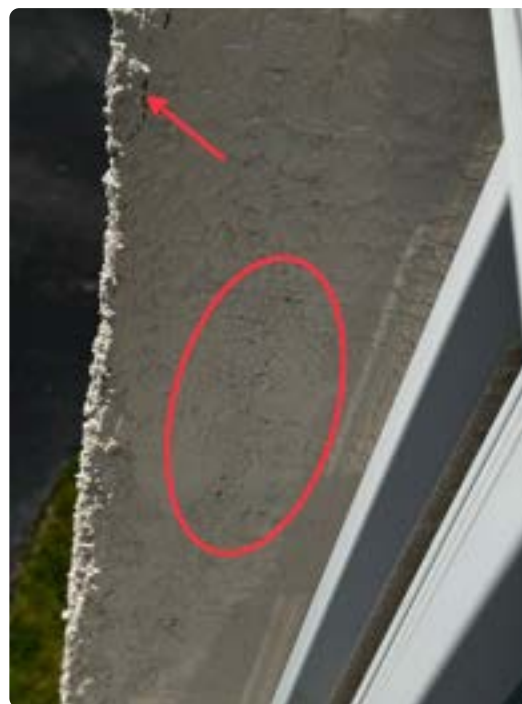
Photo of cracks on third floor from unit balcony

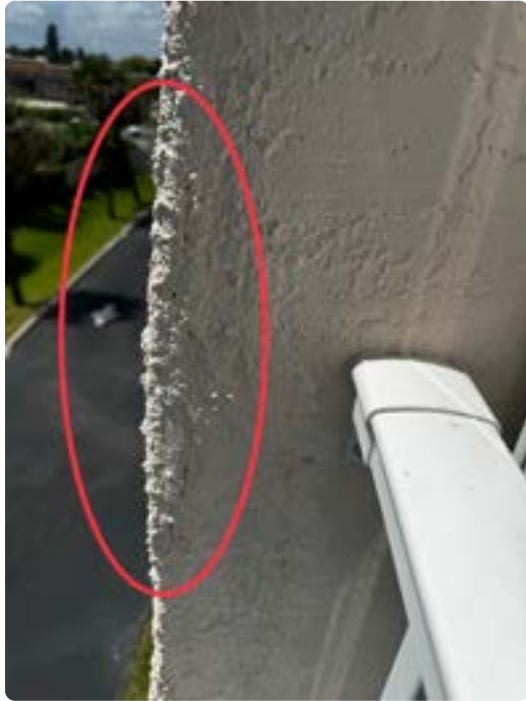
Photo of cracks on third floor from unit balcony

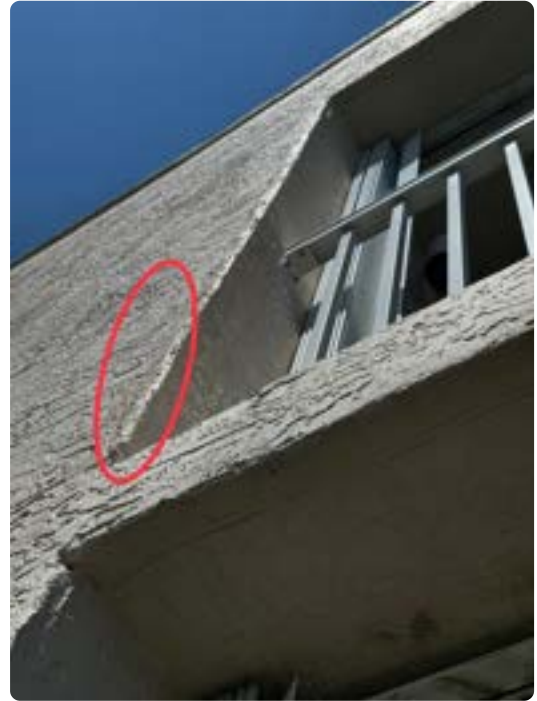
Photo of cracks on 6th floor from 5th floor balcony

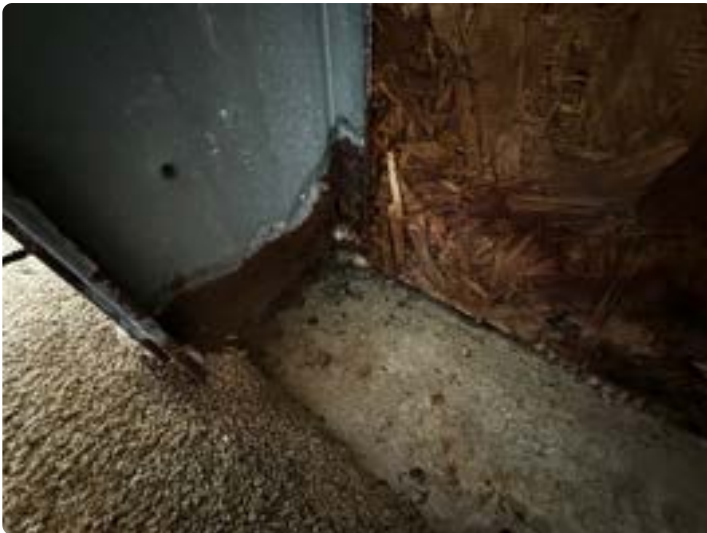
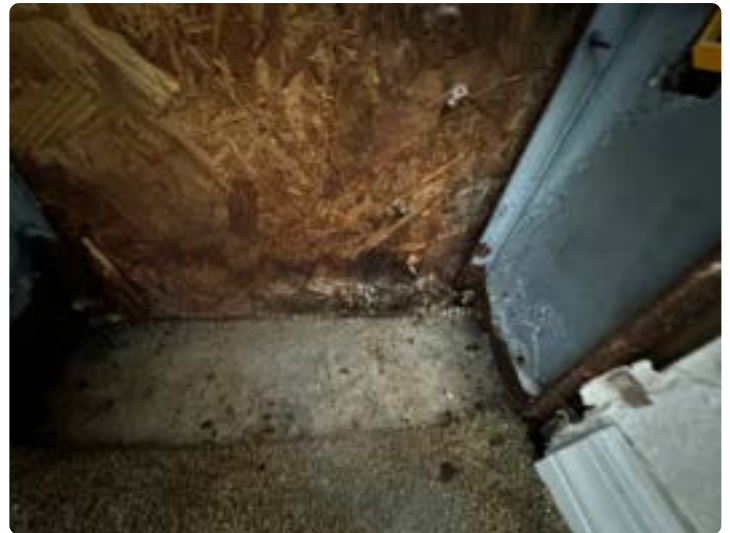
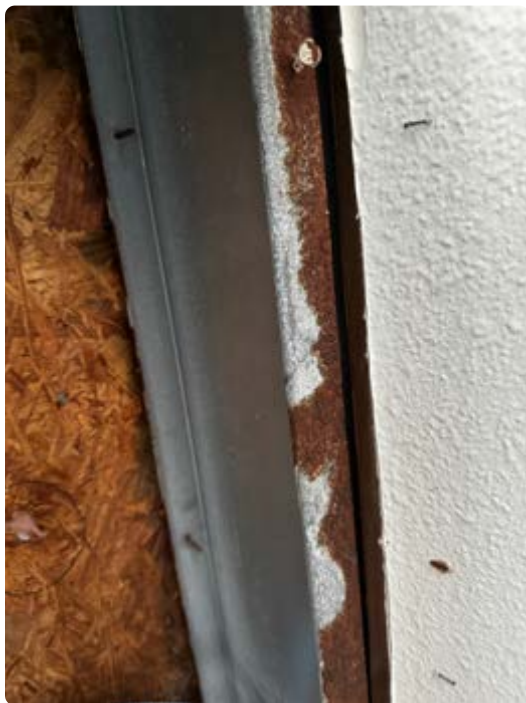
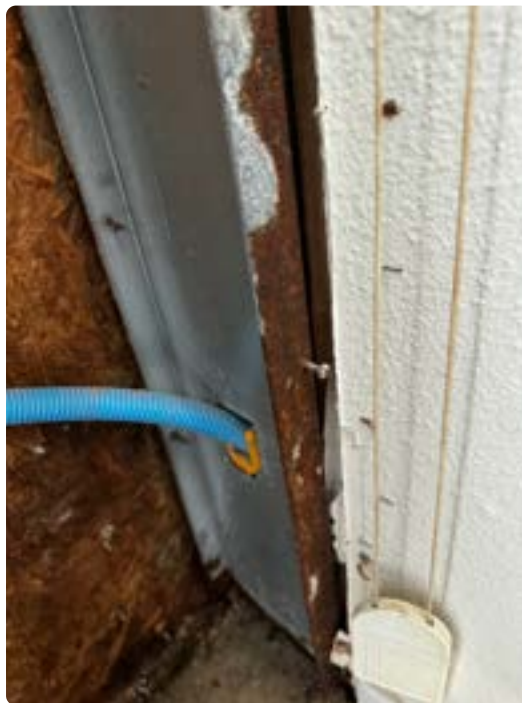
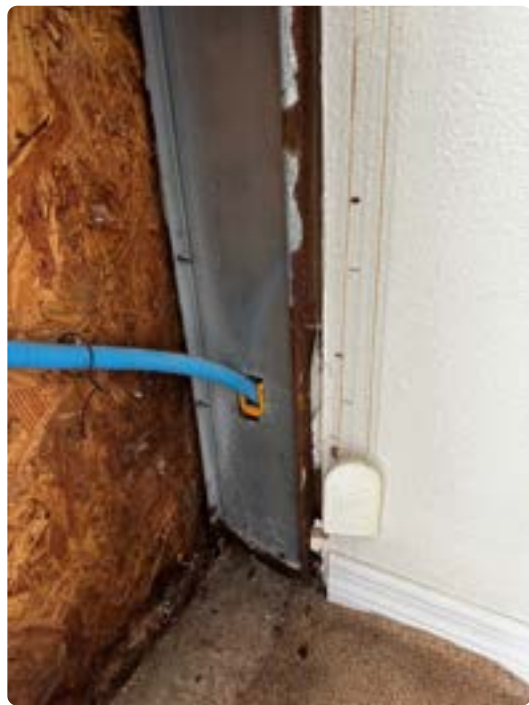
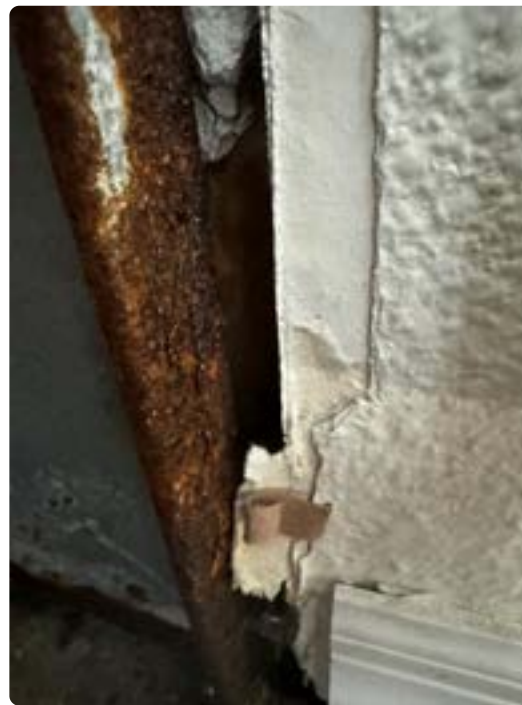
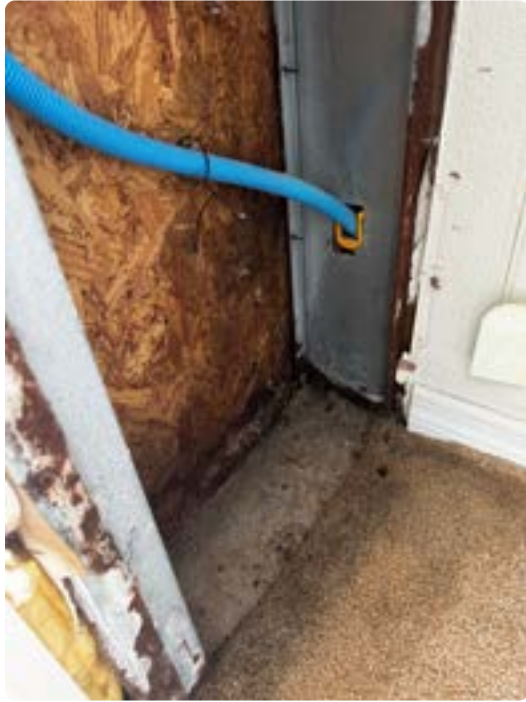
Water damage to sheathing and corroded steel studs due to water intrusion into Unit 304

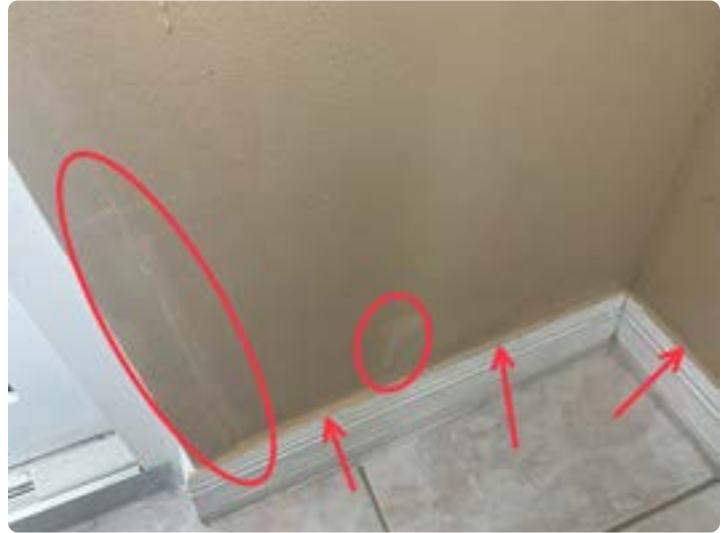
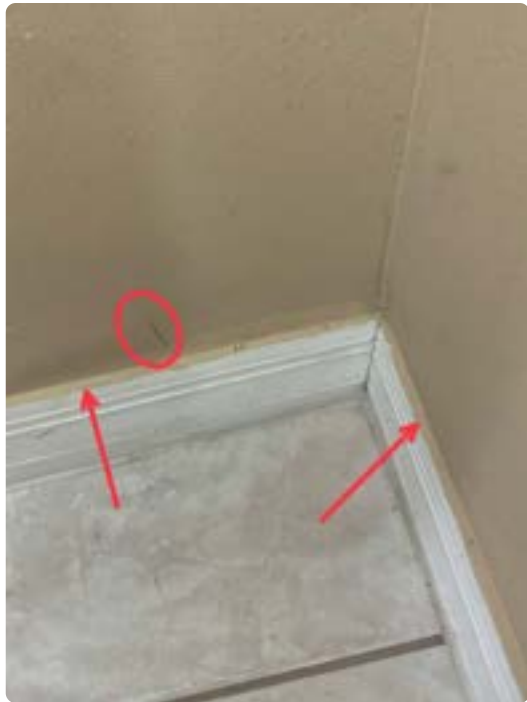
Drywall damage and re-painted area between wall and baseboards in Unit 504

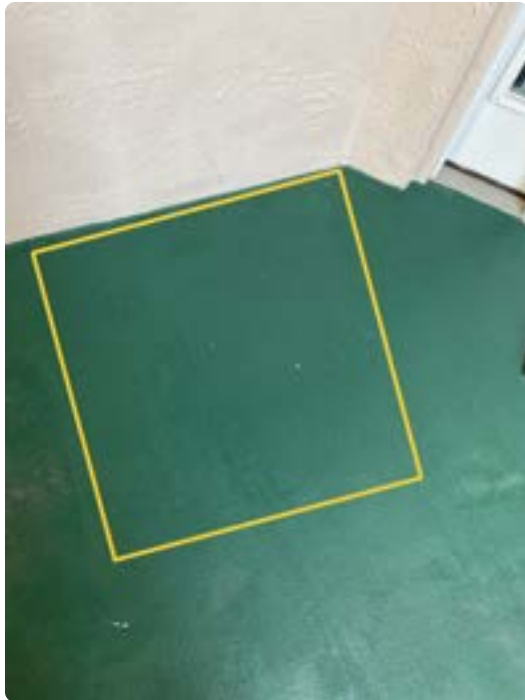
Hollow area on walkway near Unit 504

| Maintenance | <ul style="list-style-type: none"><li>• Multiple hollow areas identified on walkways. Hollow areas are likely due to delaminated coating, as no signs of distress were identified on the underside of the slabs. Due to the high amount of areas with delaminated coating, it is recommended that the coating on the walkways be completely removed and a new coating applied during the next walkway painting cycle.</li><li>• Rout and reseal crack at edge of walkway near Unit 502.</li></ul> |

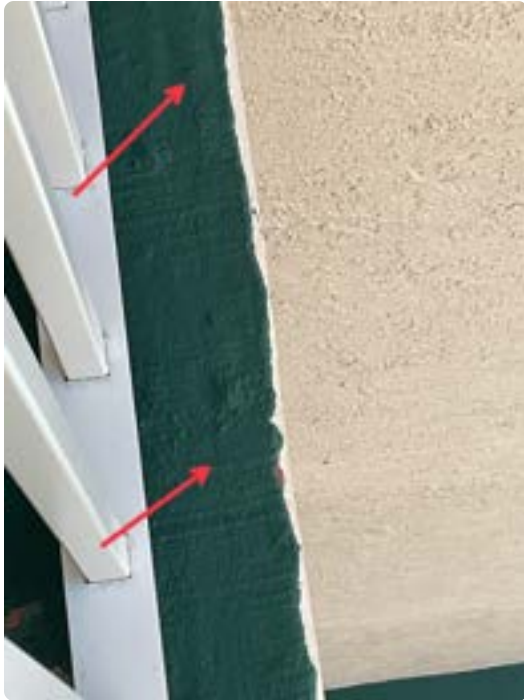
Crack in 5th floor walkway near Unit 502

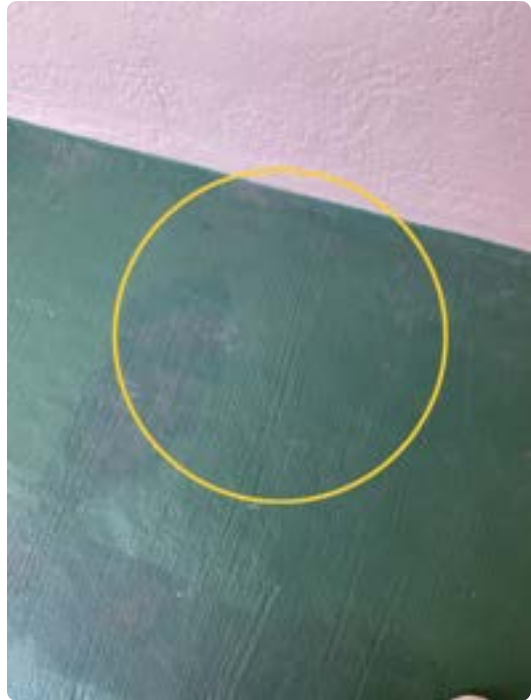
Hollow area near Unit 402. Area appears to have had previous patch.

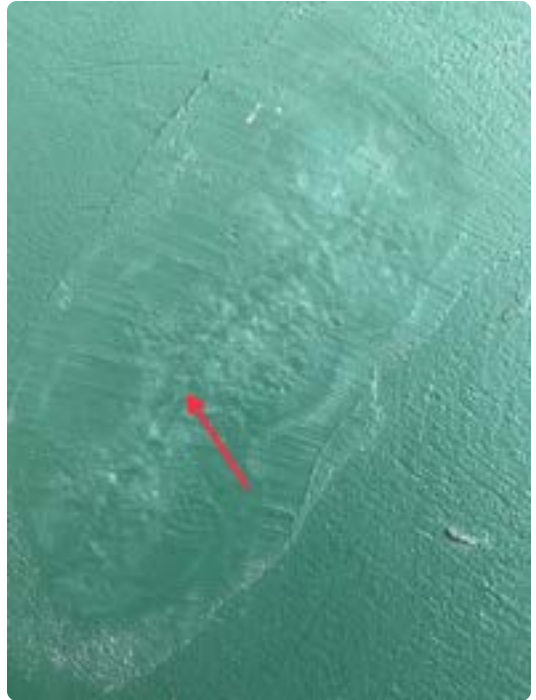
Hollow area near Unit 201. Has had previous remediation and is currently cracking.

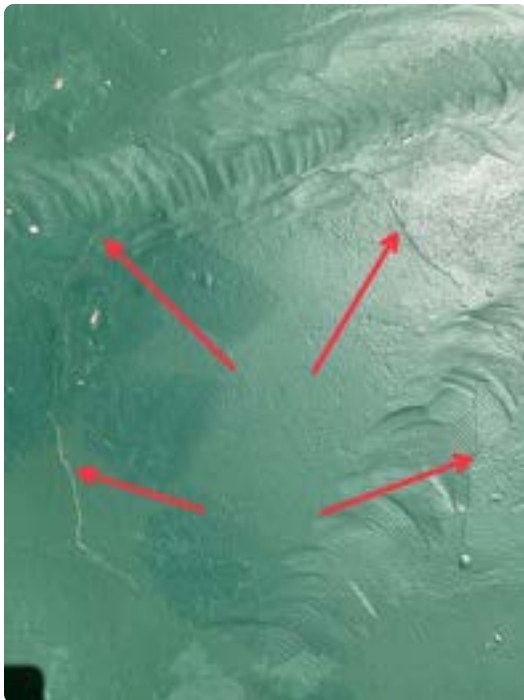
Hollow area near Unit 202. Has had previous remediation and is currently cracking.

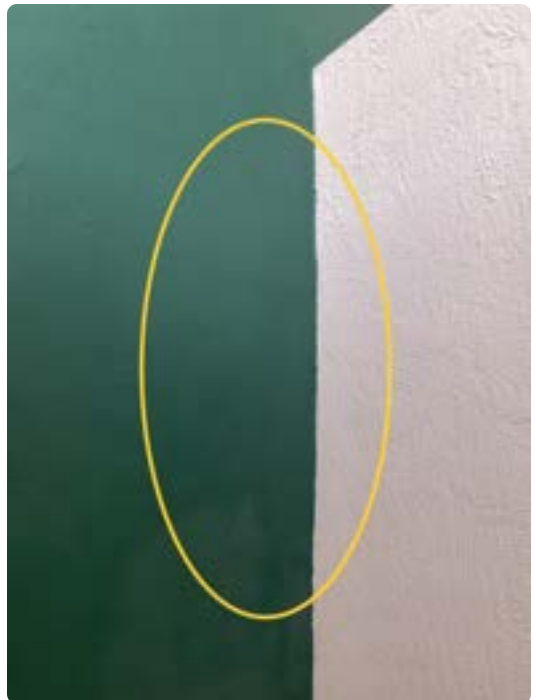
Hollow area near Unit 202

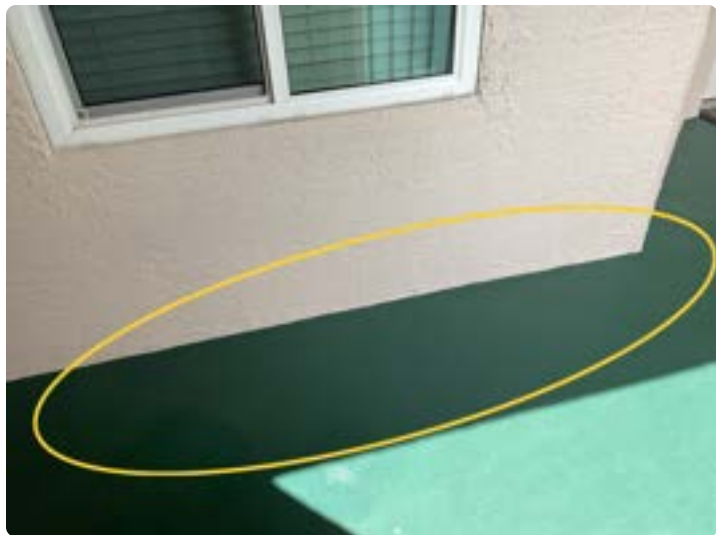
Hollow area near Unit 203

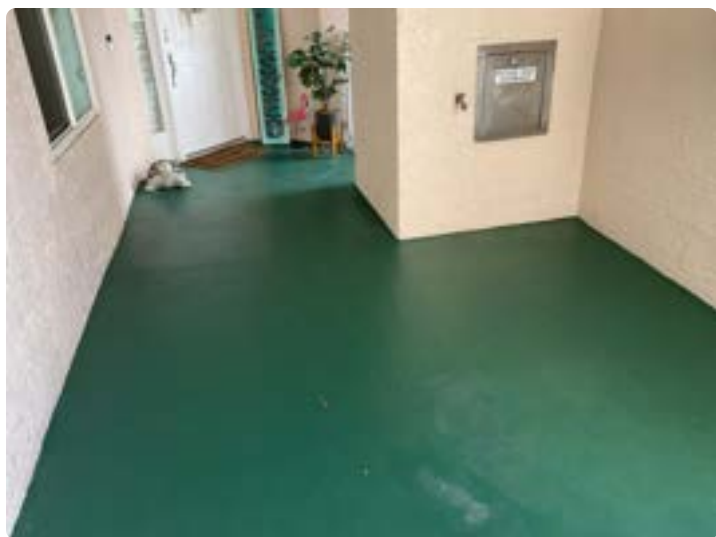
Entire area hollow near Unit 201

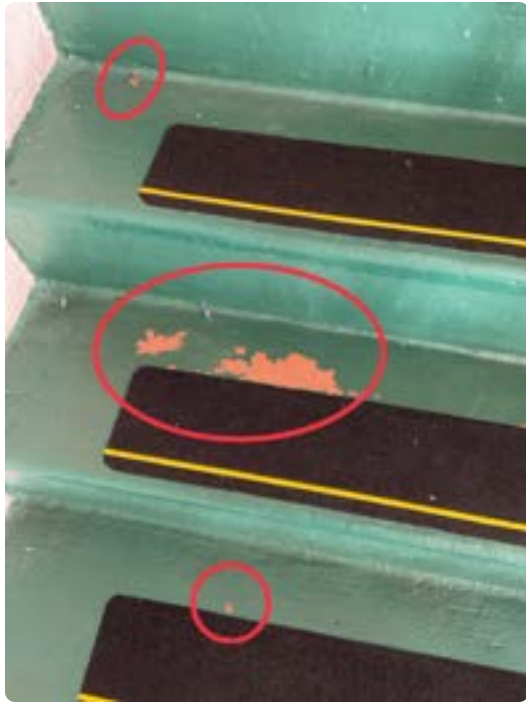
Delaminated paint on 5th floor north staircase

| Maintenance | Re-paint areas with delaminated paint during next walkway/staircase painting cycle. |

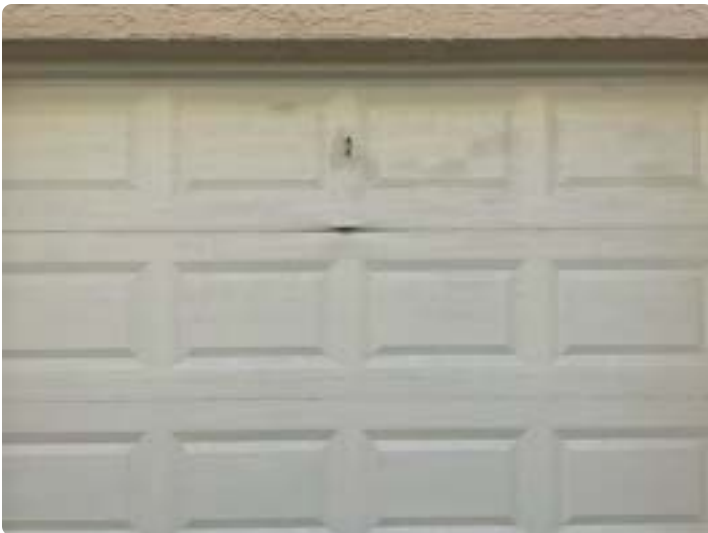
Dent in small garage door

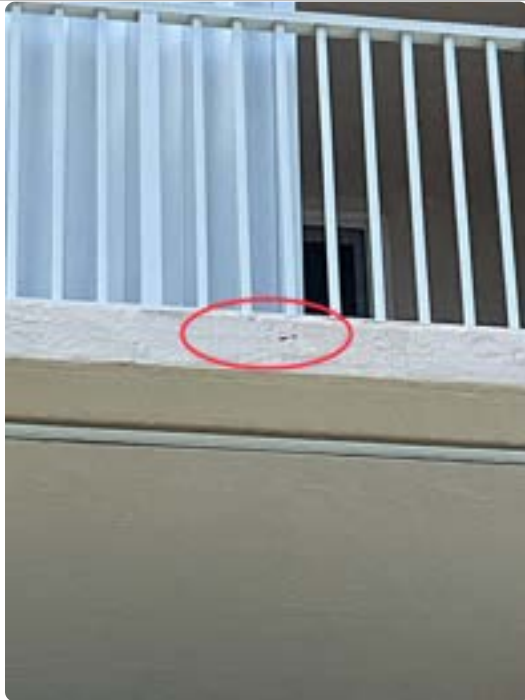
Crack on face of Unit 304 balcony

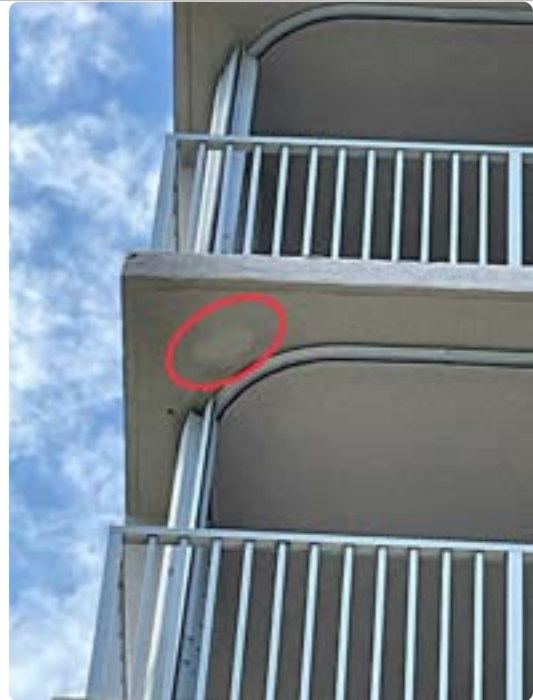
Painted over rust spot on Unit 504 balcony

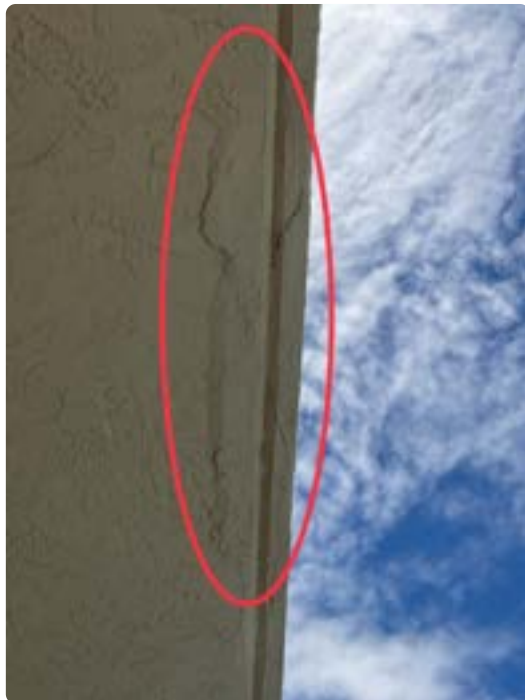
Delaminated stucco and balcony edge spall on Unit 204 balcony

| Maintenance | Remove stucco at areas identified with delaminated coating. Properly re-apply stucco in the areas. If any concrete slab damage is identified when stucco is removed, make appropriate repairs at that time. |

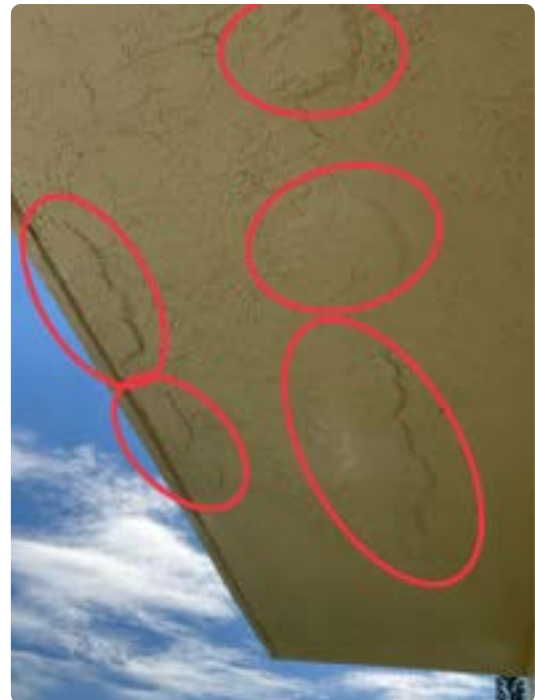
Delaminated coating on Unit 204 balcony

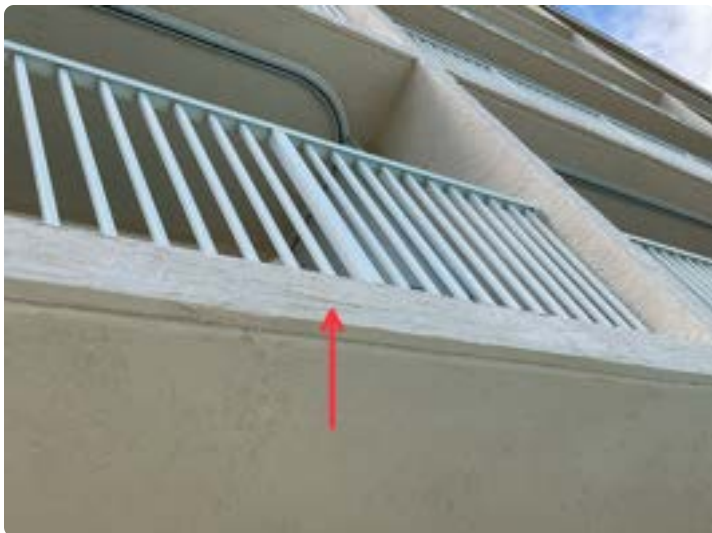
Crack on face of Unit 204 balcony slab

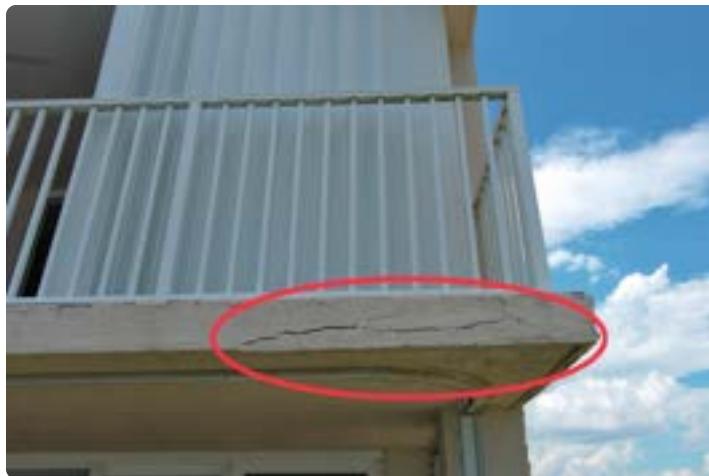
| Deficiencies | Cracks identified on the face of multiple balcony slabs. A Phase II with destructive testing must occur at the cracked areas on Unit 501 and 504 balconies to examine the condition of the rebar in the concrete. |

Crack on face of Unit 501 balcony slab

At Units 501 and 504 balcony slabs, delaminated concrete will be chipped away to observe the condition of the rebar in the balcony slabs.

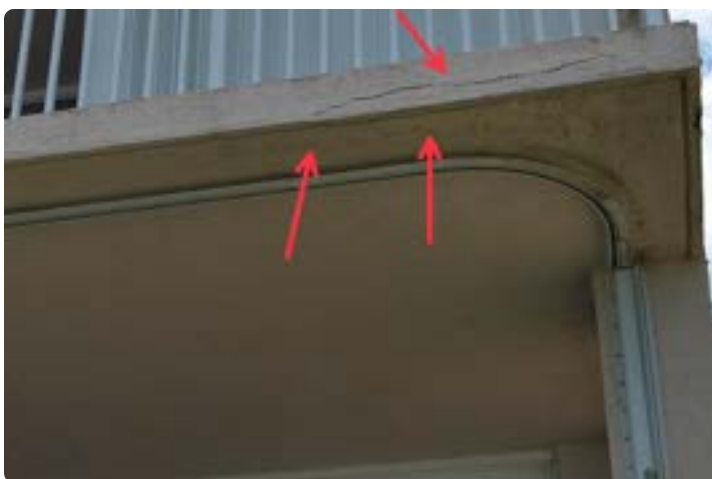
Delaminated coating below crack on Unit 501 balcony slab

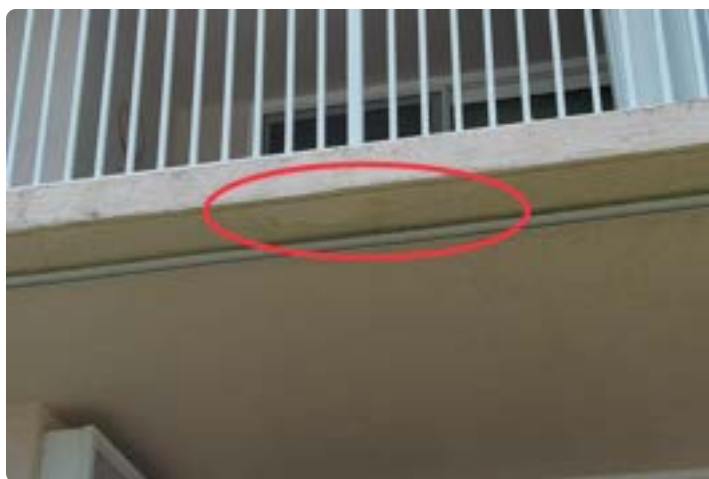
Delaminated coating on Unit 501 balcony slab

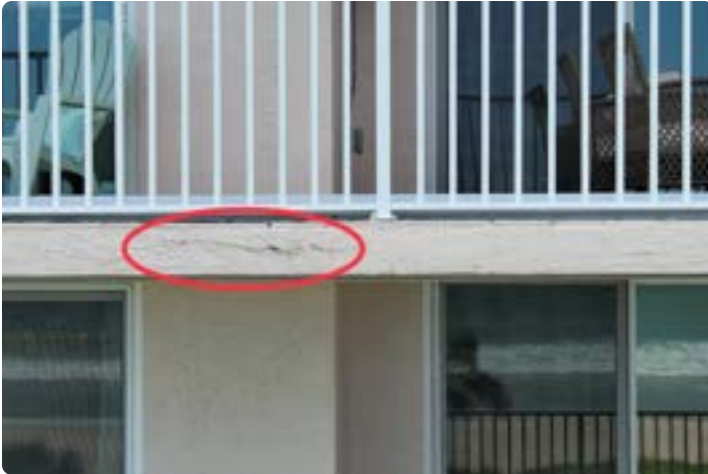
Crack on face of Unit 401 balcony slab

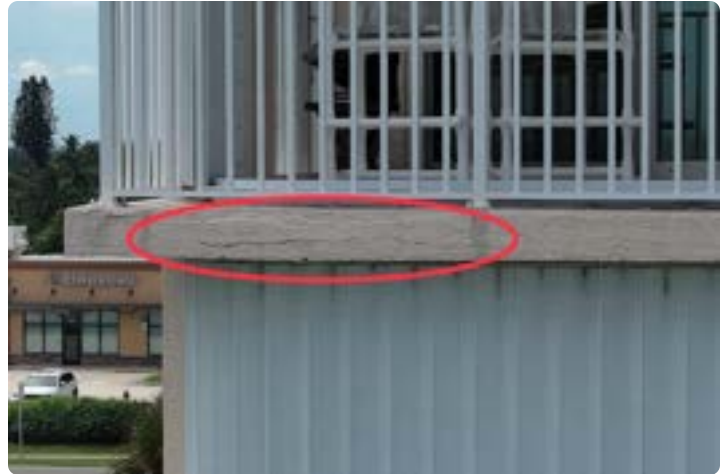
Crack on face of Unit 504 balcony slab

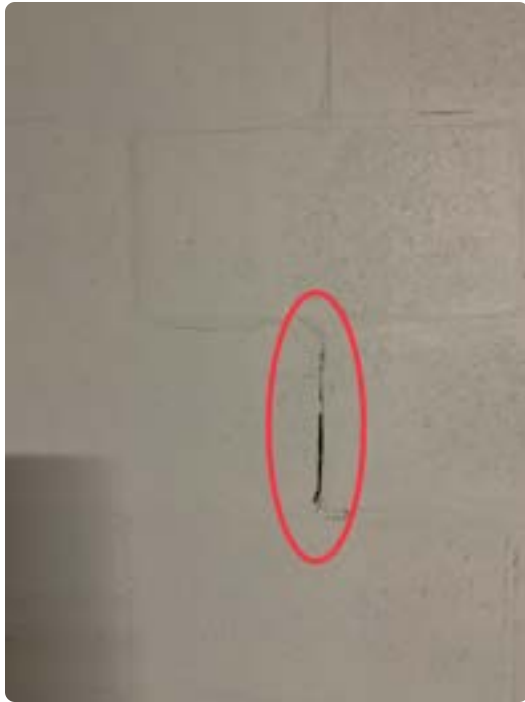
Crack in grout on parking garage wall near pool area exit. Area appears to have had past remediation.

| Maintenance | Seal (2) areas identified with cracks in grout and CMU block with a polyurethane sealant. |

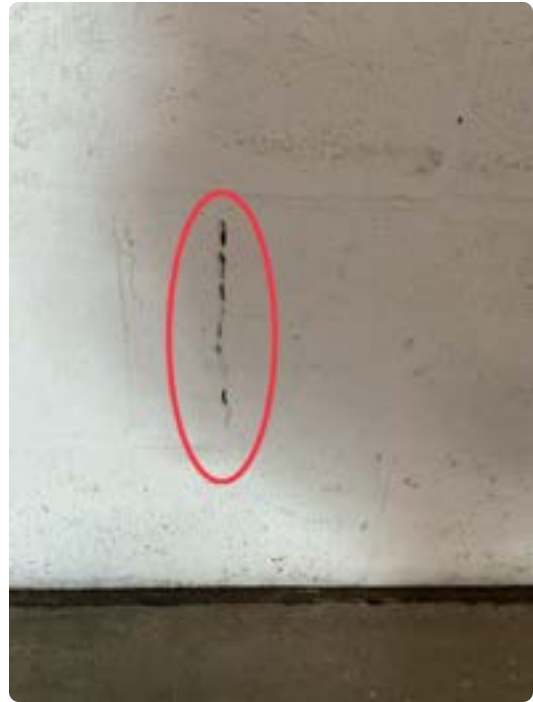
Crack in CMU block on parking garage wall near pool exit area
