**Opus 21 Homeowners Association Inc**  
**Non-SIRS Components**  
***Melbourne Beach, FL***

Report #: 51753-0  
Beginning: January 1, 2025  
Expires: December 31, 2025

**RESERVE STUDY**  
**"Full"**

September 16, 2024

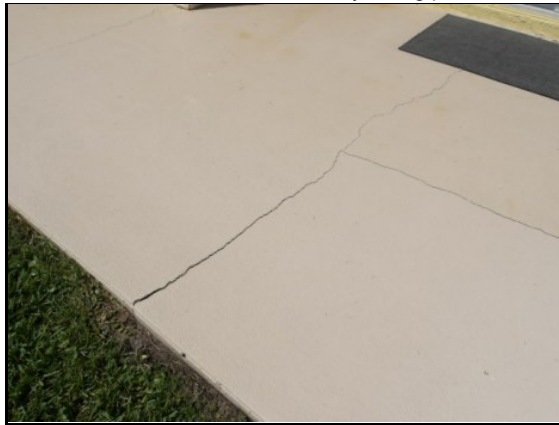
Useful Life:  
6 years

Remaining Life:  
1 years

Best Case: \$ 7,400

Worst Case: \$ 9,100

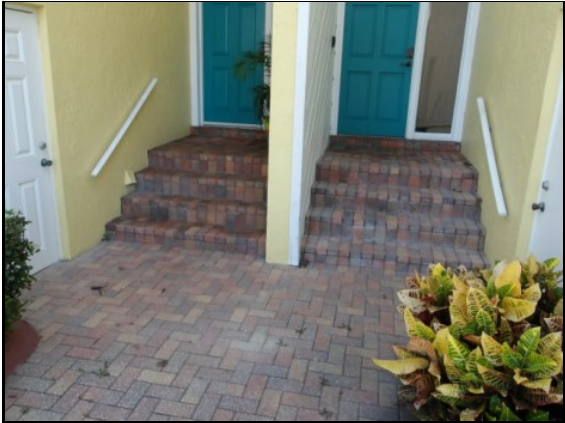
Useful Life:  
40 years

Remaining Life:  
23 years

Best Case: \$ 16,000

Worst Case: \$ 19,600

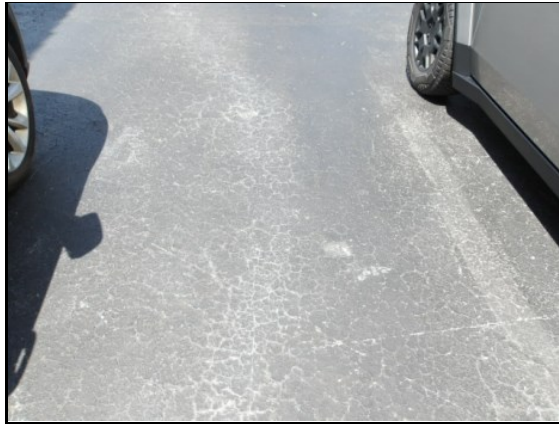
Remaining Life:

4 years

Best Case: \$ 5,900

Worst Case: \$ 7,300

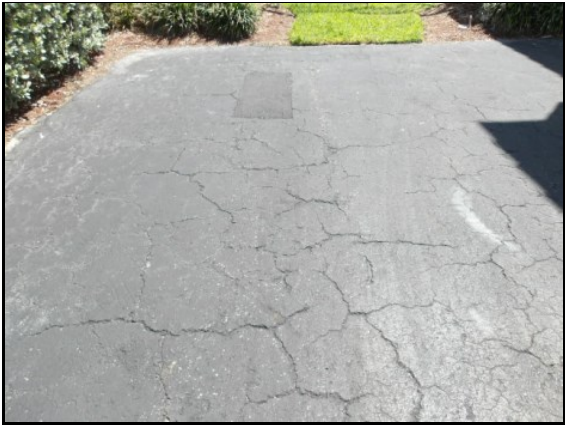
Useful Life:  
20 years

Remaining Life:  
3 years

Best Case: \$ 38,300

Worst Case: \$ 46,900

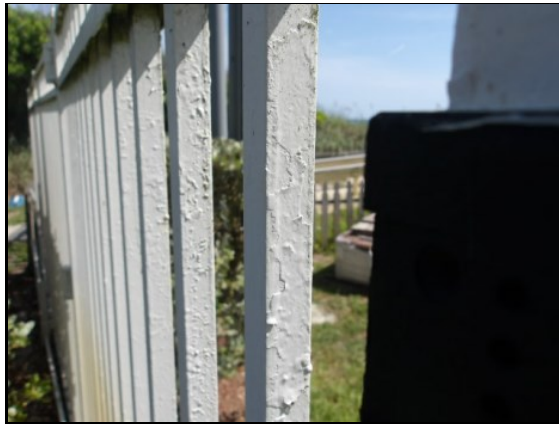
Useful Life:  
6 years

Remaining Life:  
1 years

Best Case: \$ 1,100

Worst Case: \$ 1,400

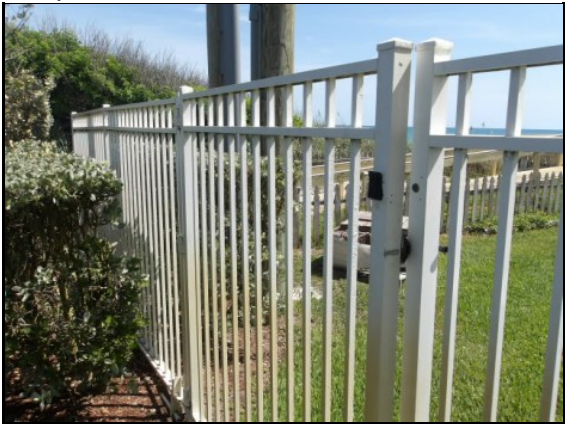
Useful Life:  
24 years

Remaining Life:  
13 years

Best Case:   \$ 8,700

Worst Case:   \$ 10,700

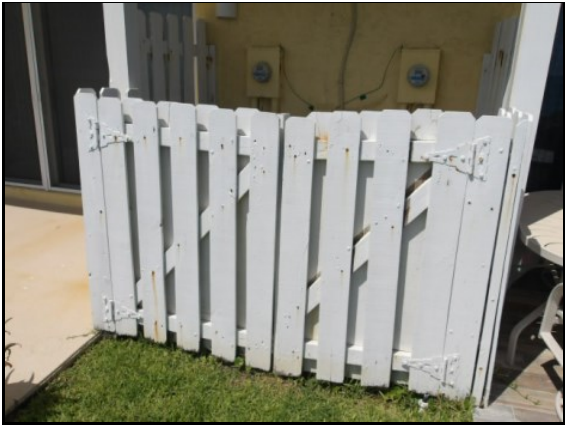
Useful Life:  
6 years

Remaining Life:  
1 years

Best Case:   \$ 1,000

Worst Case:   \$ 1,200

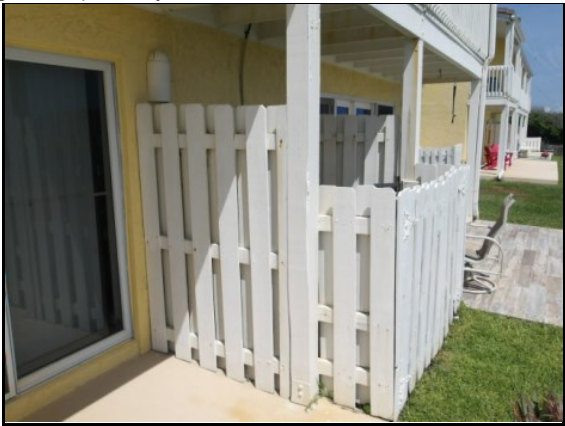
Useful Life:  
18 years

Remaining Life:  
7 years

Best Case:   \$ 5,800

Worst Case:   \$ 7,100

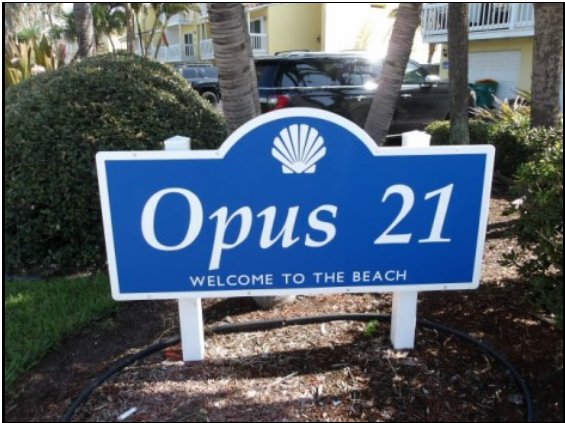
Useful Life:  
20 years

Remaining Life:  
16 years

Best Case: \$ 4,500

Worst Case: \$ 5,500

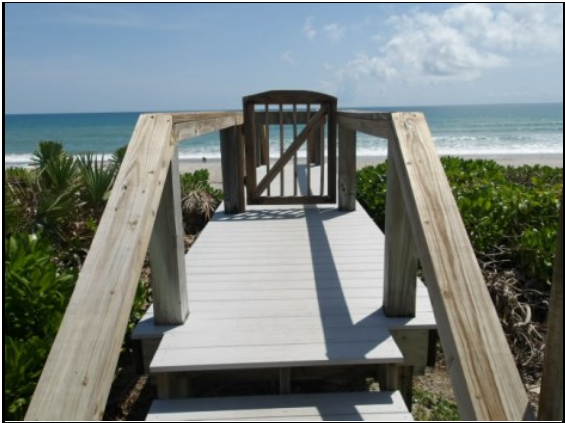
Useful Life:  
20 years

Remaining Life:  
13 years

Best Case: \$ 21,100

Worst Case: \$ 25,800

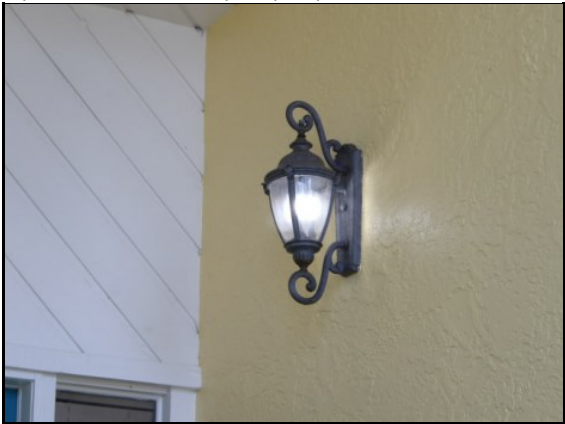
Useful Life:  
20 years

Remaining Life:  
10 years

Best Case:    \$ 17,200

Worst Case:    \$ 21,000

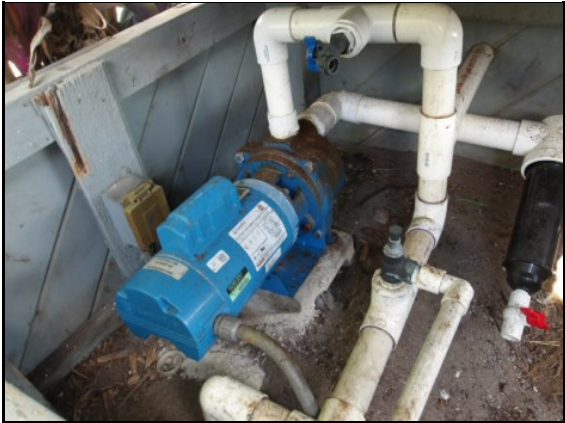
Useful Life:  
15 years

Remaining Life:  
12 years

Best Case: \$ 4,500

Worst Case: \$ 5,500
