# **Harbor Villa Townhouses**

Indian Harbour Beach, Florida

## **Exterior Building Balcony Structure Inspection Report**

**June 23, 2021**

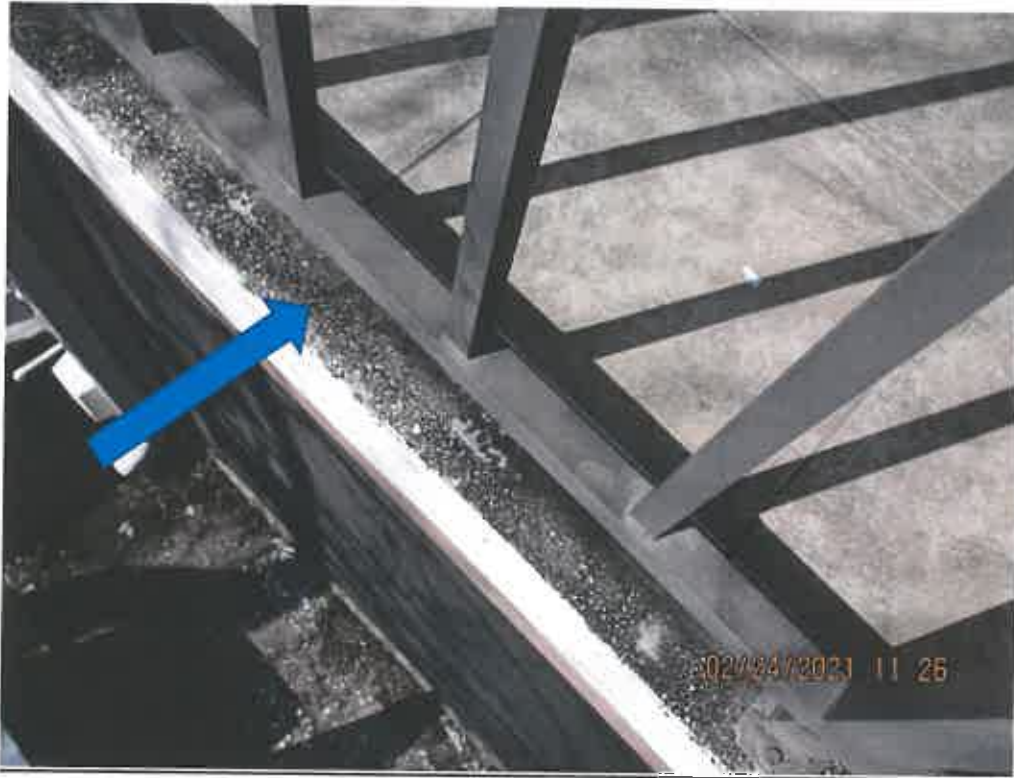
**Example view of balcony edge cracking indicative of slab edge spalling due to reinforcing steel corrosion**

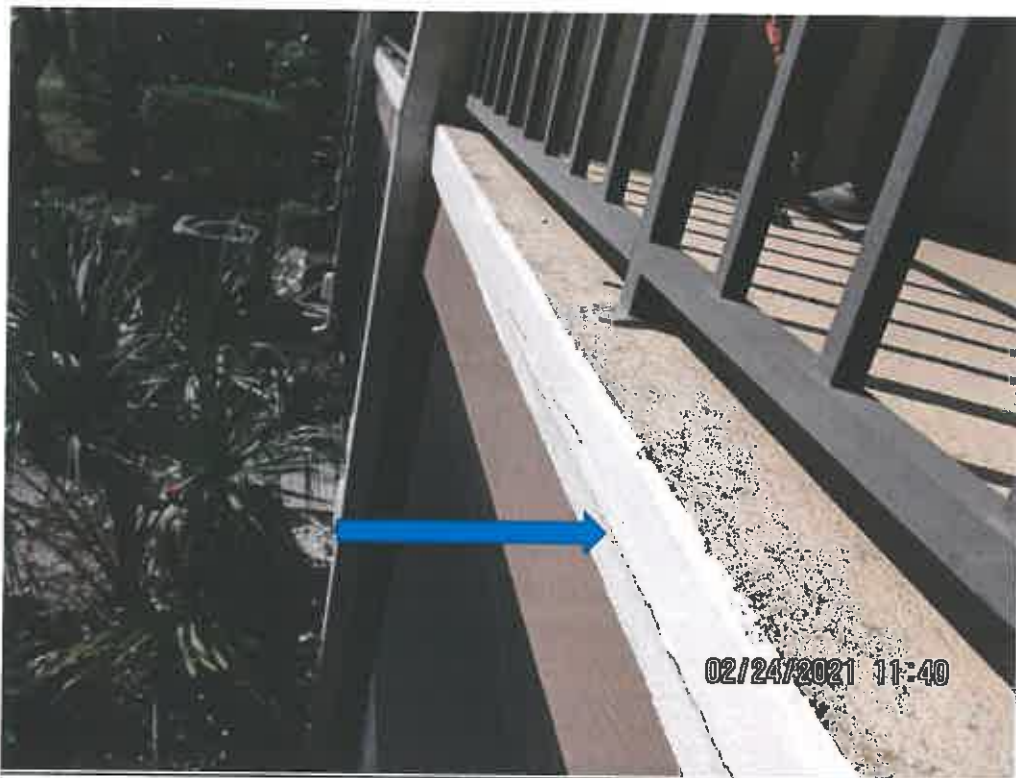
**Example view of balcony edge cracking indicative of slab edge spalling due to reinforcing steel corrosion**

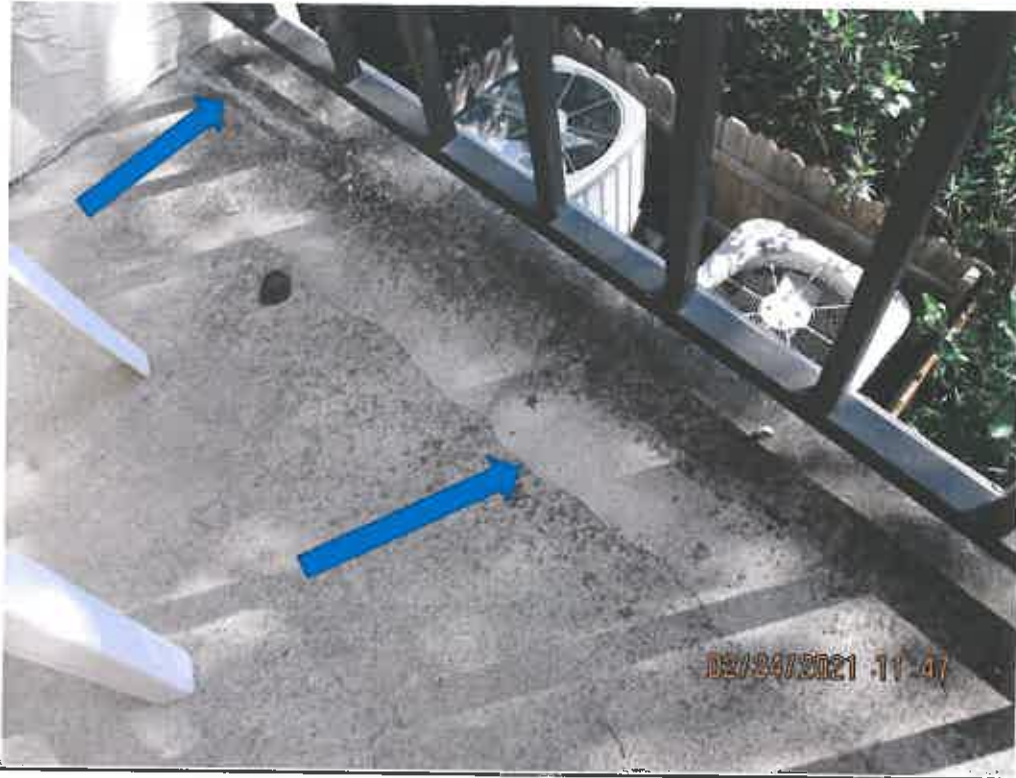
**Example view of balcony edge cracking indicative of slab edge spalling due to reinforcing steel corrosion**

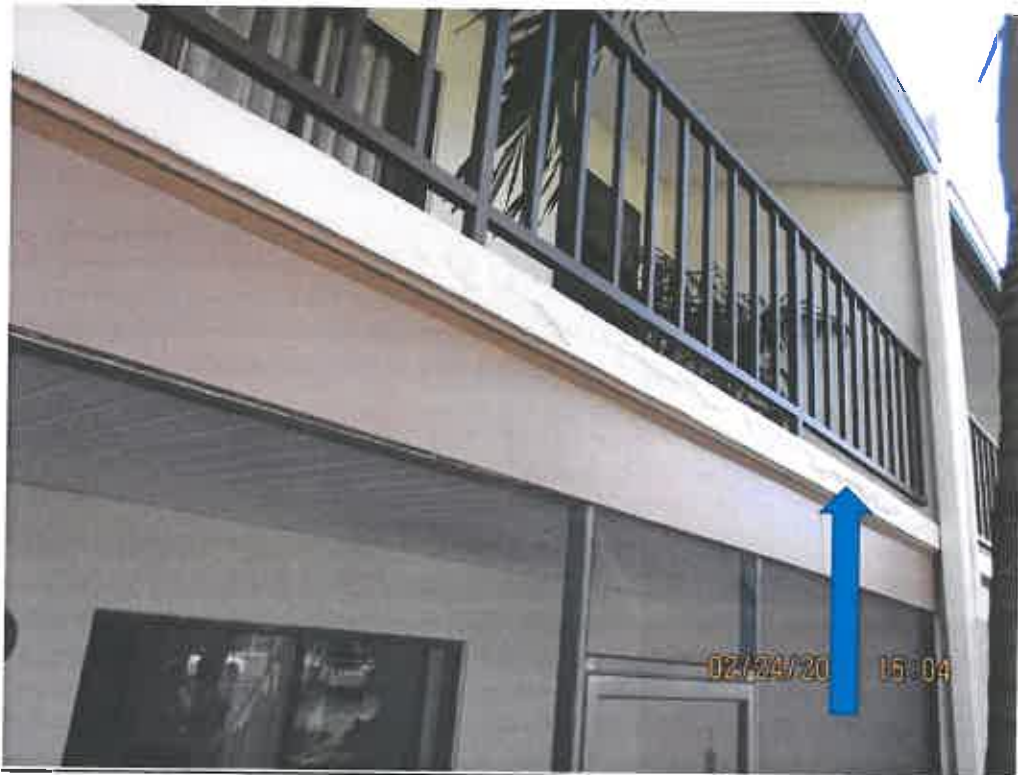
**Example view of balcony edge cracking indicative of slab edge spalling due to reinforcing steel corrosion**

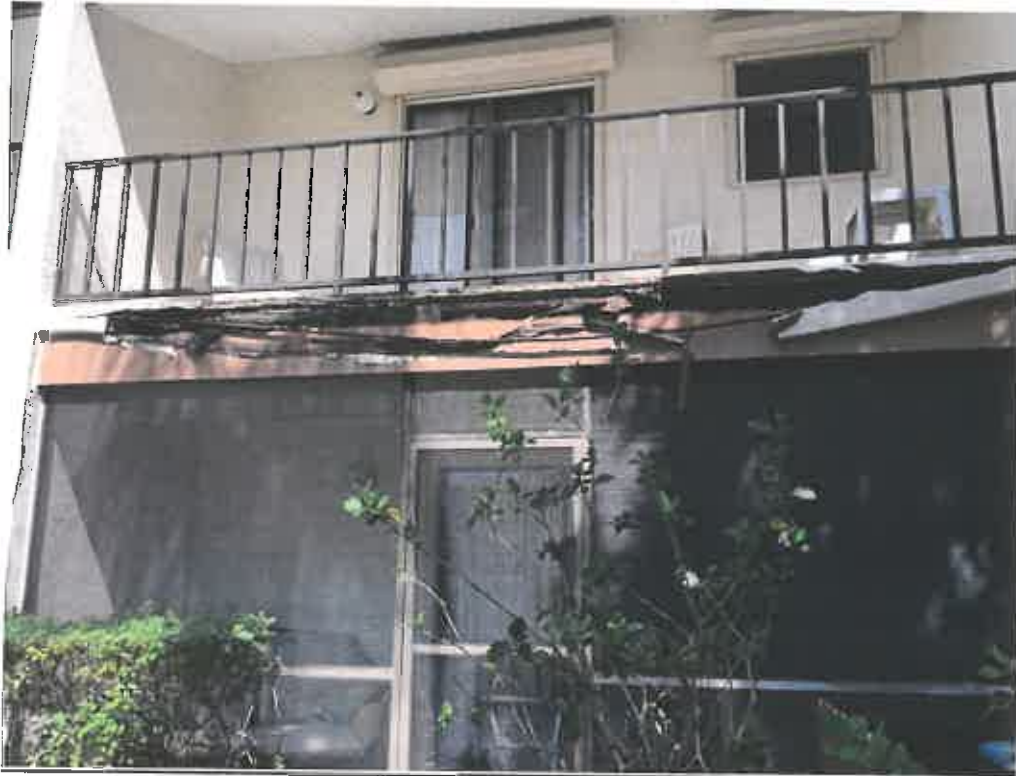
**Example view of past balcony edge damage (unit 104) reportedly repaired in 2016**

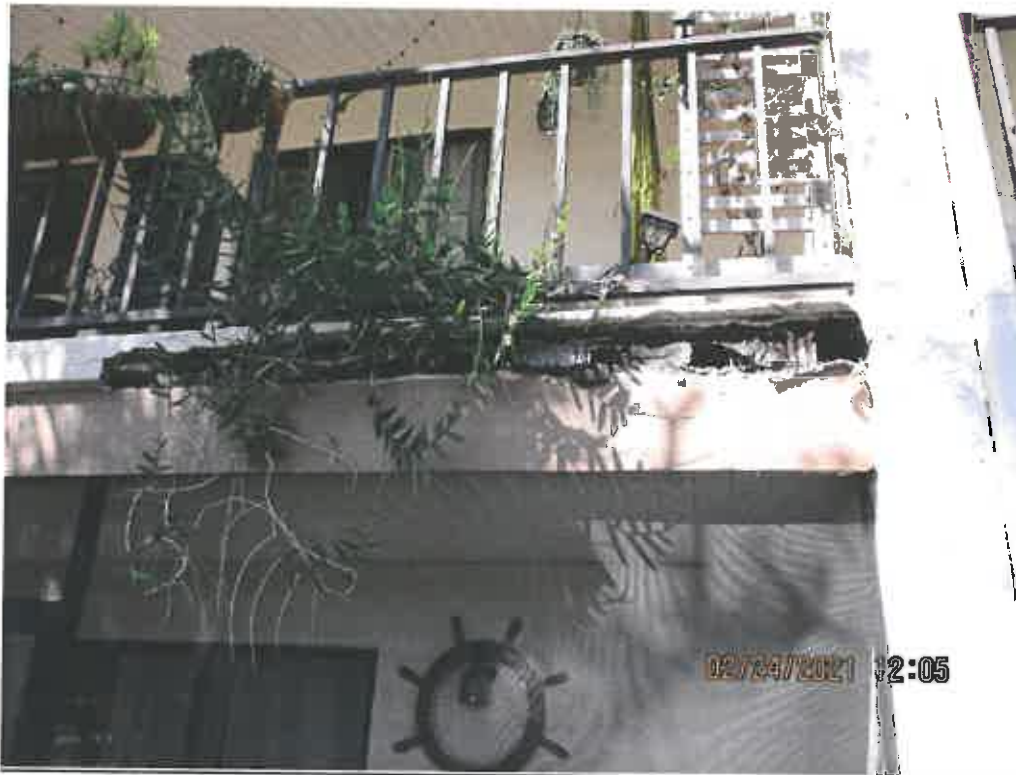
**Example view of balcony slab edge failure (unit 106) and exposed wood support framing**

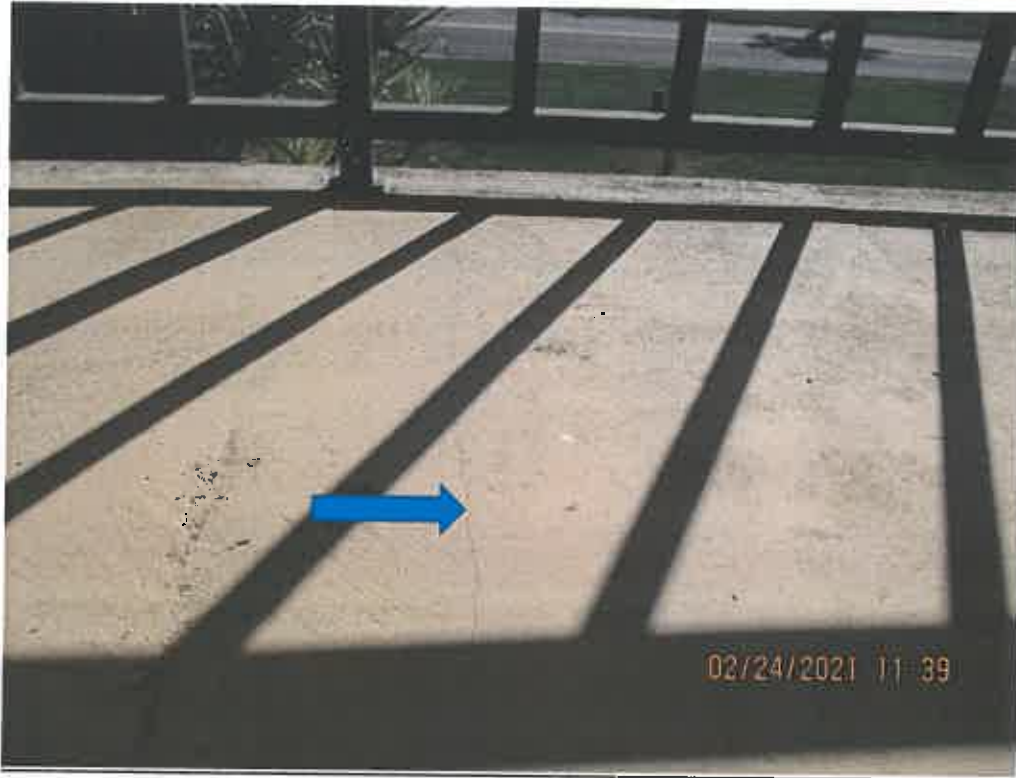
**Example view of balcony slab cracks due to lack of proper waterproof coatings-that will lead to concrete spalling and support wood rot**

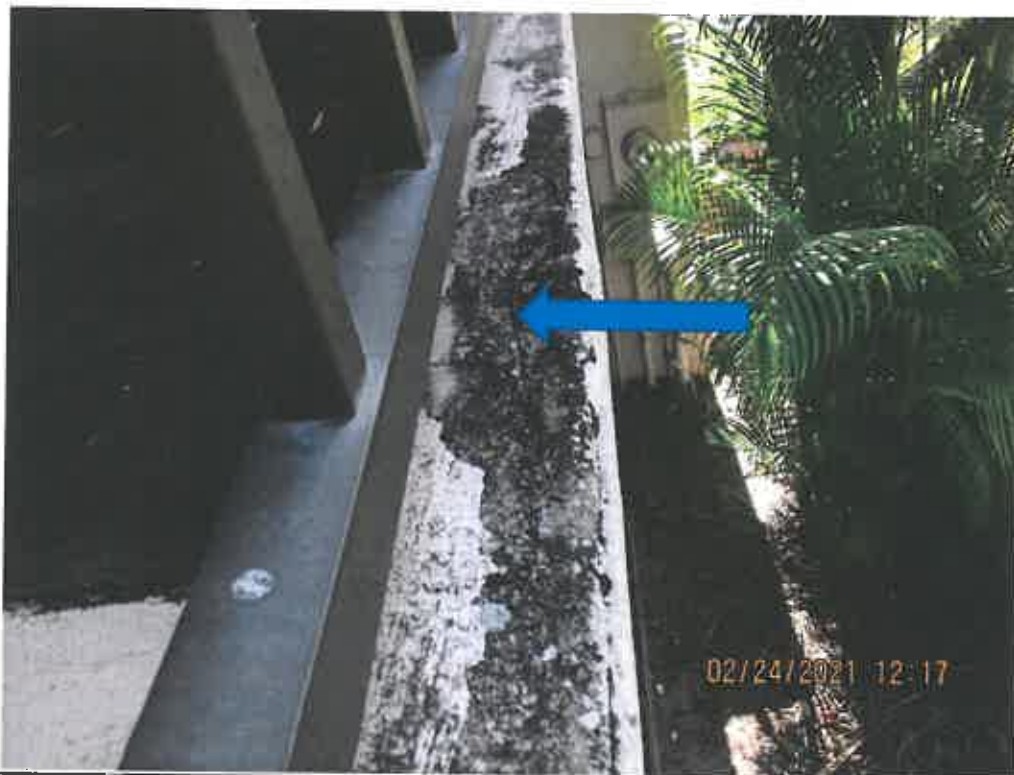
**Example view of balcony slab cracks (edge spalling) due to lack of proper waterproof coatings-that will lead to concrete spalling and support wood rot**

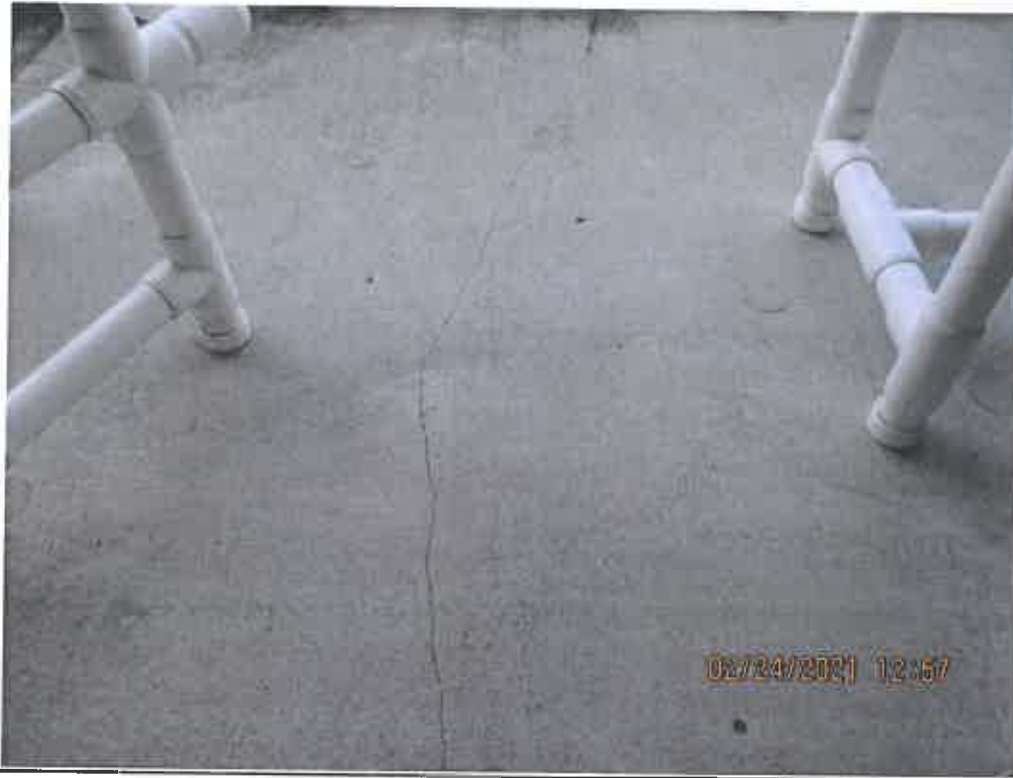
**Example view of balcony slab cracks due to lack of proper waterproof coatings-that will lead to concrete spalling and support wood rot**

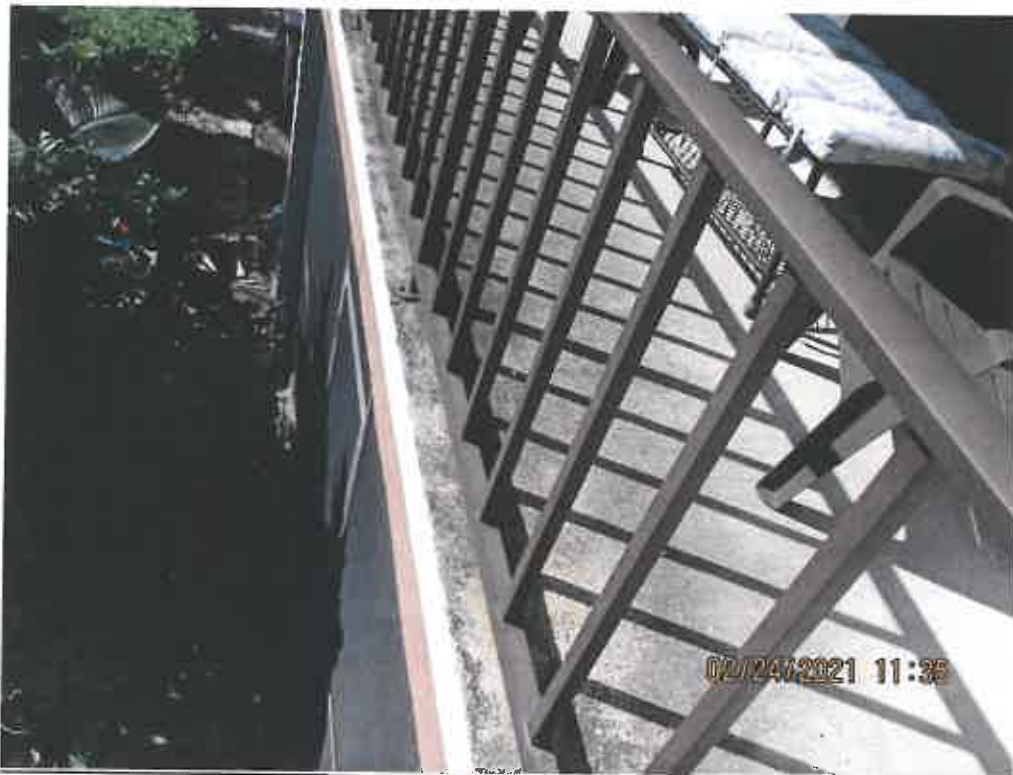
**Example view of balcony slab with lack of proper waterproof coatings-that will lead to concrete spalling and support wood rot**

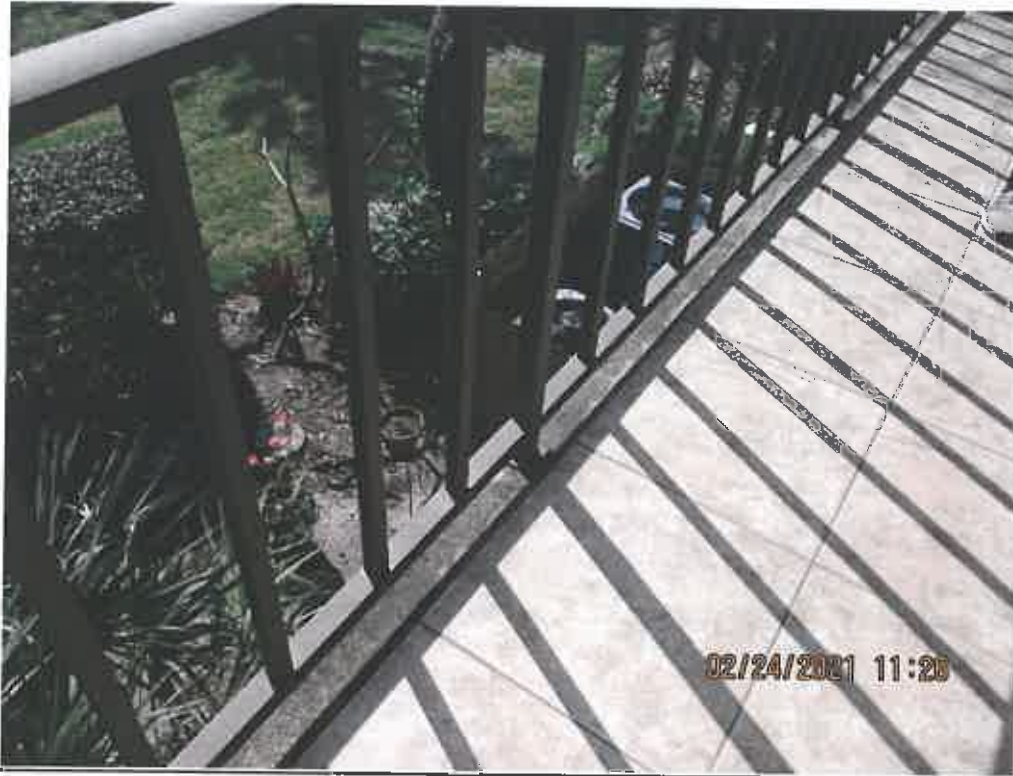
**Example view of tiled balcony slab which provides a lack of proper waterproofing-that will lead to concrete spalling and support wood rot**

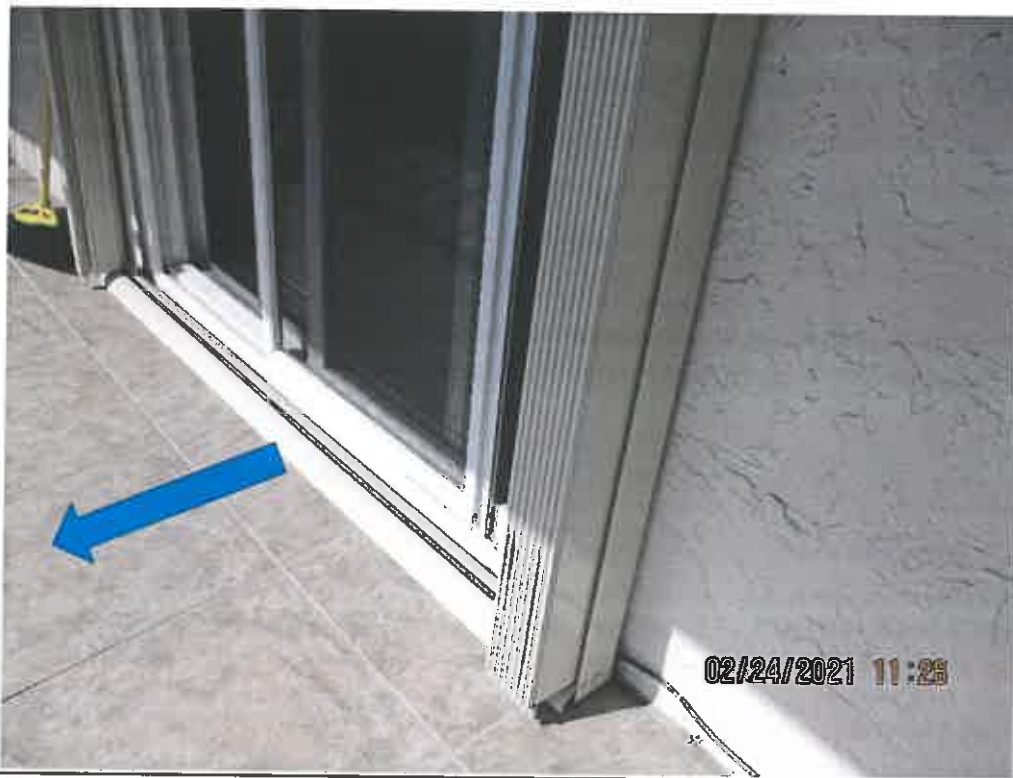
**Example view of shutter track installed without recommended drainage shims-will lead to concrete spalling and wood rot due to lack of positive drainage away from door**

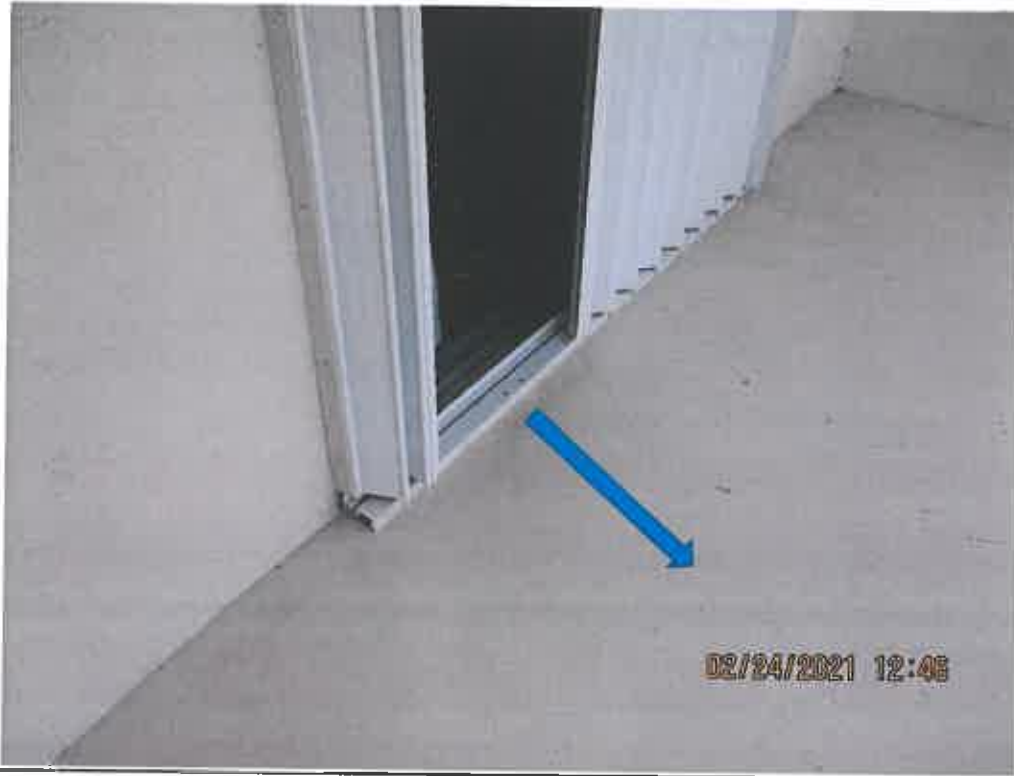
**Example view of shutter track installed without recommended drainage shims-will lead to concrete spalling and wood rot due to lack of positive drainage away from door**

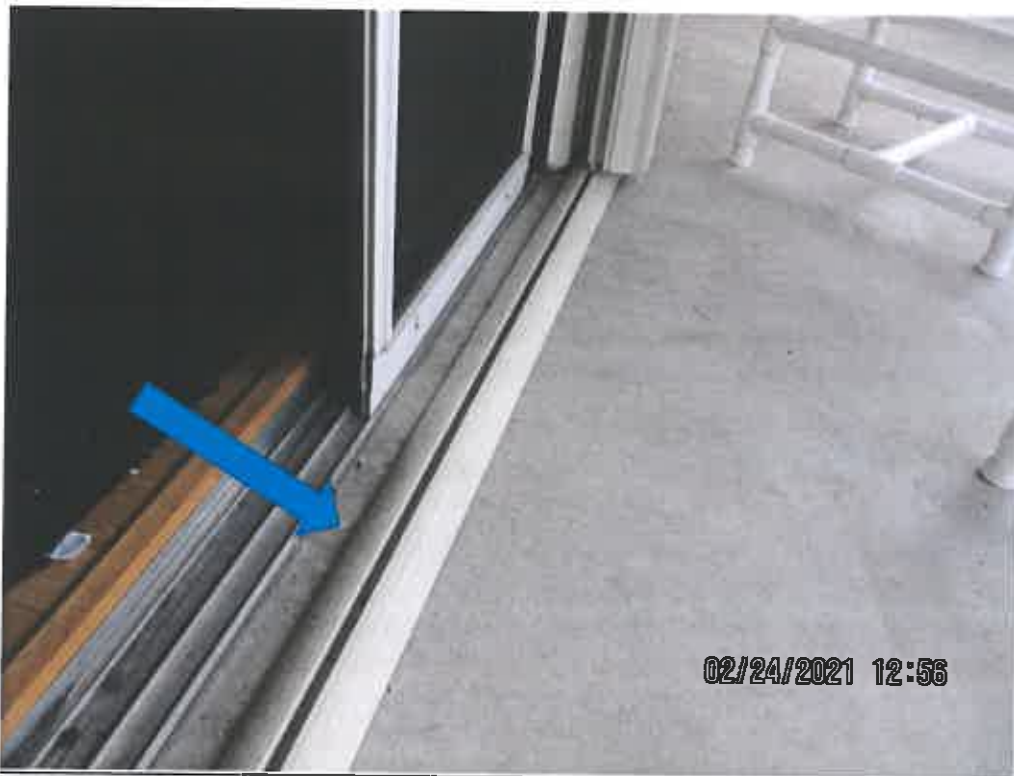
**Example view of shutter track installed without recommended drainage shims-will lead to concrete spalling and wood rot due to lack of positive drainage away from door**

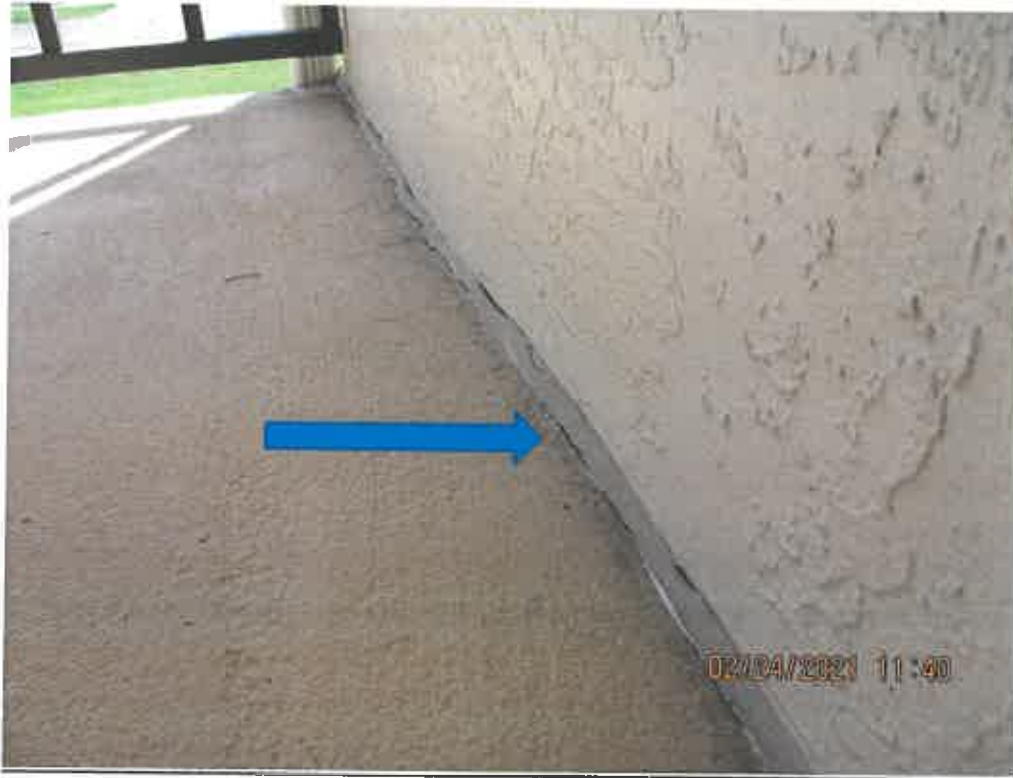
Example view of failing floor to wall sealant-will lead to concrete spalling and wood rot due to water intrusion

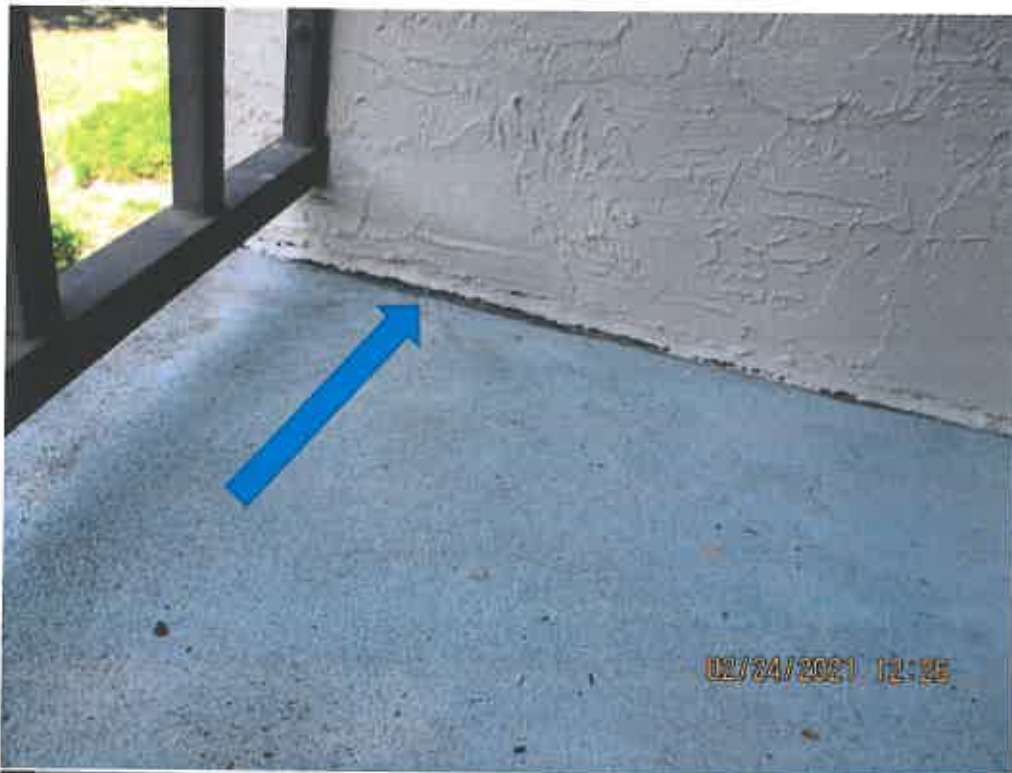
Example view of failing floor to wall sealant-will lead to concrete spalling and wood rot due to water intrusion

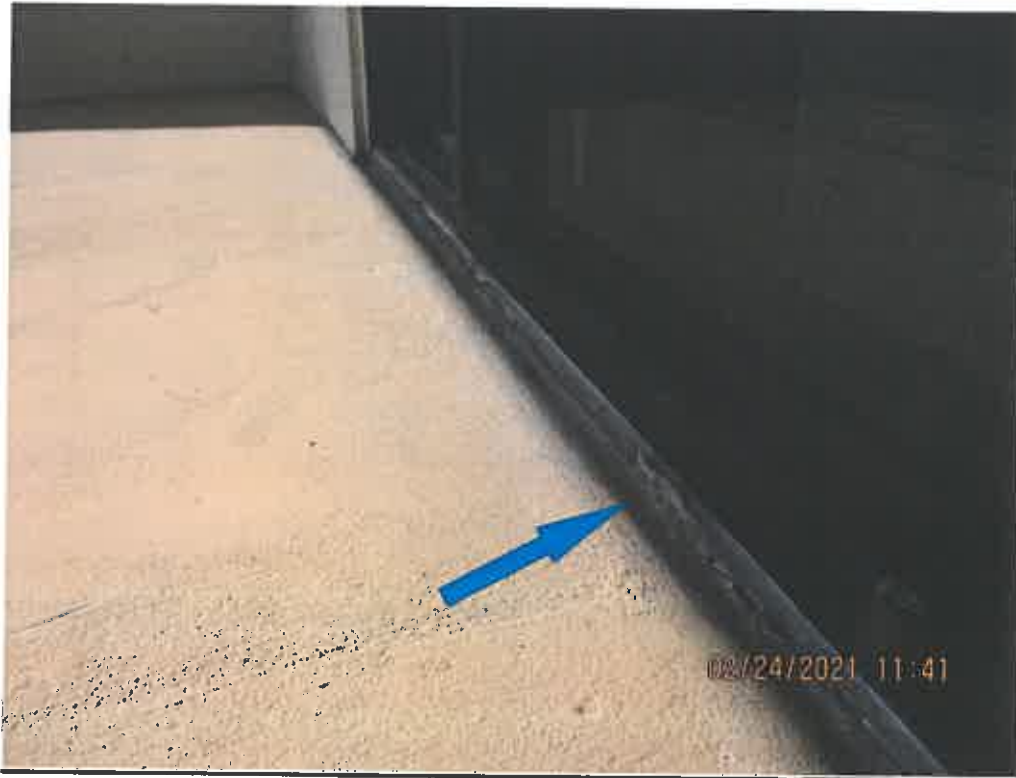
**Example view of failing door perimeter sealant-will lead to concrete spalling and wood rot due to water intrusion**

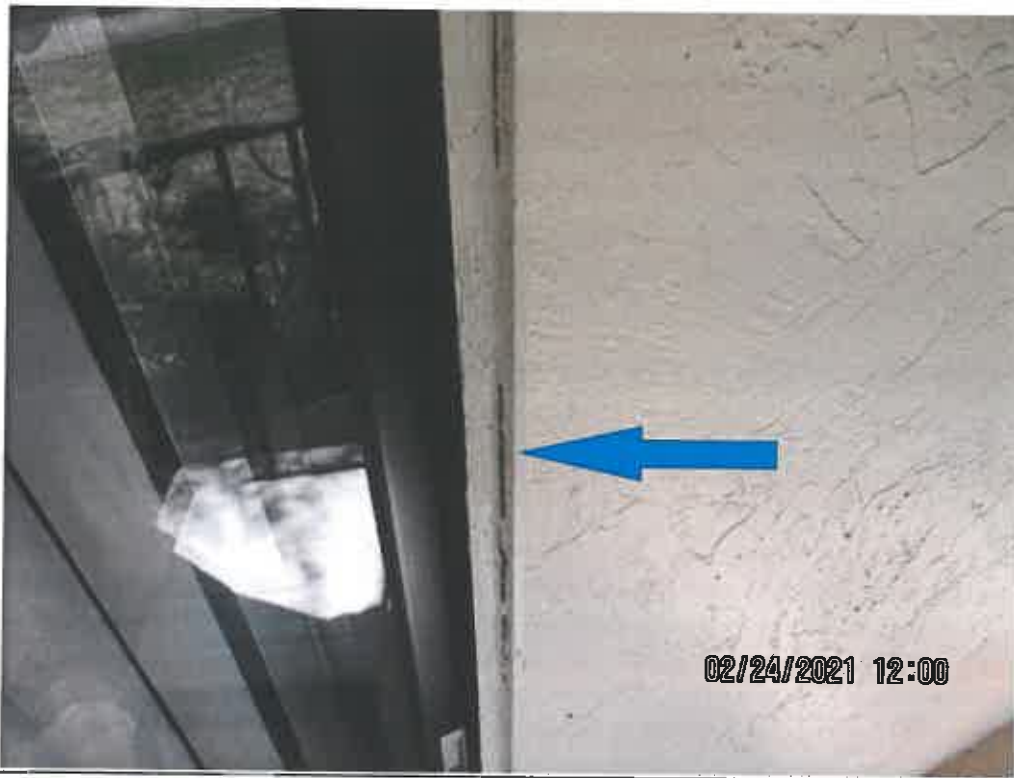
**Example view of failing door perimeter sealant-will lead to concrete spalling and wood rot due to water intrusion**

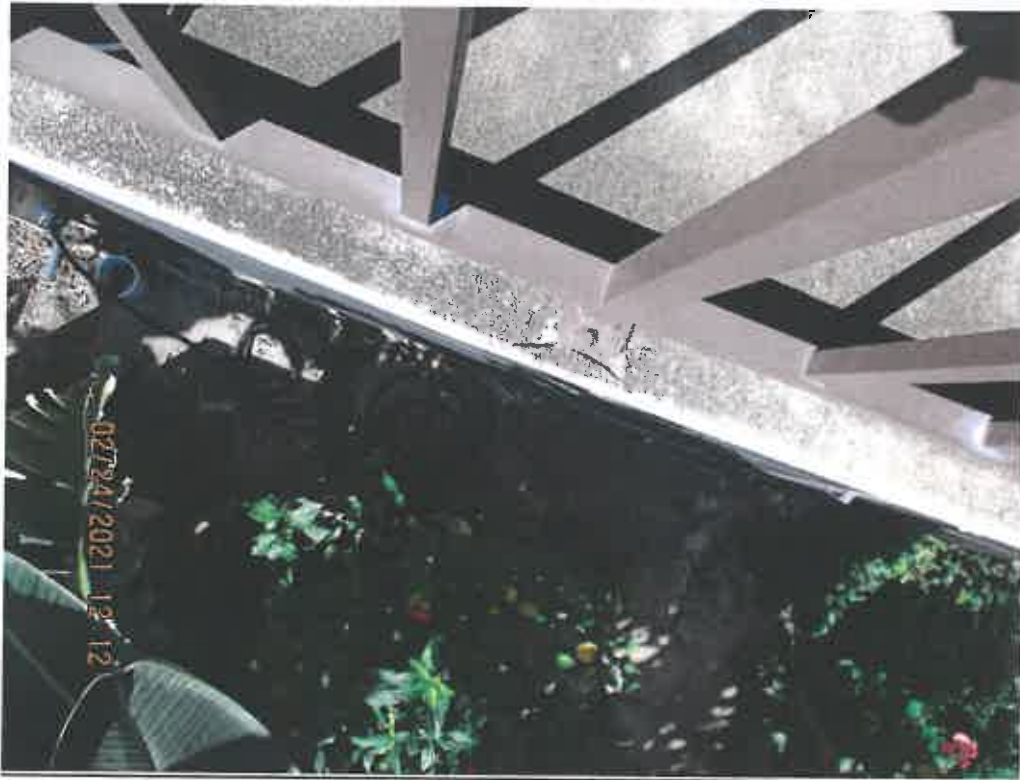
Example view of unsealed railing fastener installation that will lead to water intrusion, concrete spalling and rotted wood

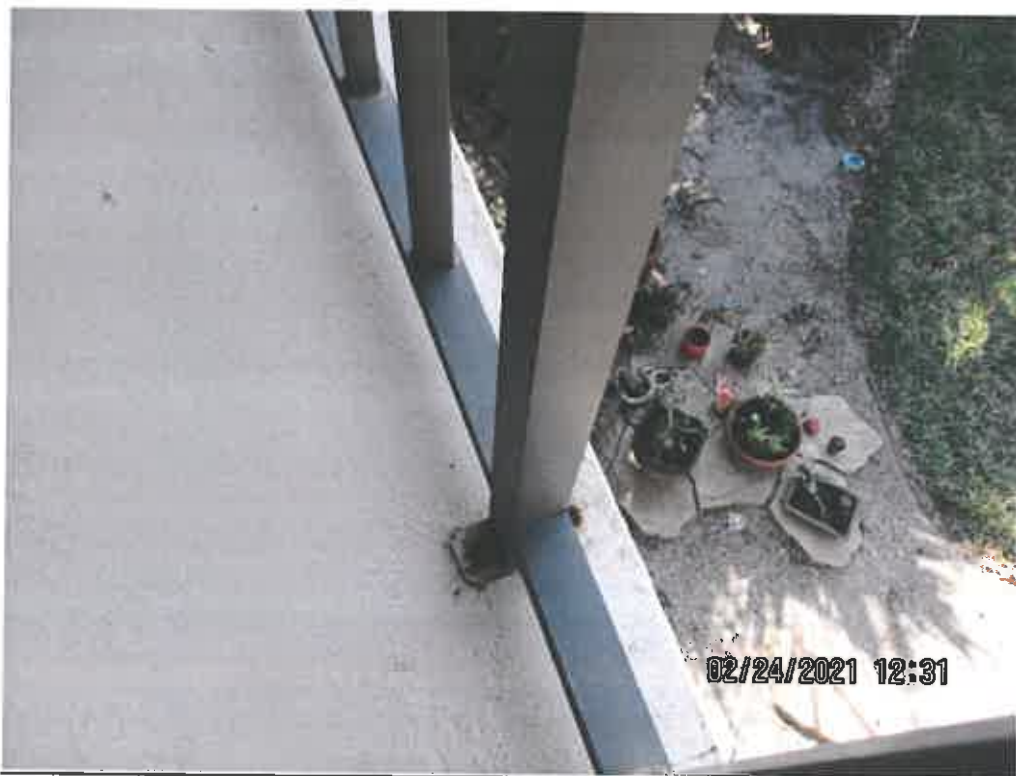
Example view of unsealed corroding railing fastener installation that will lead to water intrusion, concrete spalling and rotted wood

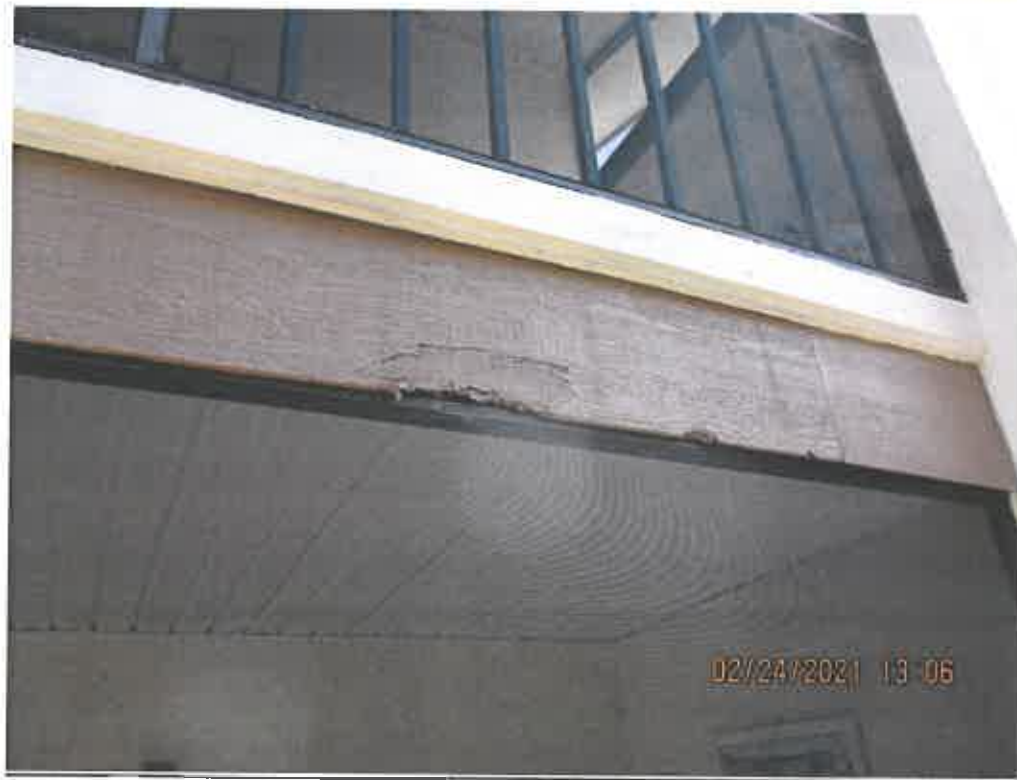
Example view of rotted wood fascia

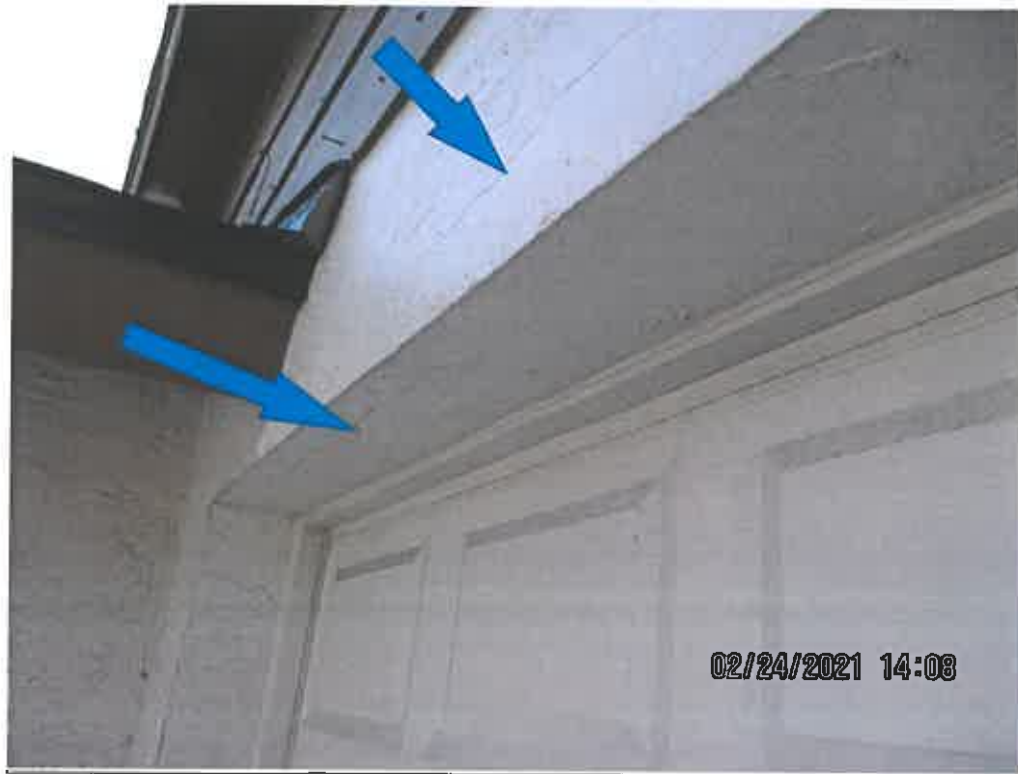
Example view of garage header beam cracking and spalling due to reinforcing steel corrosion

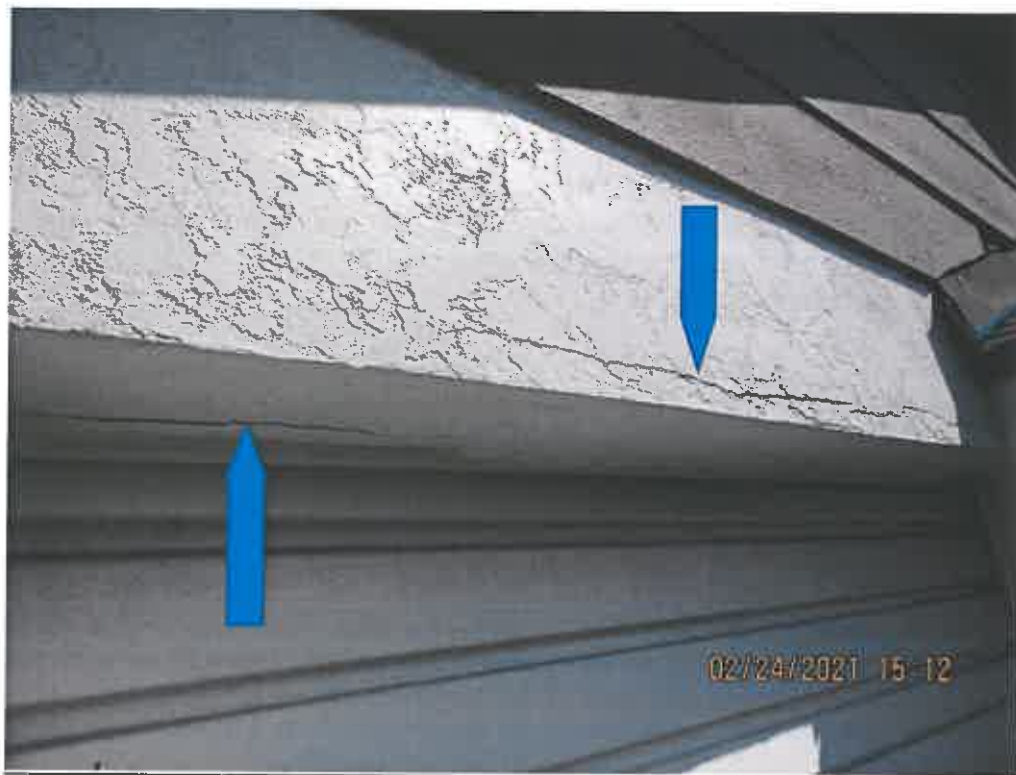
Example view of garage header beam cracking and spalling due to reinforcing steel corrosion

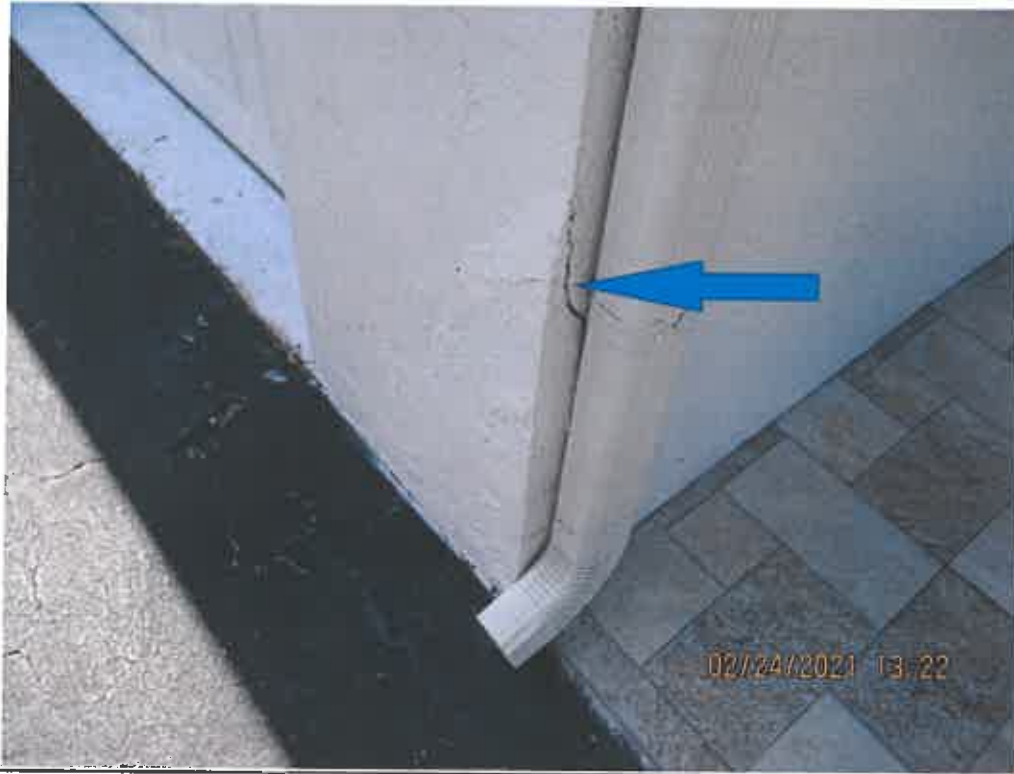
Example view of garage column cracking and spalling due to reinforcing steel corrosion

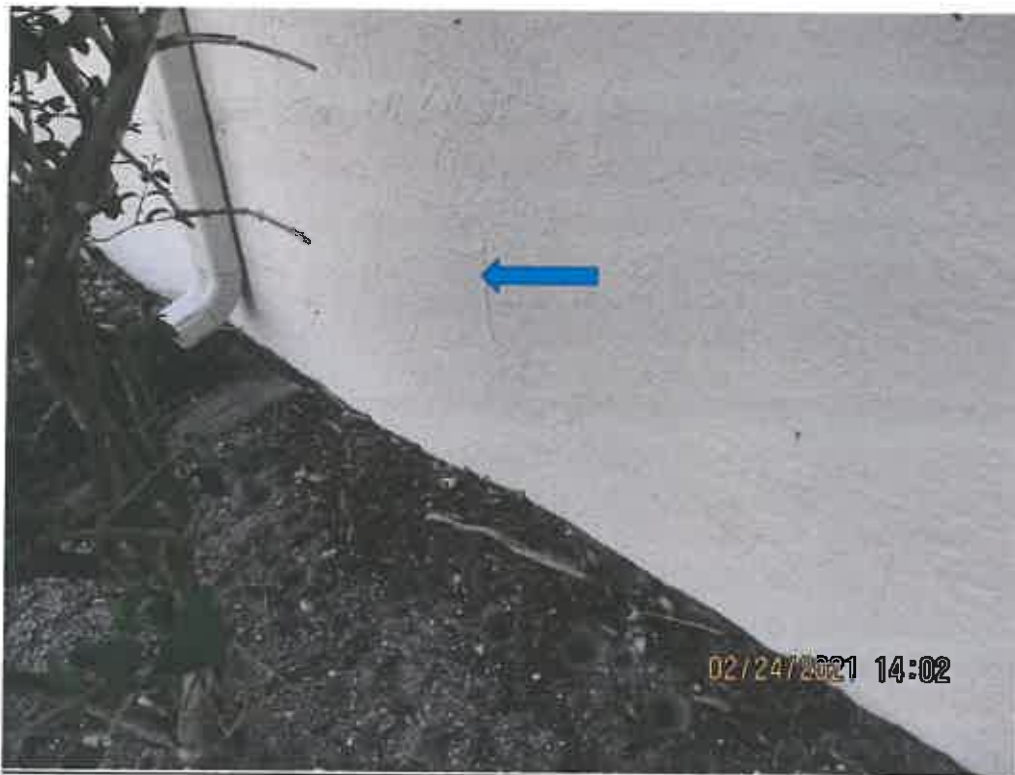
Example view of stucco wall cracks that can allow water intrusion-solved with a proper painting and waterproofing process

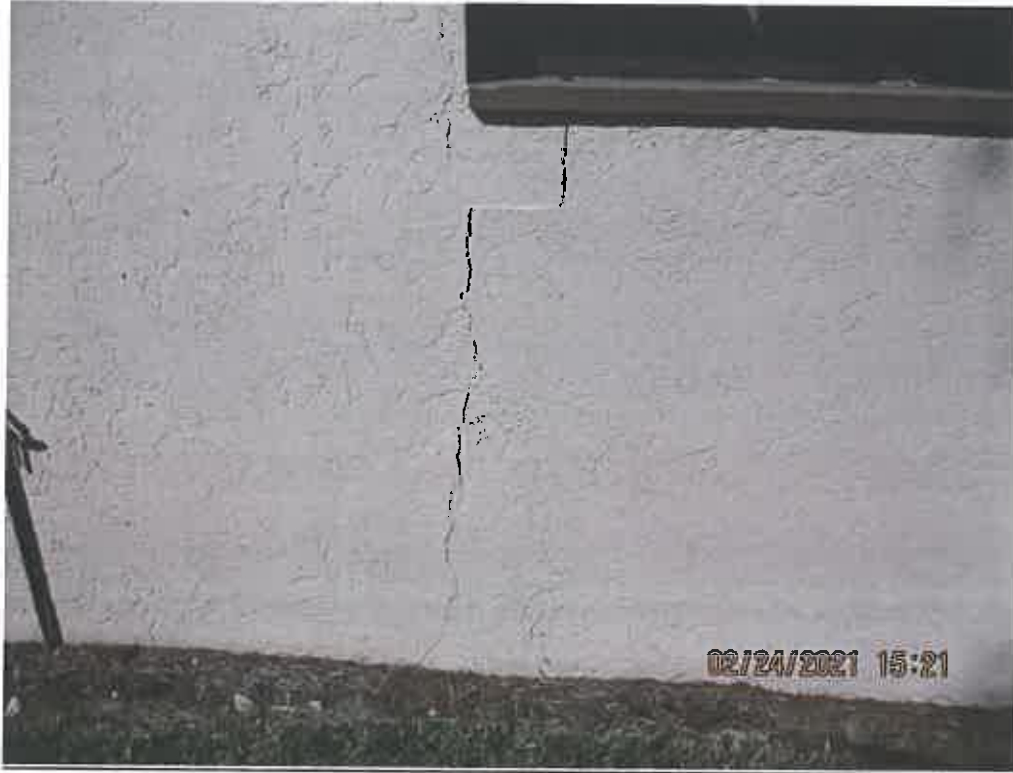
**Example view of stucco wall cracks that can allow water intrusion-solved with a proper painting and waterproofing process**

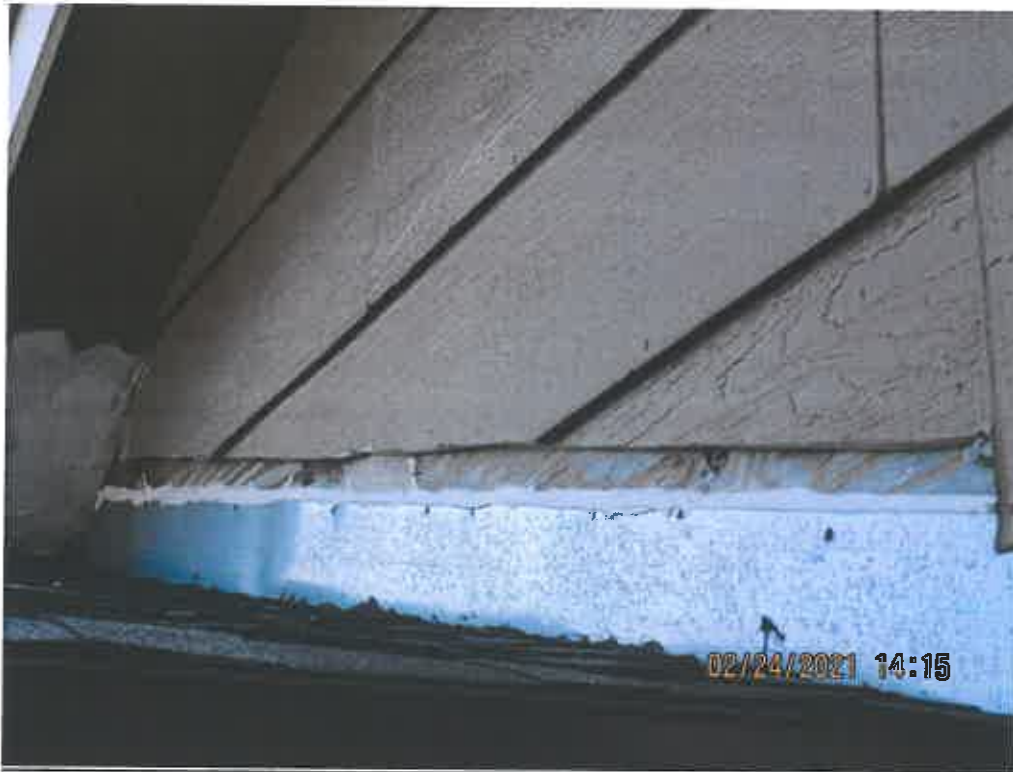
**Example view of exposed plywood substrate at recently installed roof flashing-these details and overall poor condition of siding will necessitate siding replacement**

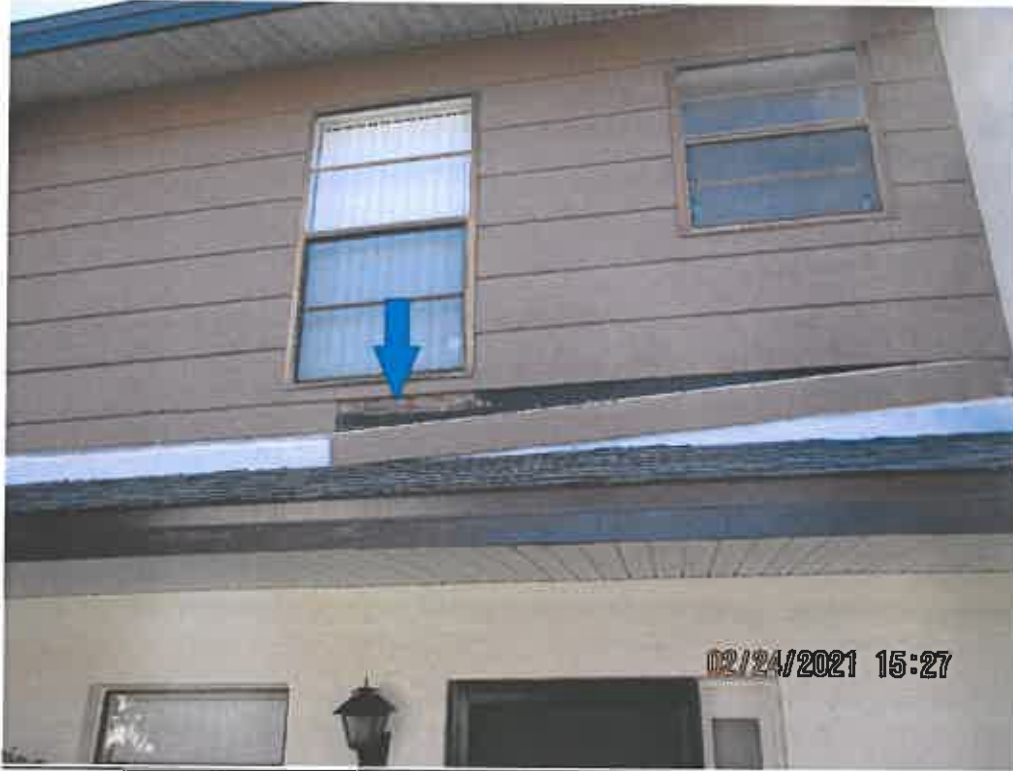
**Example view of exposed plywood substrate at recently installed roof flashing-these details and overall poor condition of siding will necessitate siding replacement**
