# **Harbor Villa Townhouses**

Indian Harbour Beach, Florida

## **Exterior Building Balcony Structure Inspection Report**

**June 23, 2021**

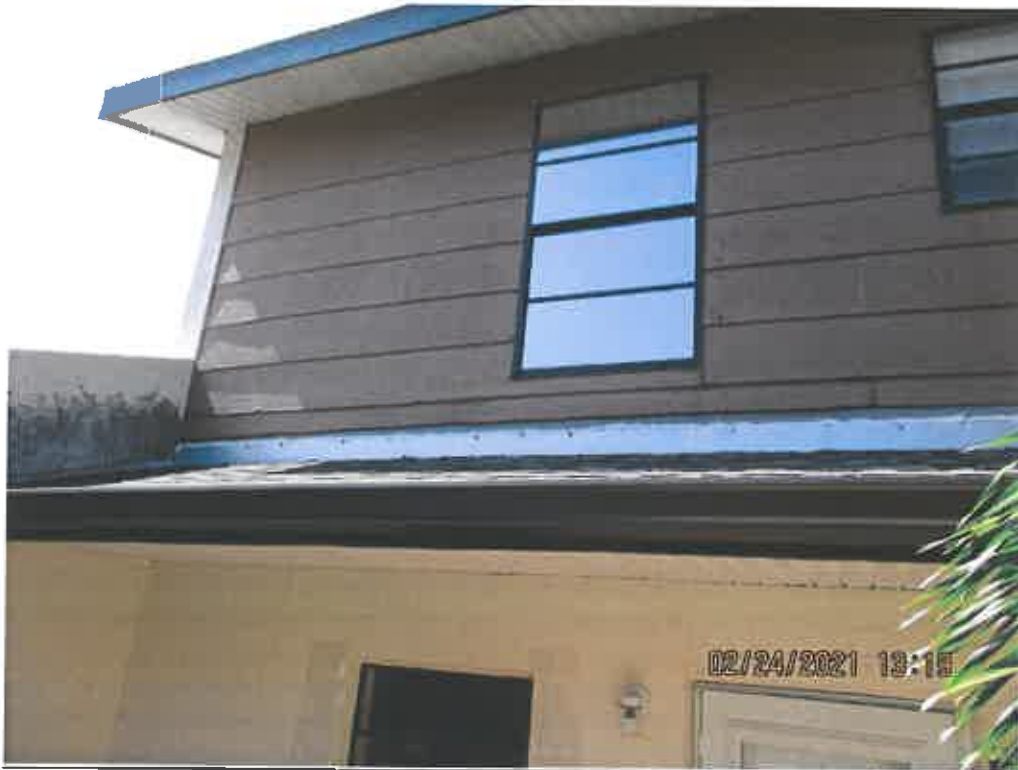
**Example view of exposed plywood substrate at recently installed roof flashing-these details and overall poor condition of siding will necessitate siding replacement**

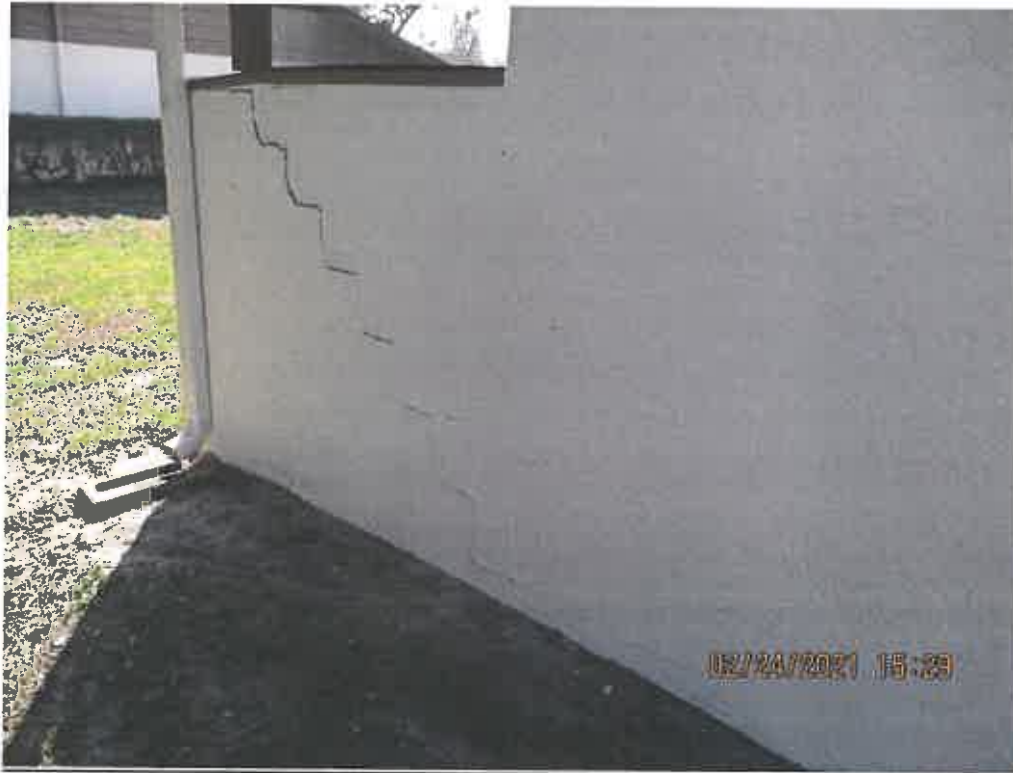
Example view of wing end wall failure due to soil settlement and erosion

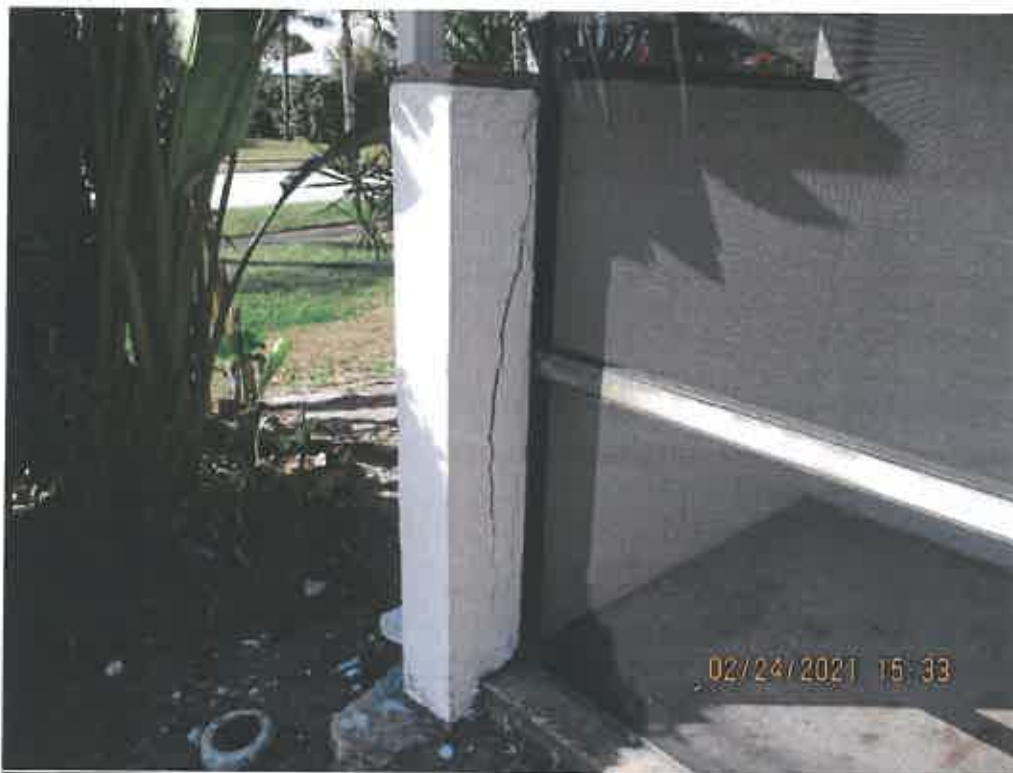
Example view of wing end wall failure due to soil settlement and erosion or spalling
