**Serena Shores Condominium Association**  
**Non-SIRS Components**  
***Indian Harbor Beach, FL***

Report #: 36712-0  
Beginning: January 1, 2026  
Expires: December 31, 2026

**RESERVE STUDY**  
**"Full"**

June 30, 2025

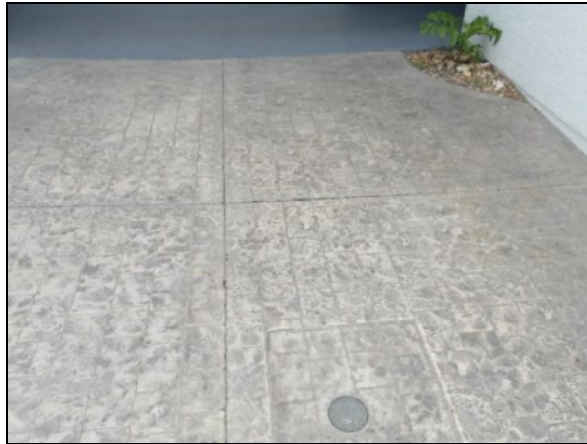
Concrete pavers in sidewalk/path applications should have a very long useful life and typically are replaced for aesthetic reasons before physical failure. Should be inspected regularly for trip hazards, lifting, etc. to avoid liability issues. Individual sections can usually be removed and replaced to address settling issues, lifting from tree roots, cracked pavers, etc. A wide variety of sizes, color patterns and other design choices are available. Cost estimates shown here are based on replacement to a similar standard as existing pavers.

**Useful Life:**  
40 years**Remaining Life:**  
17 years

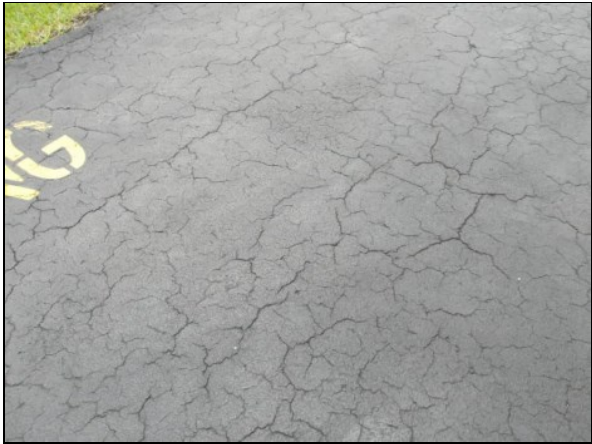
**Comp #: 2123 Asphalt - Seal/Repair**

**Useful Life:**  
5 years

**Remaining Life:**  
4 years

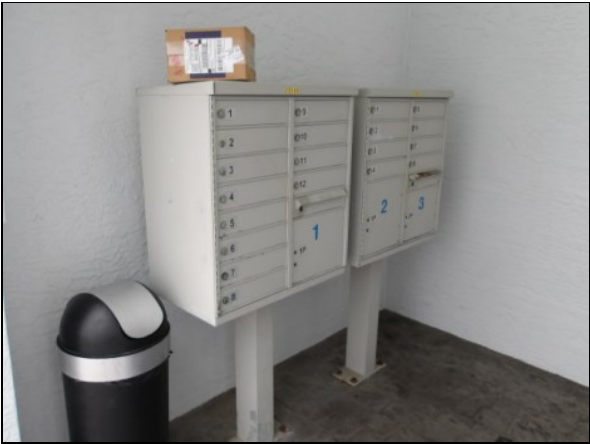
**Useful Life:**  
20 years

**Remaining Life:**  
5 years

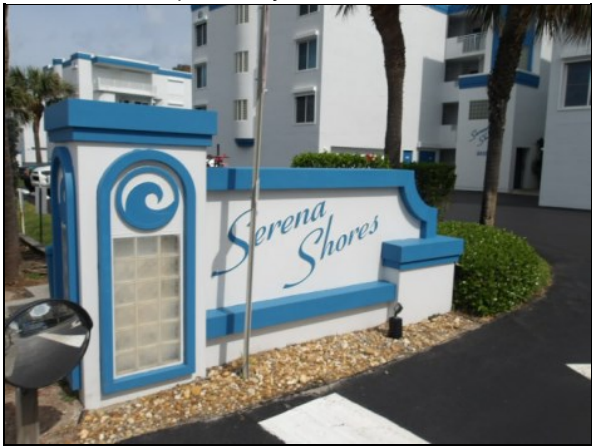
**Useful Life:**  
20 years

**Remaining Life:**  
14 years

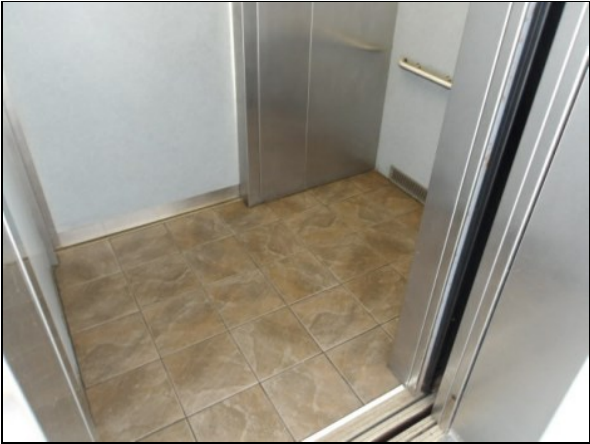
**Useful Life:**  
25 years

**Remaining Life:**  
2 years

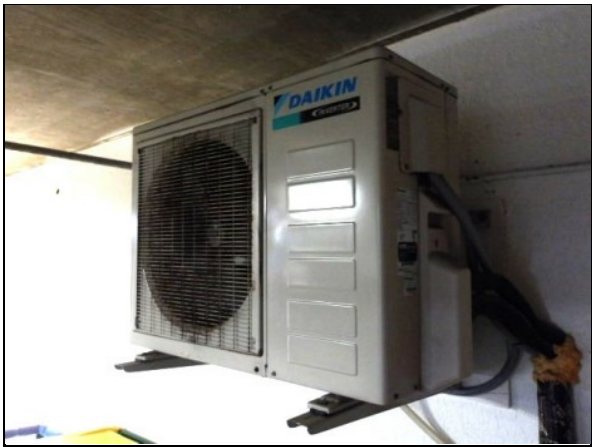
**Useful Life:**  
15 years

**Remaining Life:**  
10 years

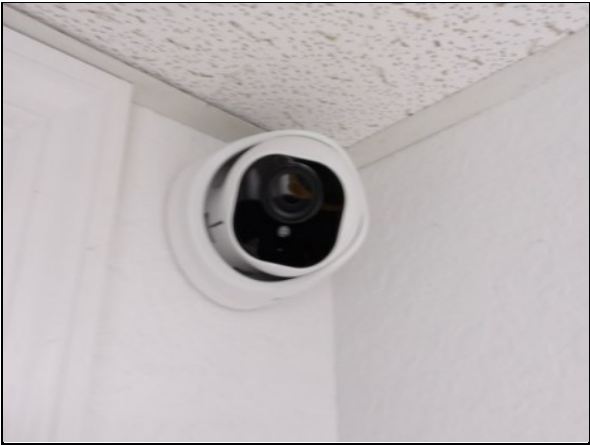
**Useful Life:**  
10 years

**Remaining Life:**  
8 years

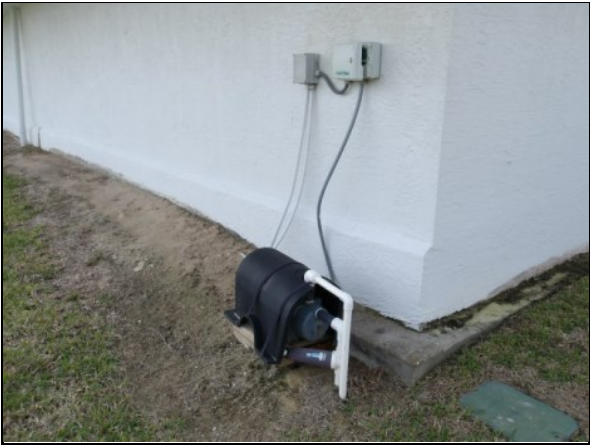
**Useful Life:**  
20 years

**Remaining Life:**  
18 years

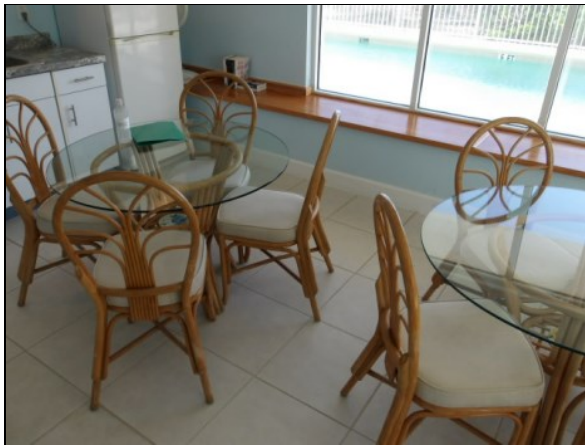
**Useful Life:**  
20 years

**Remaining Life:**  
15 years

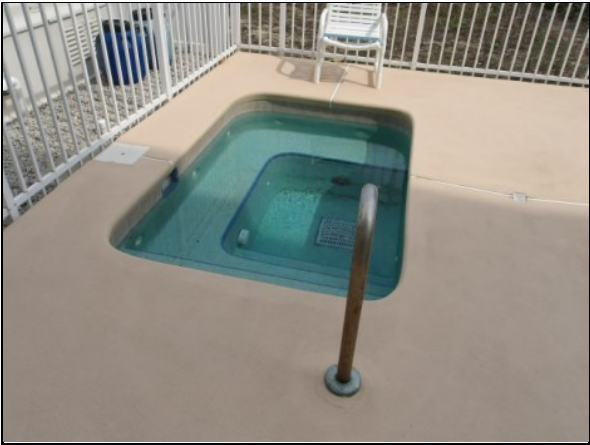
**Useful Life:**  
12 years

**Remaining Life:**  
3 years

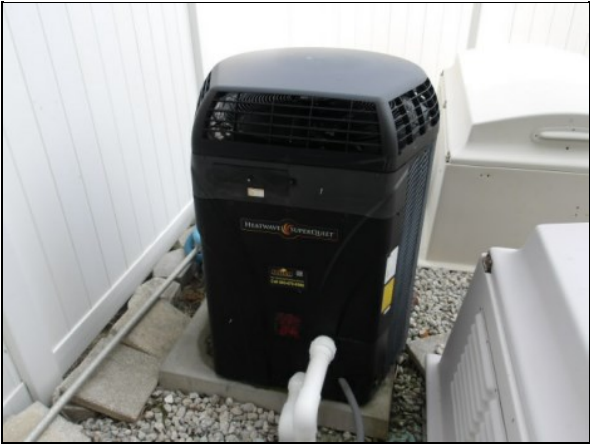
**Useful Life:**  
8 years

**Remaining Life:**  
1 years

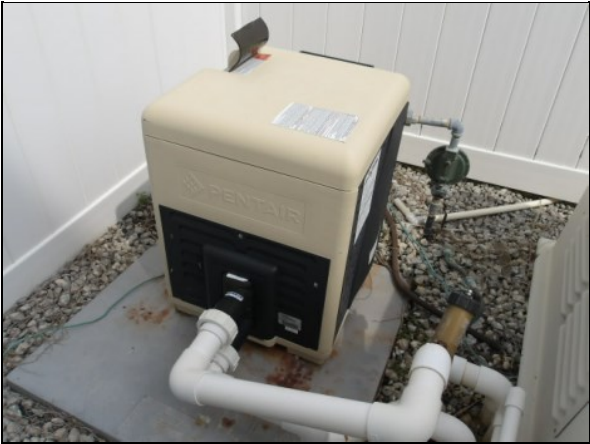
**Useful Life:**  
5 years

**Remaining Life:**  
3 years

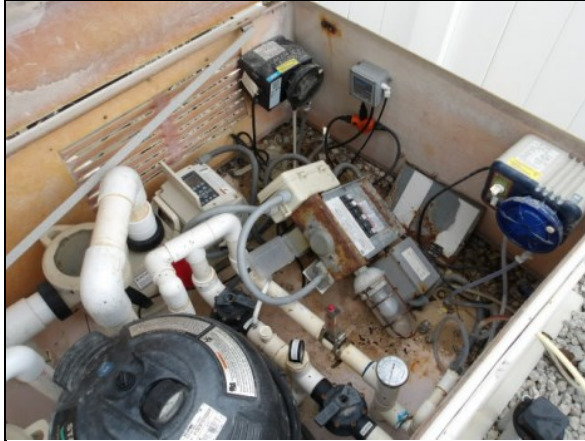
**Useful Life:**  
10 years

**Remaining Life:**  
6 years
