**Opus 21 Homeowners Association Inc**  
**SIRS Components**  
***Melbourne Beach, FL***

Report #: 51753-0  
Beginning: January 1, 2025  
Expires: December 31, 2025

**RESERVE STUDY**  
**"Full"**

September 16, 2024

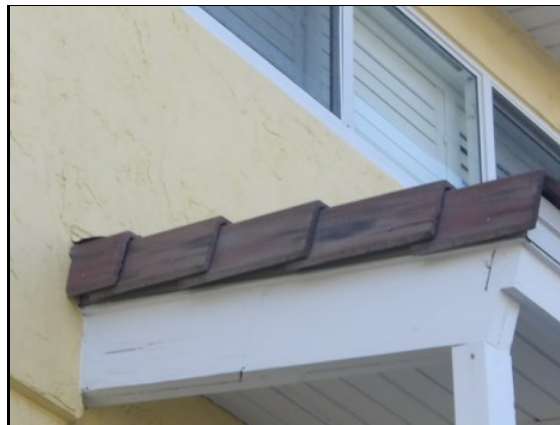
### Comp #: 2383 Tile Roofing - Replace

Useful Life:  
25 years

Remaining Life:  
13 years
