# Uniform Mitigation Verification Inspection Form

| Inspection Date: 10/03/2022 | | |
| Owner Name: Opus 21 Homeowners Association | | Contact Person: |
| Address: 2935, 2937, 2939, 2941, 2943, 2945 S Highway A1A | | Home Phone: |

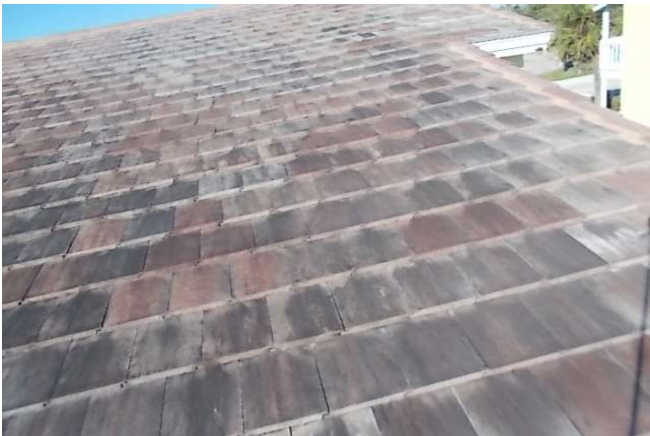
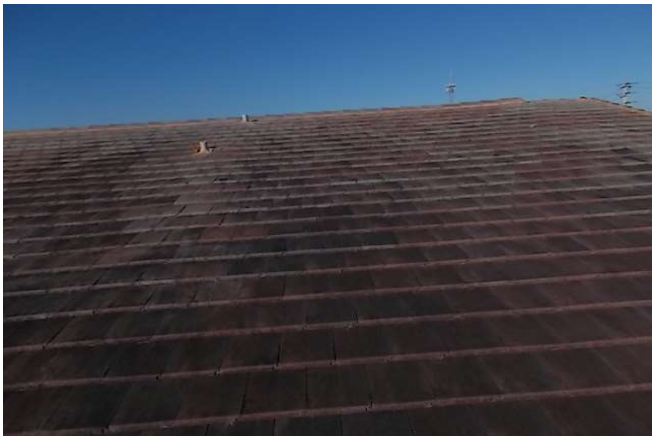
Roof

| 2.1 Roof Covering Type: | Permit Application Date | FBC or MDC Product Approval # | Year of Original Installation or Replacement | No Information Provided for Compliance |
|---|---|---|---|---|
| <input checked="" type="checkbox"/> 2. Concrete/Clay Tile | 10/29/14 | P#14BC12704 | | <input type="checkbox"/> |

- ☒ A. All roof coverings listed above meet the FBC with a FBC or Miami-Dade Product Approval listing current at time of installation OR have a roofing permit application date on or after 3/1/02 OR the roof is original and built in 2004 or later.

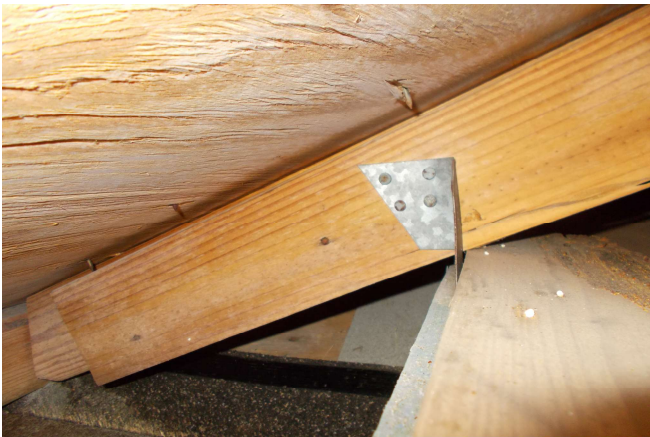
- ☒ B. Clips
  - ☒ Metal connectors that do not wrap over the top of the truss/rafter, **or**
  - ☐ Metal connectors with a minimum of 1 strap that wraps over the top of the truss/rafter and does not meet the nail position requirements of C or D, but is secured with a minimum of 3 nails.

Clips

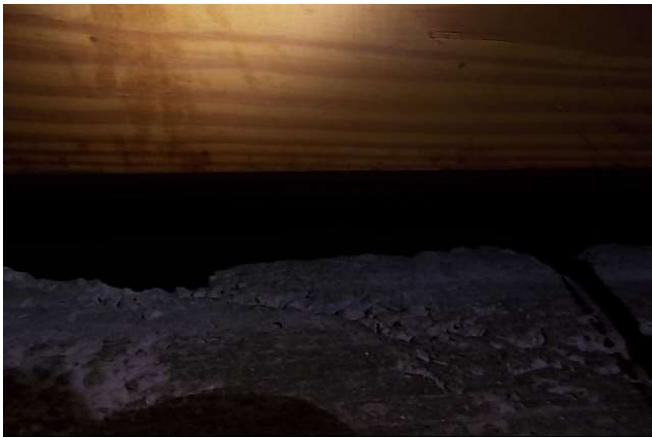
- ☐ A. SWR (also called Sealed Roof Deck) Self-adhering polymer modified-bitumen roofing underlayment applied directly to the sheathing or foam adhesive SWR barrier (not foamed-on insulation) applied as a supplemental means to protect the dwelling from water intrusion in the event of roof covering loss.
- ☒ B. No SWR.
- ☐ C. Unknown or undetermined.

Non SWR (Tar paper)

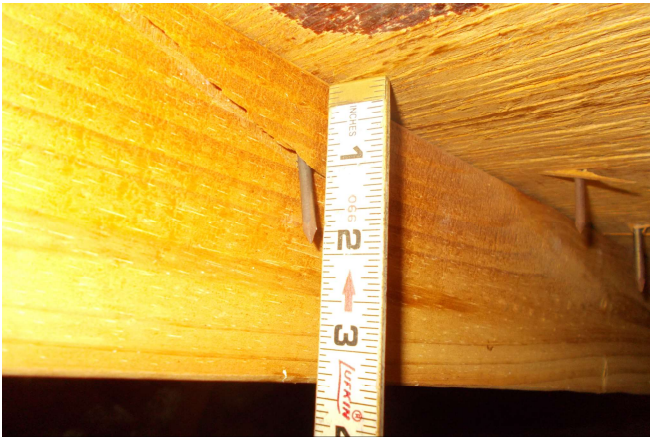
- ☒ C. Plywood/OSB roof sheathing with a minimum thickness of 7/16" attached to the roof truss/rafter (spaced a maximum of 24 inches o.c.) by 8d common nails spaced a maximum of 6" inches in the field. -OR- Dimensional lumber/Tongue & Groove decking with a minimum of 2 nails per board (or 1 nail per board if each board is equal to or less than 6 inches in width). -OR- Any system of screws, nails, adhesives, other deck fastening system or truss/rafter spacing that is shown to have an equivalent

8D nails

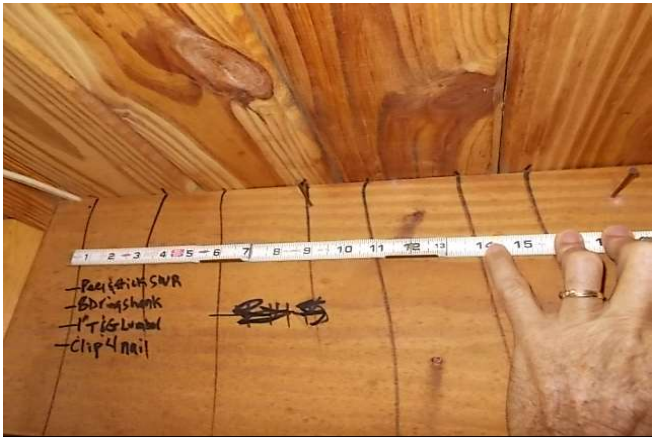
Nailing pattern
