# Riverside Landing Condominium Association, Inc.

Inspected: February 13, 2024 • Revised on: June 26, 2024  
Cocoa, FL

STRUCTURAL INTEGRITY  
RESERVE STUDY

Riverside Landing Condominium Association, Inc.  
Cocoa, Florida

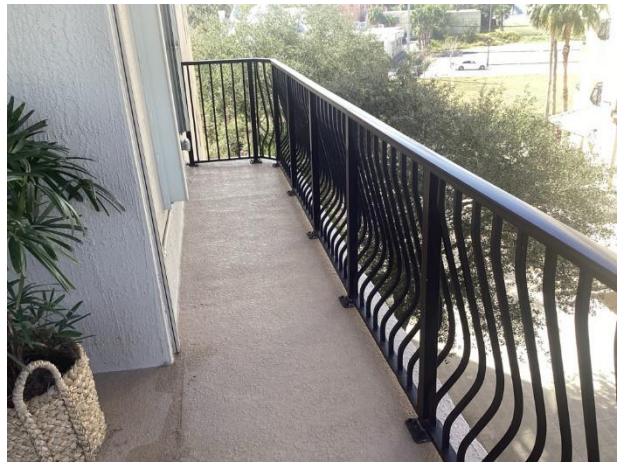
**Condition:** Good overall with isolated coating deterioration evident. We note the following:

- Sealants are in good condition
- The coatings are in good condition
- Isolated concrete coating deterioration is evident

Concrete balcony overview

**Useful Life:** Capital repairs including a close-up visual inspection, patching of delaminated concrete, routing and filling of cracked concrete, and waterproof coating applications every 8- to 12-years.

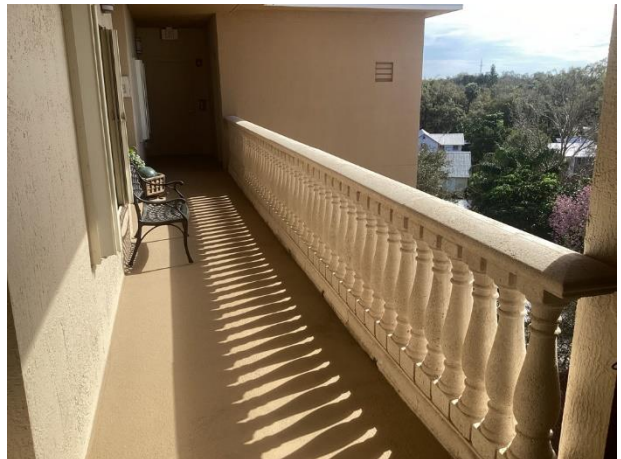
Concrete breezeway overview

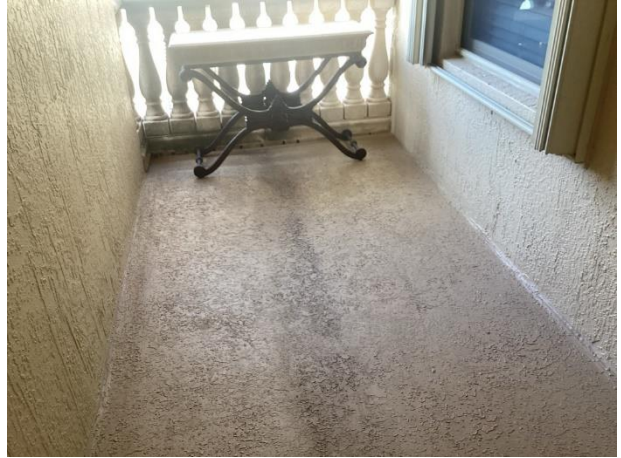
**Coating deterioration at the concrete breezeways**

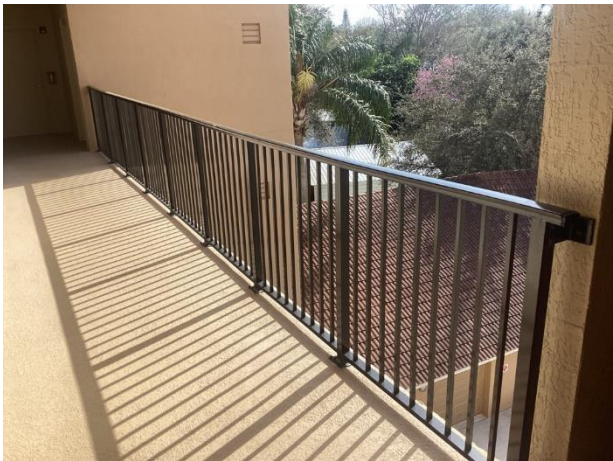
**Conditions:** The railings are in good overall condition and the railing finishes are in good condition

Metal breezeway railings overview

**Useful Life:** Railings of this type have a useful life of up to 40 years with the benefit of periodic maintenance. Periodic maintenance should include applications of a protective paint finish and partial replacement of deteriorated metal every 8- to 12-years.

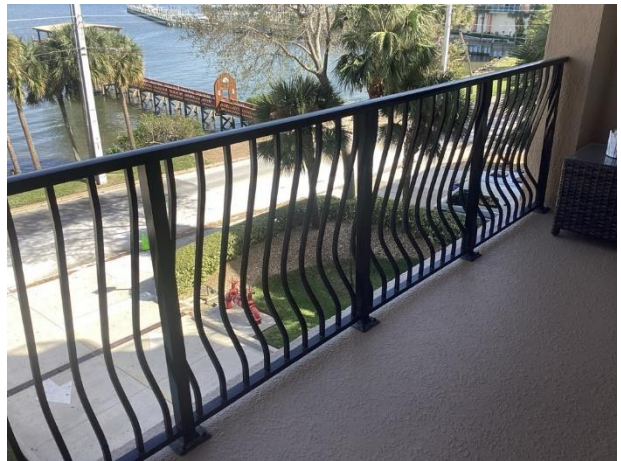
Metal balcony railings overview

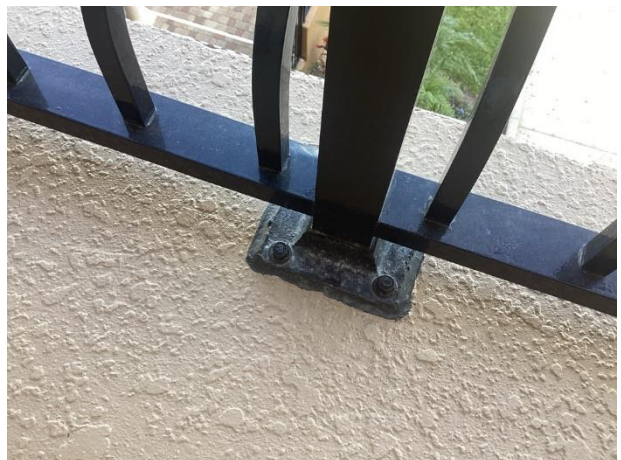
Mechanically attached railing post

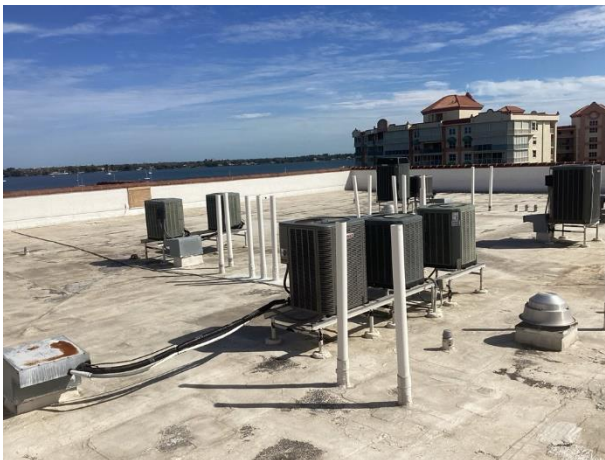
**Condition:** Good to fair overall with coating deterioration and bulges in the membrane evident. Management and the Board do not report history of leaks. We note the following:

- Isolated previous membrane repairs are evident
- Isolated sealant failure is evident
- Isolated expansion joint deterioration is evident
- Isolated blocked roof drains are evident

Thermoplastic roof overview

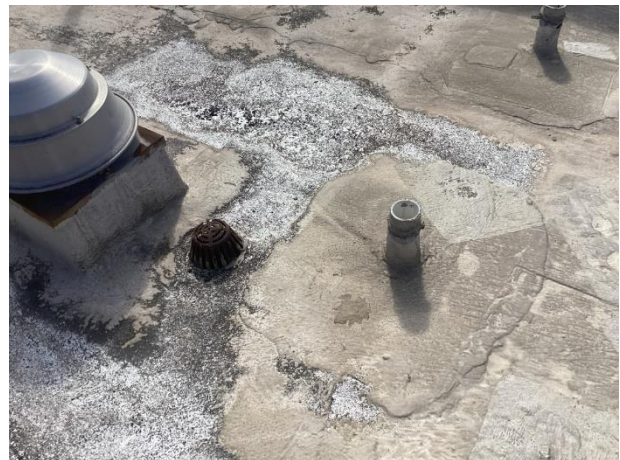
Typical roof drain and penetration

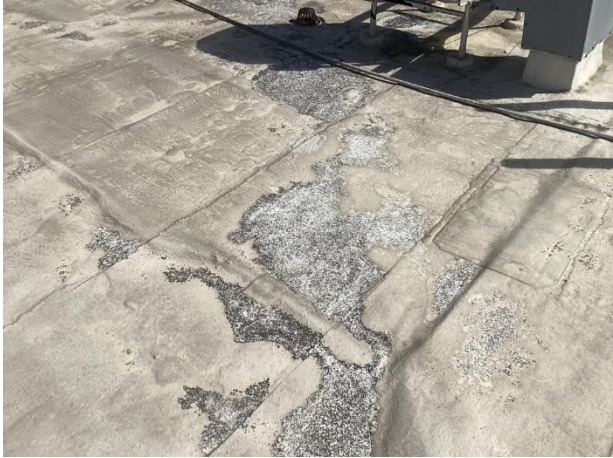
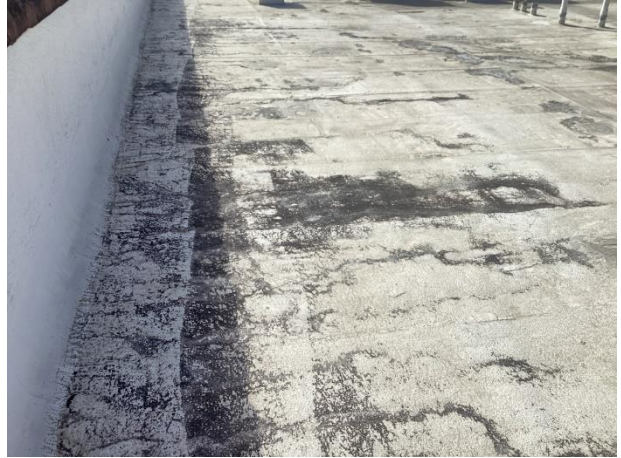
**Coating deterioration**

**Useful Life:** 15- to 20-years

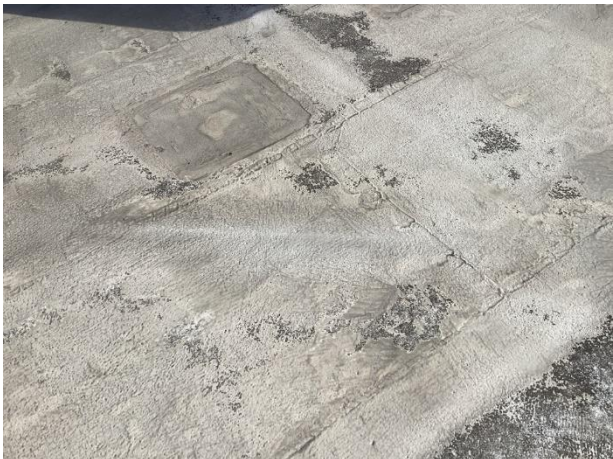
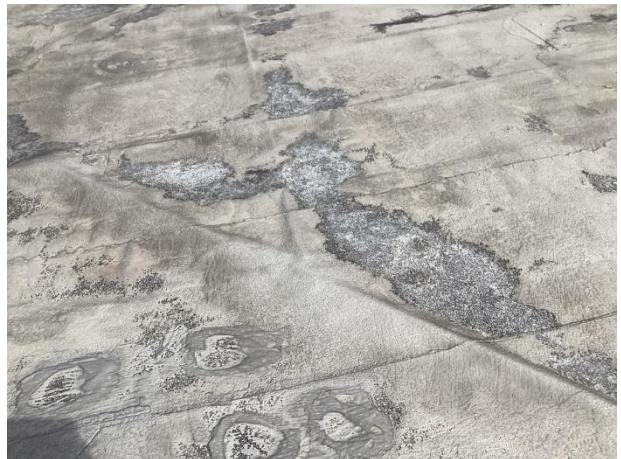
**Bulges in the membrane**

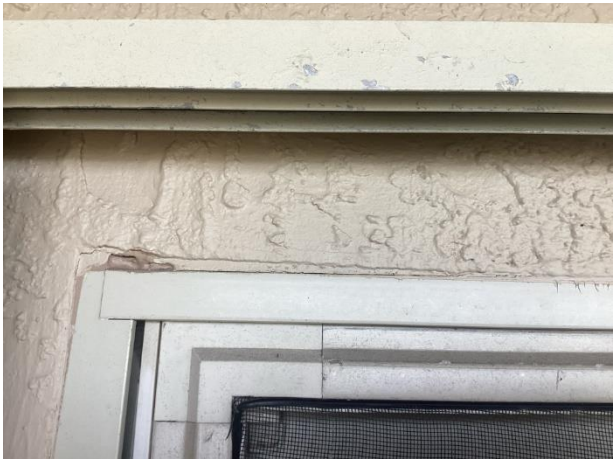
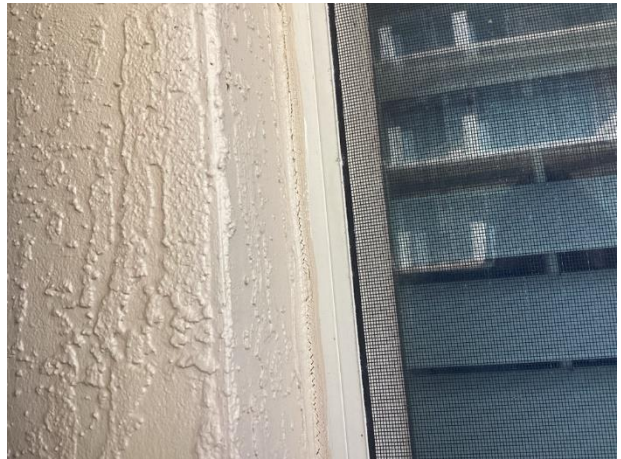
**Condition:** Good overall with isolated deterioration evident.

Sealant deterioration

**Useful Life:** Up to 20 years

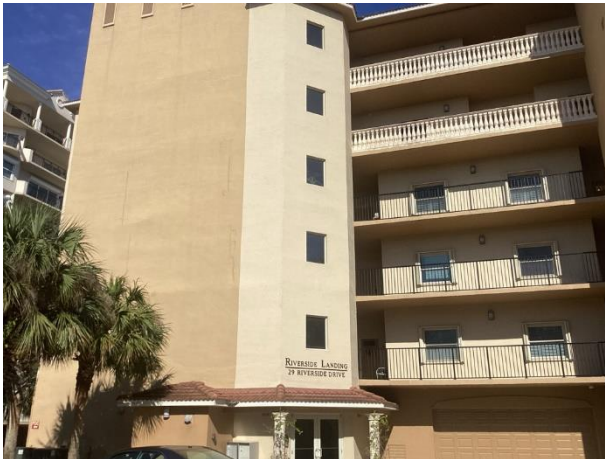
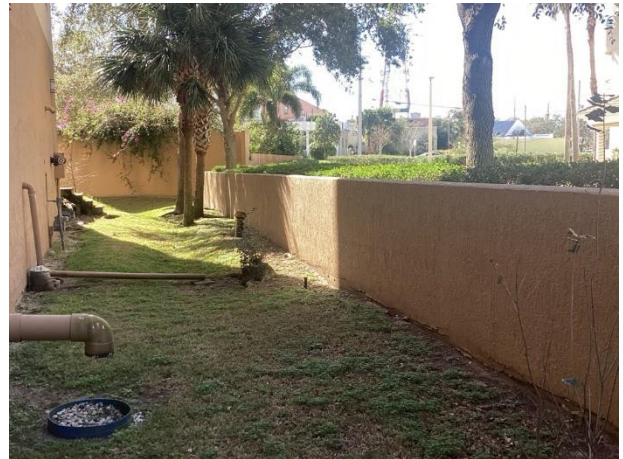
**Condition:** Good to fair overall with evidence of previously repaired cracks and finish deterioration evident. We note the following:

- Isolated cracks are evident
- Isolated damage or missing is evident
- Sealants are in good condition
- The Stucco properly terminates four inches above grade
- The Stucco properly terminates two inches above the roof
- Kickout/diverter flashing is evident

Stucco perimeter wall overview

Perimeter wall stucco wall finishes

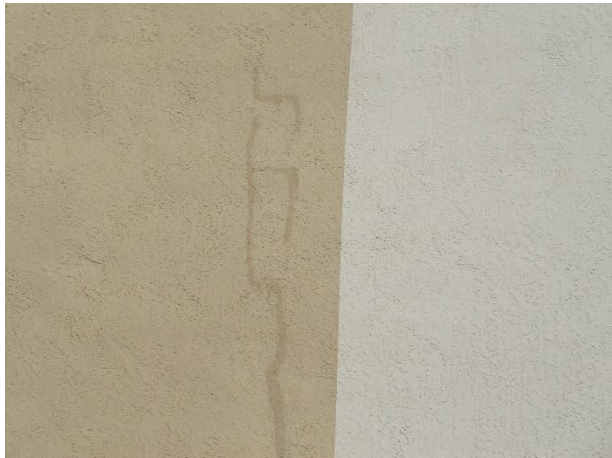
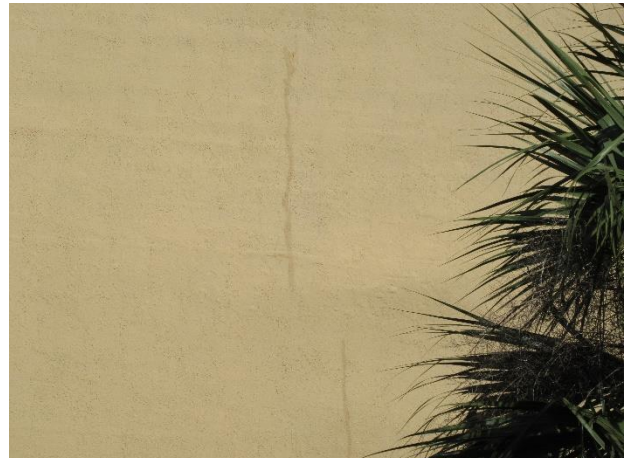
Evidence of previously repaired cracks

**Useful Life:** We recommend inspections, repairs and paint finish applications every five- to seven-years. However, the Association informs us the stucco paint finishes have a 10-year warranty with required annual inspections to maintain the warranty, and due to this we extend the useful life to 8- to 10-years.

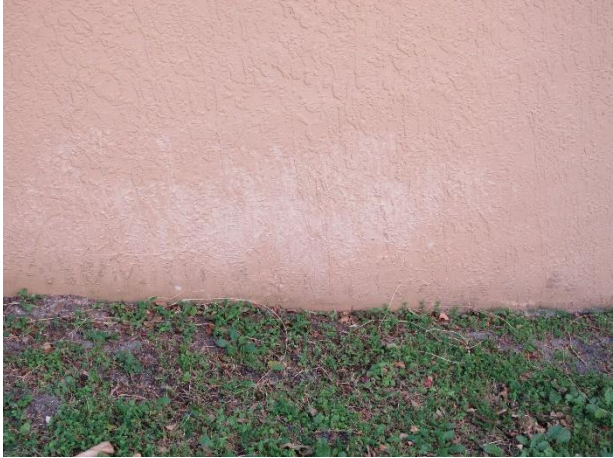
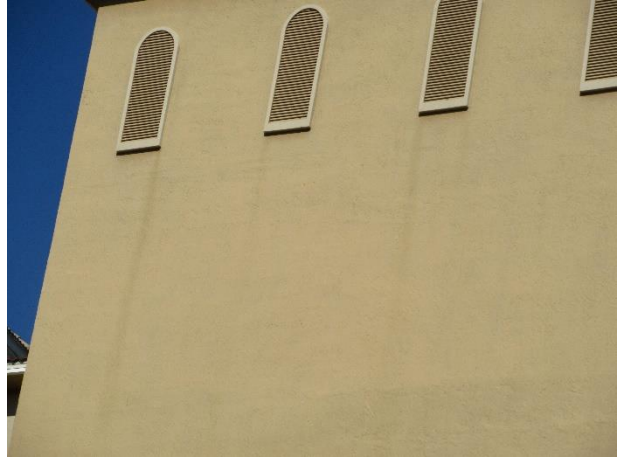
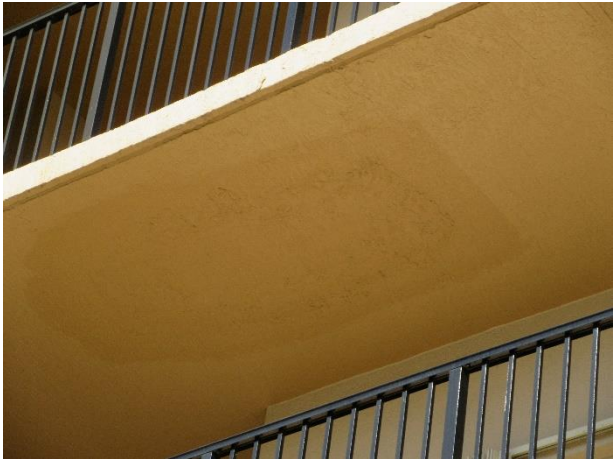
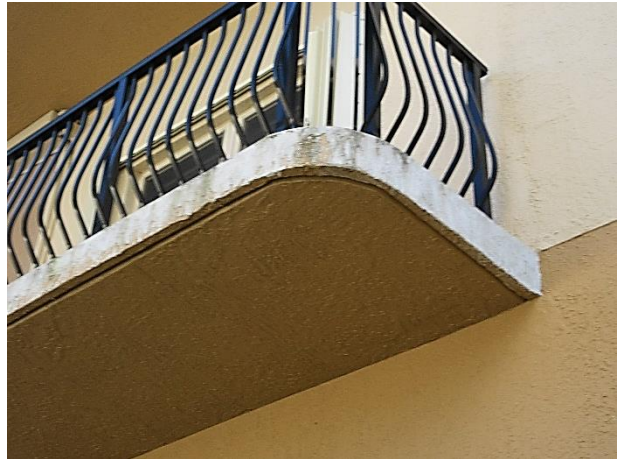
**Finish deterioration**

Correct and complete preparation of the surface before application of the paint finish maximizes the useful life of the paint finish and surface. The contractor should remove all loose, peeled or blistered paint before application of the new paint finish. The contractor should then power wash the surface to remove all dirt and biological growth. Water-soluble cleaners that will not attack Portland cement are acceptable for removing stains.

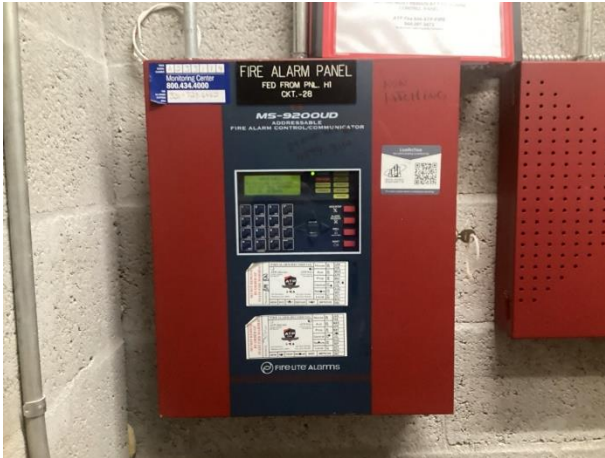
**Conditions:** Reported satisfactory without operational deficiencies. The life safety system was last inspected on June 23, 2024. The life safety system was tagged acceptable during the most recent inspection.

**Control panel**

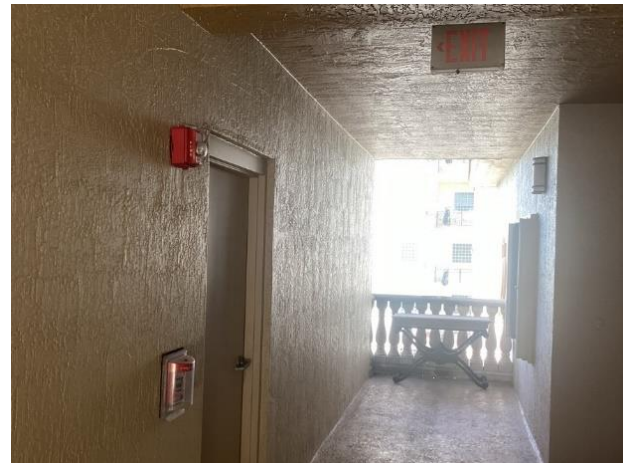
**Emergency devices**

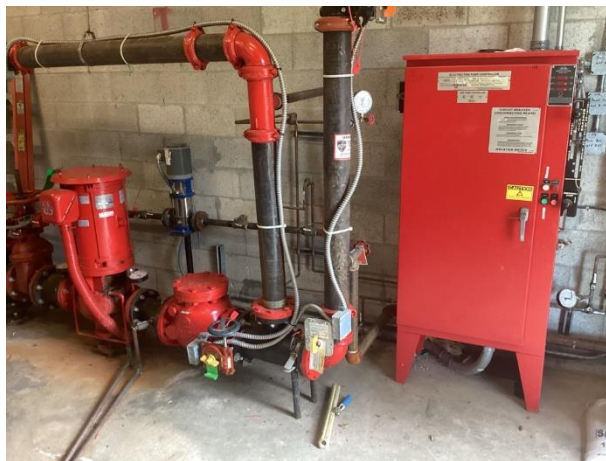
**Condition:** Reported satisfactory without operational deficiencies. We note the following:

- The fire suppression pump was last inspected in April of 2023.
- The inspection tag color is acceptable
- The Association does not report a history of leaks.

Fire suppression pump

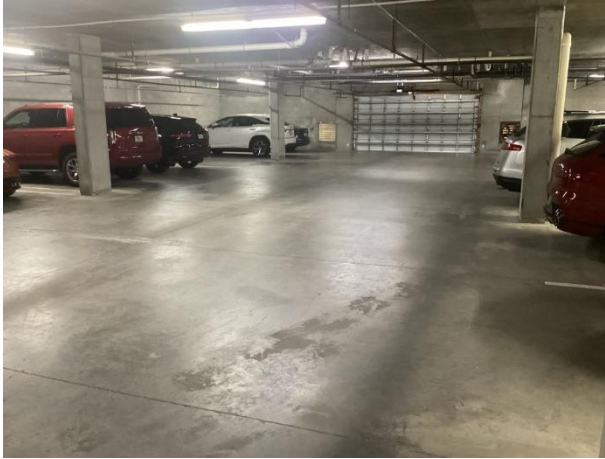
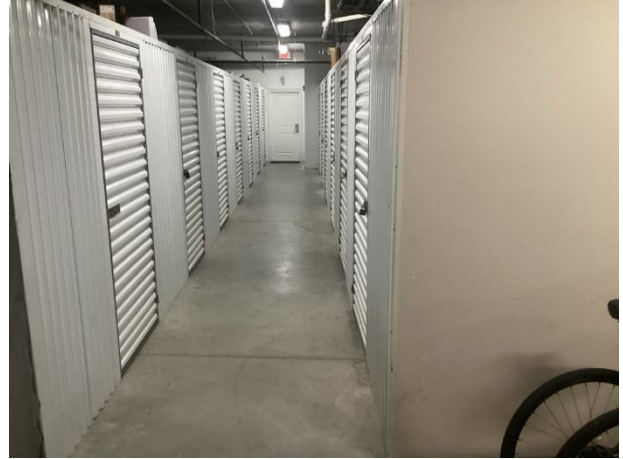
**Condition:** Good overall with cracks evident. We note the following:

**On-grade garage floor overview**

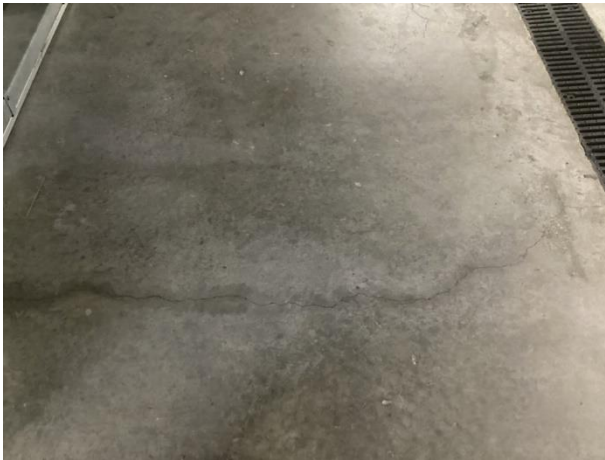
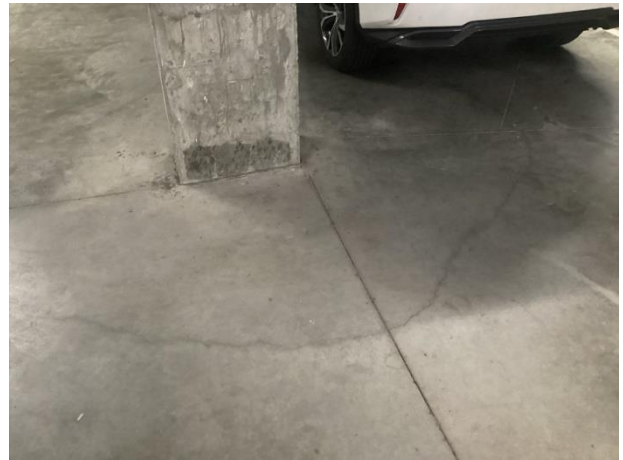
- We note isolated areas of cracks
- The overall condition of the floor drains is satisfactory
- Isolated areas of ponding water or evidence of poor drainage were noted
- Isolated areas of vehicular damage at the columns were noted

**Concrete cracks**

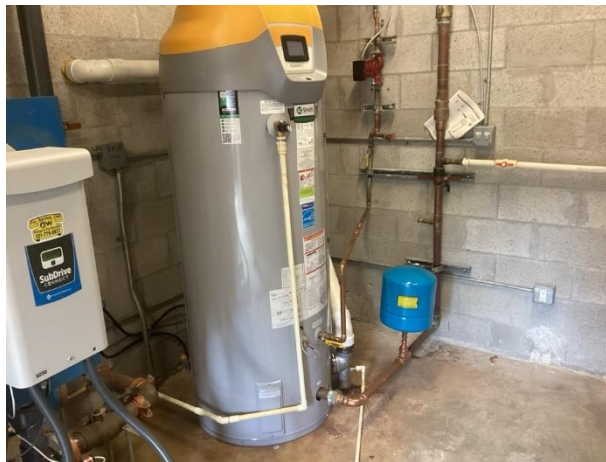
**Condition:** Reported satisfactory without operational deficiencies

**Domestic water boiler**

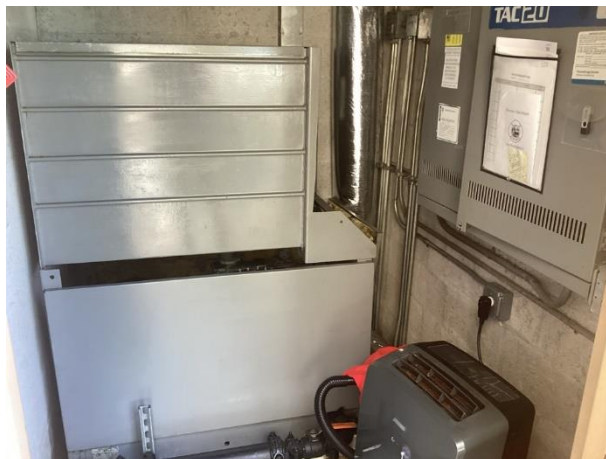
**Condition:** Reported satisfactory and service interruptions are reportedly infrequent

Hydraulic elevator equipment

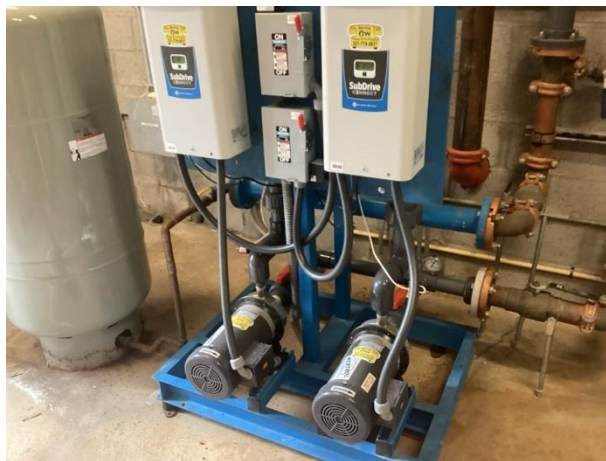
**Condition:** Reported satisfactory without operational deficiencies.

**Domestic water pumps**

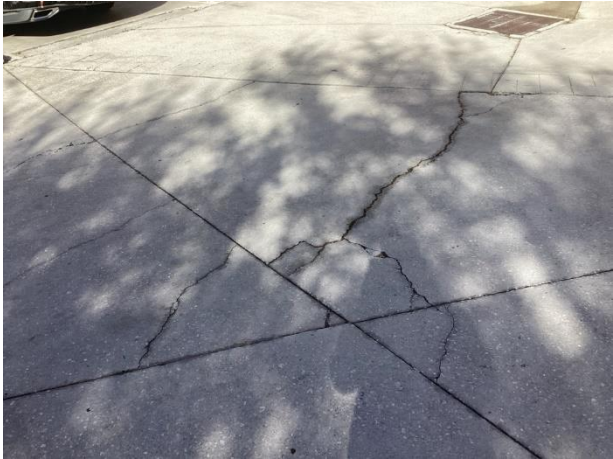
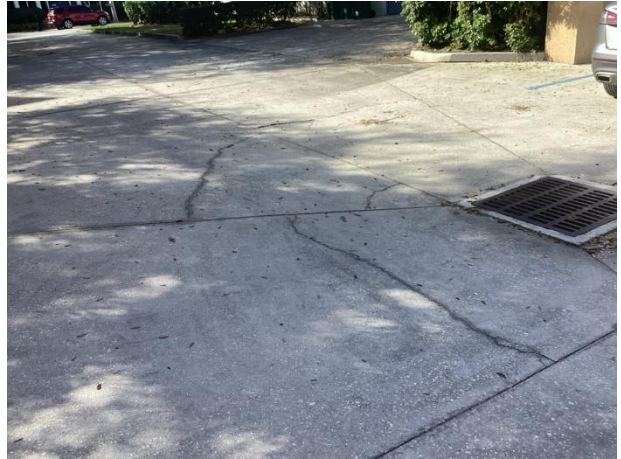
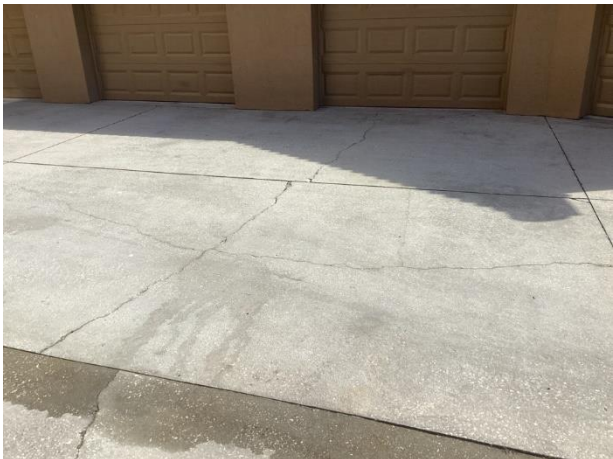
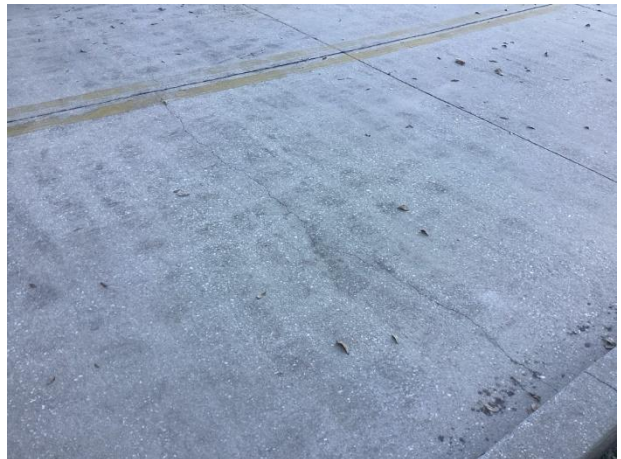
**Condition:** Good to fair overall with periodic cracks evident.

Concrete cracks

**Useful Life:** Up to 65 years although interim deterioration of areas is common

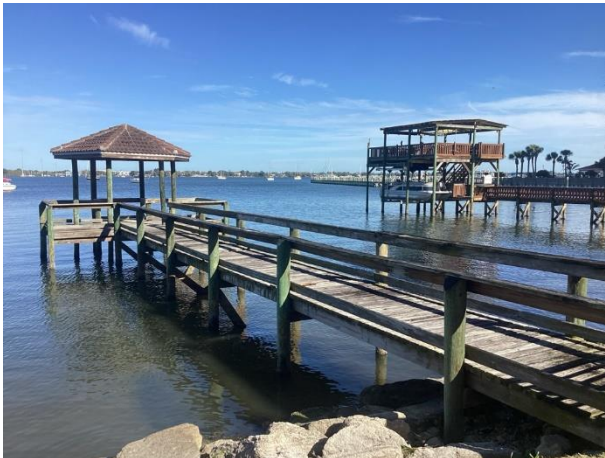
**Condition:** Fair overall with damaged deck boards evident.

**Dock with wood decking**

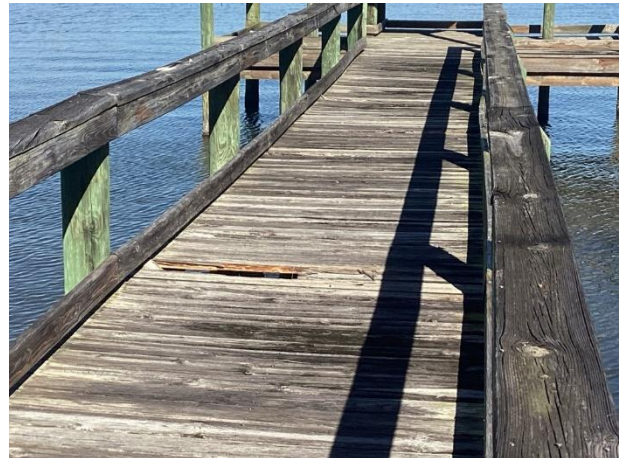
**Deck board damage**

**Useful Life:** Up to 35 years for complete replacement and 12- to 18-years for interim replacement of the decking and structure repairs

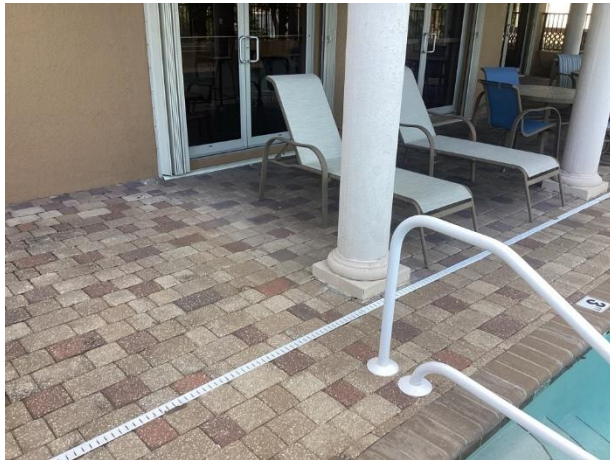
**Condition:** Good to fair overall with periodic settlement evident.

Paver pool deck overview
