# Uniform Mitigation Verification Inspection Form

| Owner Name: Opus 21 Homeowners Association | | Contact Person: |
| Address: 2959, 2961, 2963, 2965 S Highway A1A | | Home Phone: |
| Year of Home: 1978 | # of Stories: Two | Email: |

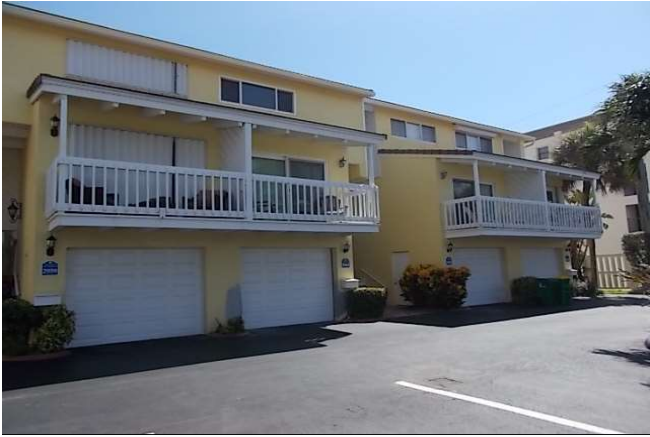
Front

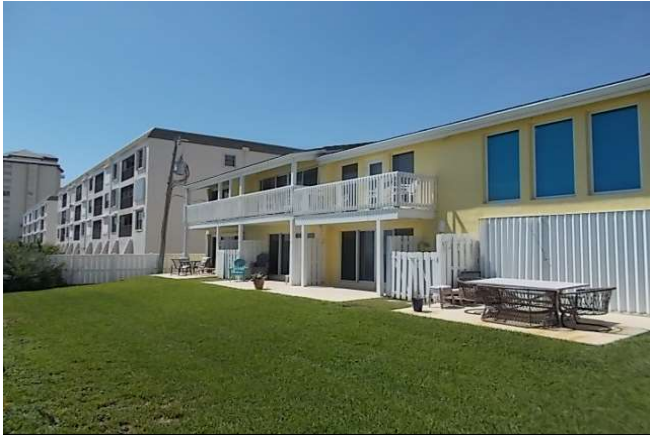
Rear

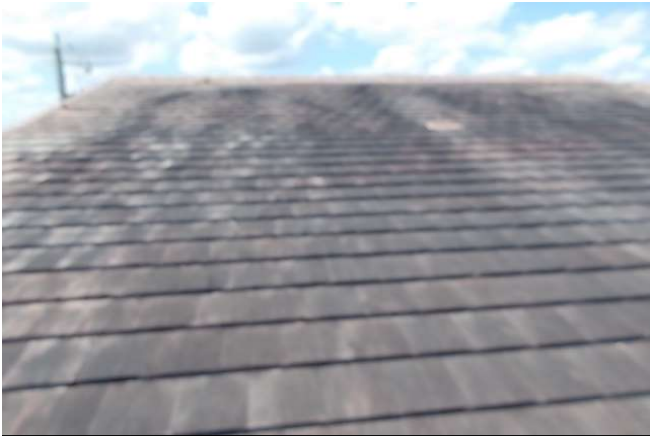
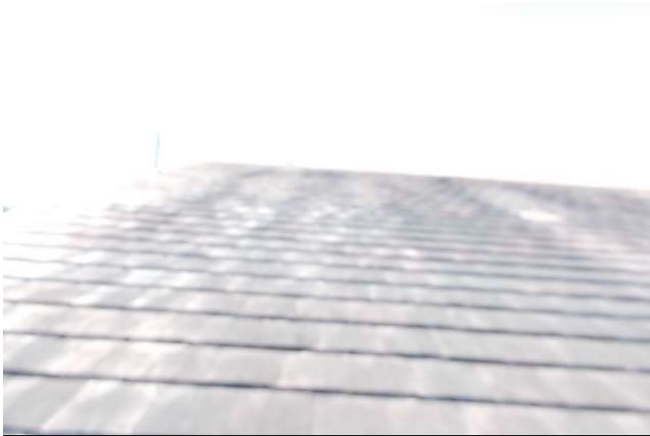
| 2.1 Roof Covering Type: | Permit Application Date | FBC or MDC Product Approval # | Year of Original Installation or Replacement | No Information Provided for Compliance |
|---|---|---|---|---|
| <input checked="" type="checkbox"/> 2. Concrete/Clay Tile | 10/29/14 | P#14BC12705 | | <input type="checkbox"/> |

Roof

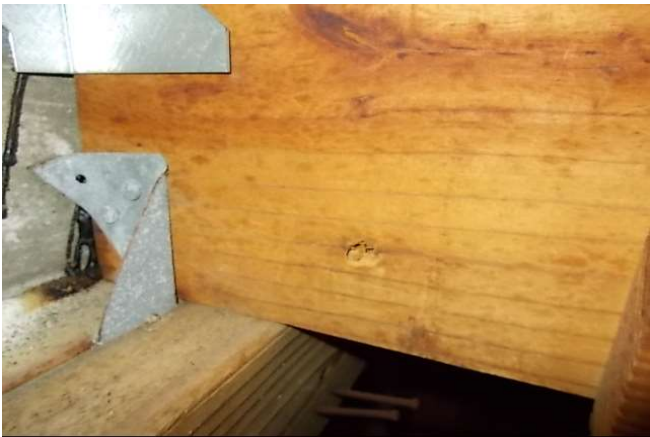
- ☒ B. Clips
  - ☒ Metal connectors that do not wrap over the top of the truss/rafter, **or**
  - ☐ Metal connectors with a minimum of 1 strap that wraps over the top of the truss/rafter and does not meet the nail position requirements of C or D, but is secured with a minimum of 3 nails.

Clips

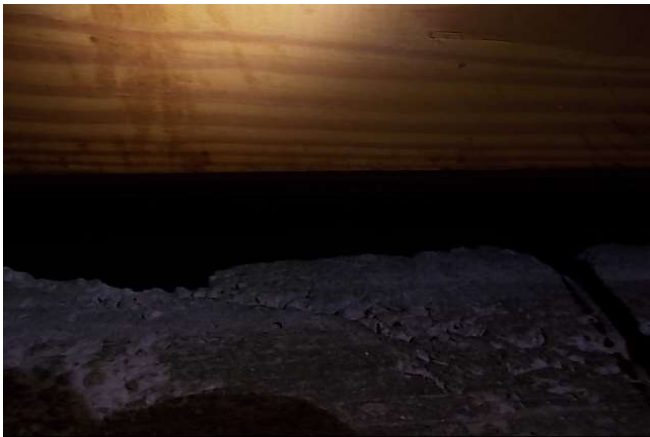
- ☐ A. SWR (also called Sealed Roof Deck) Self-adhering polymer modified-bitumen roofing underlayment applied directly to the sheathing or foam adhesive SWR barrier (not foamed-on insulation) applied as a supplemental means to protect the dwelling from water intrusion in the event of roof covering loss.
- ☒ B. No SWR.
- ☐ C. Unknown or undetermined.

Non SWR (Tar paper)

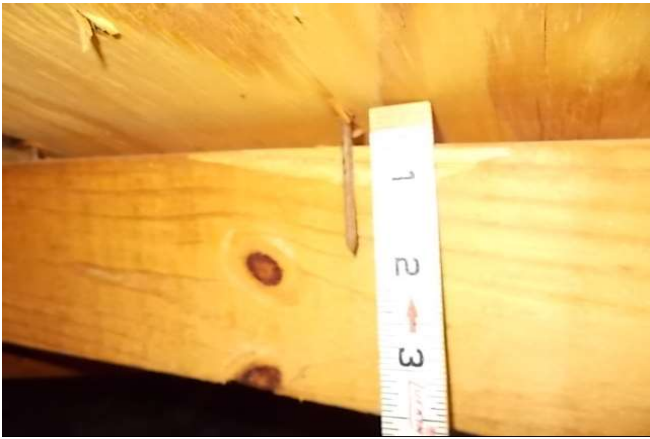
- ☒ C. Plywood/OSB roof sheathing with a minimum thickness of 7/16" attached to the roof truss/rafter (spaced a maximum of 24 inches o.c.) by 8d common nails spaced a maximum of 6" inches in the field. -OR- Dimensional lumber/Tongue & Groove decking with a minimum of 2 nails per board (or 1 nail per board if each board is equal to or less than 6 inches in width). -OR- Any system of screws, nails, adhesives, other deck fastening system or truss/rafter spacing that is shown to have an equivalent

8D nails
