# Uniform Mitigation Verification Inspection Form

| Inspection Date: 10/03/2022 | | |
| Owner Name: Opus 21 Homeowners Association | | Contact Person: |
| Address: 2927, 2929, 2931, 2933 S Highway A1A | | Home Phone: |

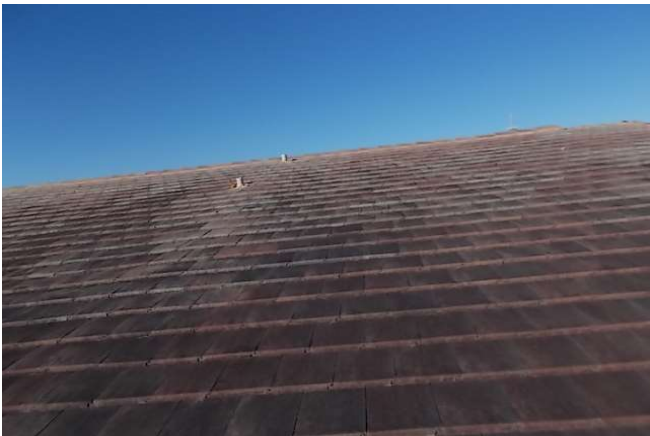
Roof

| 2.1 Roof Covering Type: | Permit Application Date | FBC or MDC Product Approval # | Year of Original Installation or Replacement | No Information Provided for Compliance |
|---|---|---|---|---|
| <input checked="" type="checkbox"/> 2. Concrete/Clay Tile | 10/29/14 | P#14BC12706 | | <input type="checkbox"/> |

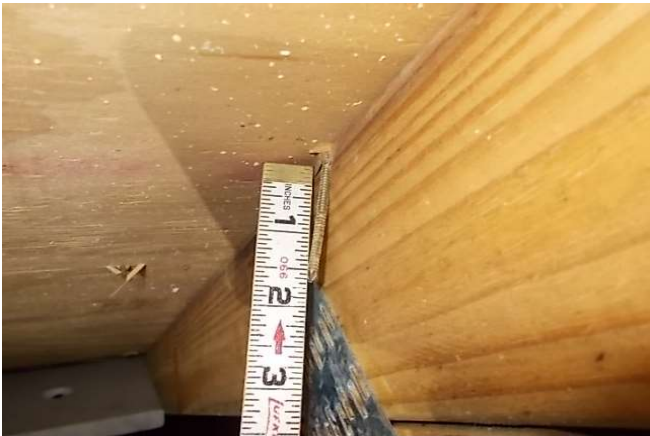
- ☒ C. Plywood/OSB roof sheathing with a minimum thickness of 7/16" attached to the roof truss/rafter (spaced a maximum of 24 inches o.c.) by 8d common nails spaced a maximum of 6" inches in the field. -OR- Dimensional lumber/Tongue & Groove decking with a minimum of 2 nails per board (or 1 nail per board if each board is equal to or less than 6 inches in width). -OR- Any system of screws, nails, adhesives, other deck fastening system or truss/rafter spacing that is shown to have an equivalent

8D nails

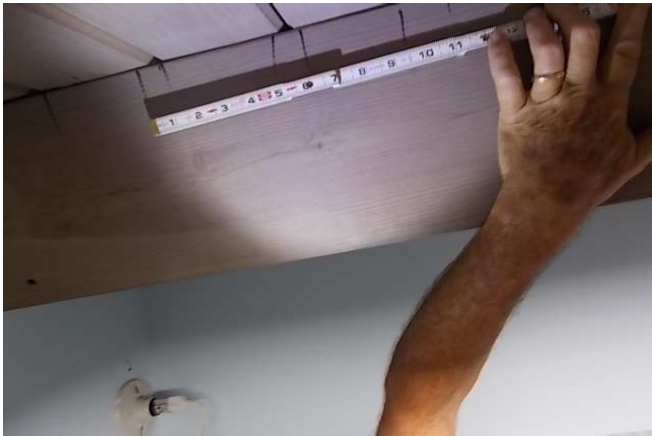
Nailing pattern

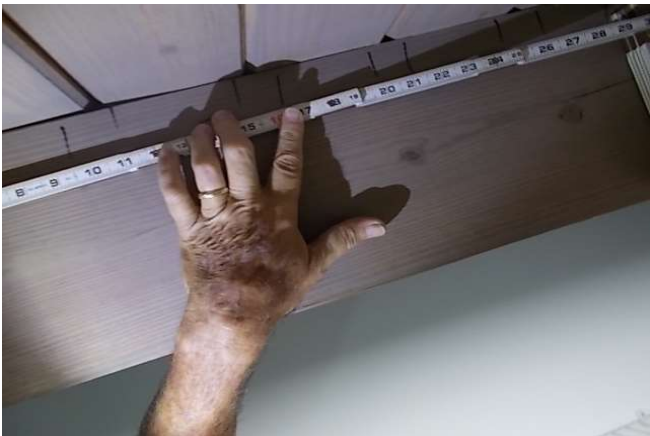
Nailing pattern
