# Uniform Mitigation Verification Inspection Form

| Inspection Date: April 18, 2025 | | |
| Owner Name: Ocean Park South Condominium - Building "G" | | Contact Person: Carol Berg |
| Address: 333 Taylor Avenue | | Home Phone: |

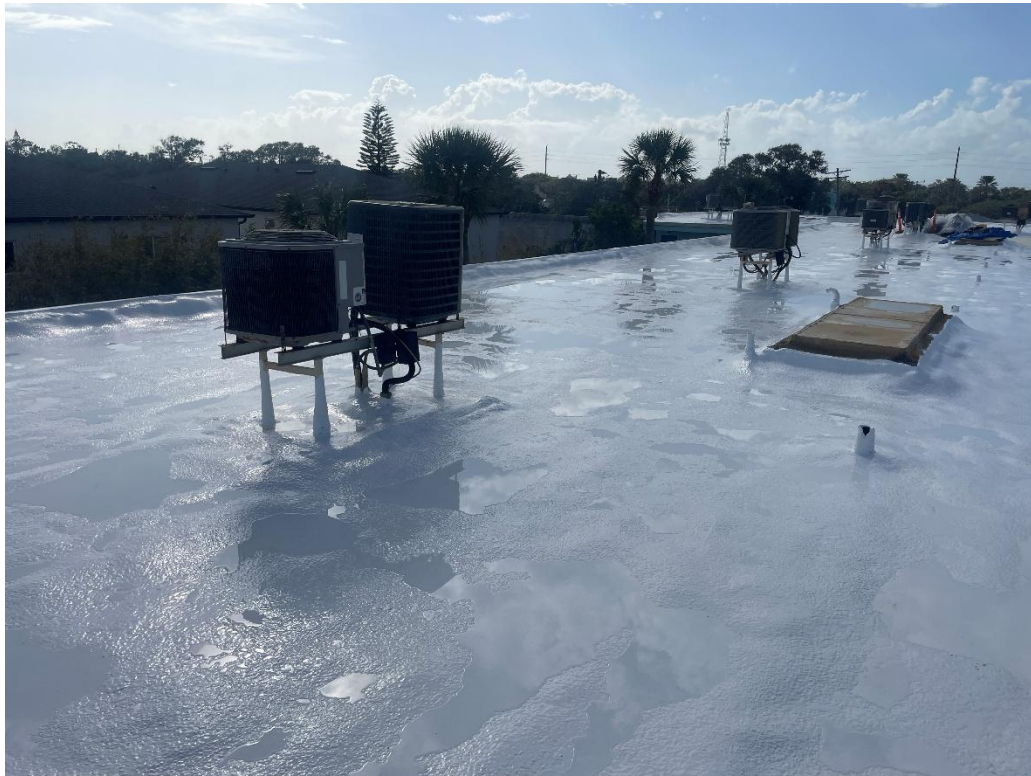
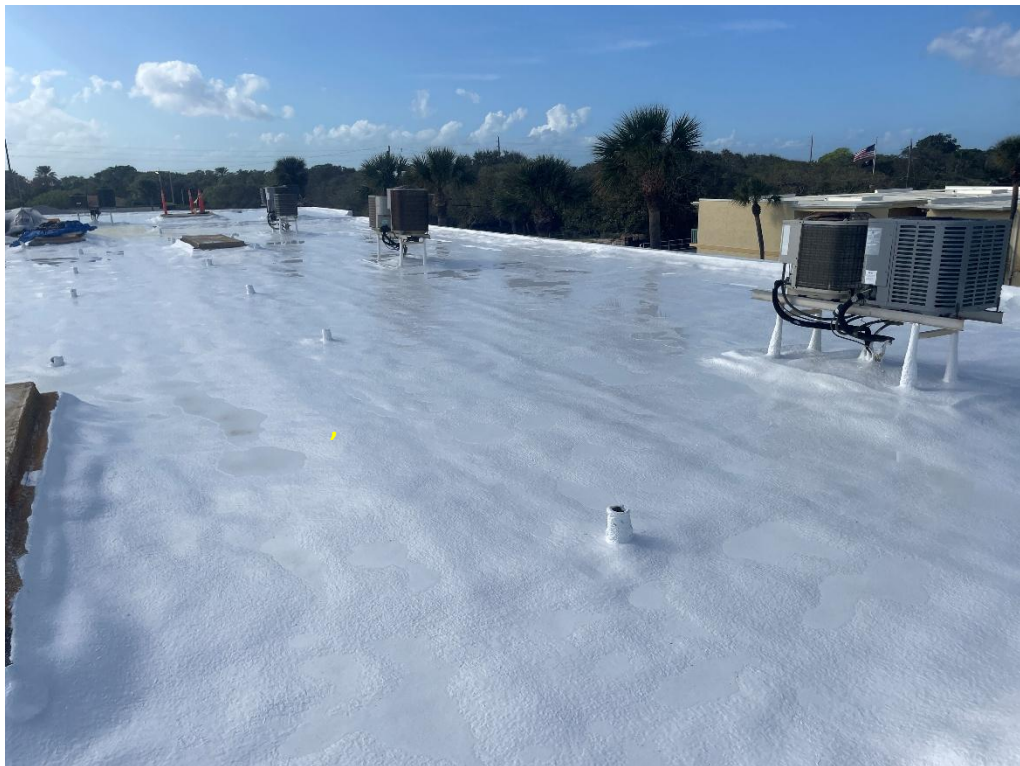
| 2.1 Roof Covering Type: | Permit Application Date | FBC or MDC Product Approval # | Year of Original Installation or Replacement | No Information Provided for Compliance |
|---|---|---|---|---|
| <input checked="" type="checkbox"/> 6. Other <u>Spray Polyurethane Foam</u> | <u>July 2024</u> | _____ | <u>2024</u> | <input type="checkbox"/> |

Photos of the newly installed Spray Polyurethane Foam roof with silicone coating.
