# Uniform Mitigation Verification Inspection Form

| Inspection Date: 10/03/2022 | | |
| Owner Name: Opus 21 Homeowners Association | | Contact Person: |
| Address: 2947, 2949, 2951, 2953, 2955, 2957 S Highway A1A | | Home Phone: |

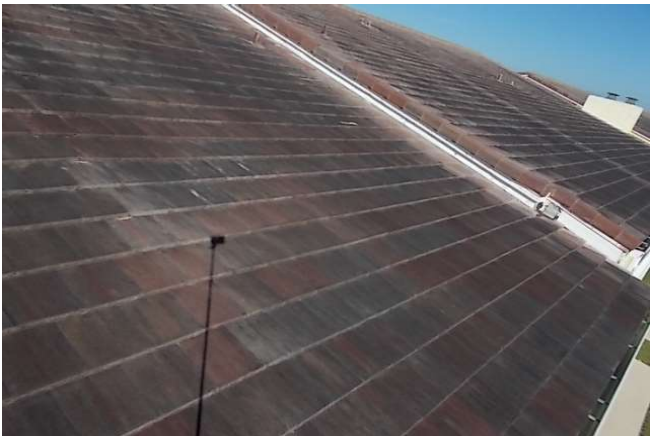
Roof

| 2.1 Roof Covering Type: | Permit Application Date | FBC or MDC Product Approval # | Year of Original Installation or Replacement | No Information Provided for Compliance |
|---|---|---|---|---|
| <input checked="" type="checkbox"/> 2. Concrete/Clay Tile | 10/29/14 | P#14BC12703 | | <input type="checkbox"/> |

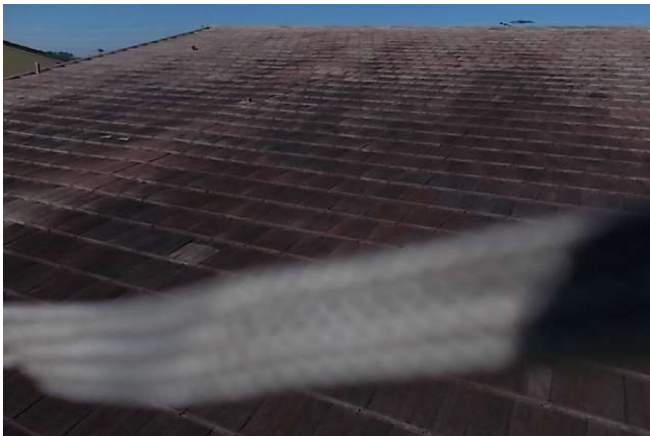
- ☐ A. Hip Roof Hip roof with no other roof shapes greater than 10% of the total roof system perimeter.  
Total length of non-hip features: \_\_\_\_\_ feet; Total roof system perimeter: \_\_\_\_\_ feet
- ☐ B. Flat Roof Roof on a building with 5 or more units where at least 90% of the main roof area has a roof slope of less than 2:12. Roof area with slope less than 2:12 \_\_\_\_\_ sq ft; Total roof area \_\_\_\_\_ sq ft
- ☒ C. Other Roof Any roof that does not qualify as either (A) or (B) above.

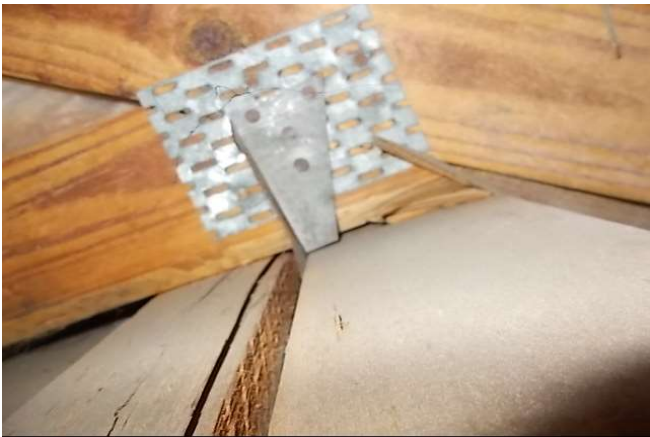
- ☒ B. Clips
  - ☒ Metal connectors that do not wrap over the top of the truss/rafter, **or**
  - ☐ Metal connectors with a minimum of 1 strap that wraps over the top of the truss/rafter and does not meet the nail position requirements of C or D, but is secured with a minimum of 3 nails.

Clips

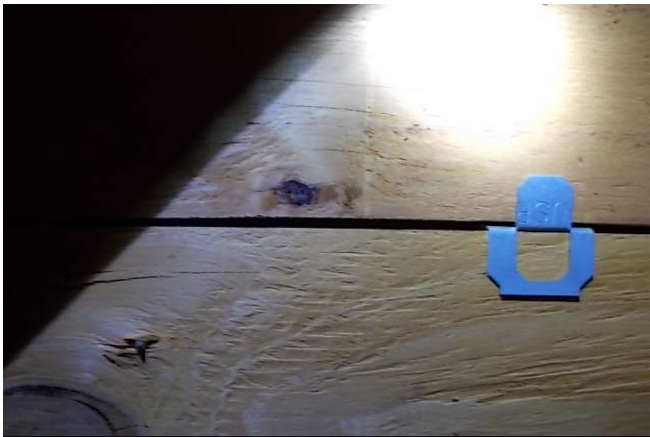
- ☐ A. SWR (also called Sealed Roof Deck) Self-adhering polymer modified-bitumen roofing underlayment applied directly to the sheathing or foam adhesive SWR barrier (not foamed-on insulation) applied as a supplemental means to protect the dwelling from water intrusion in the event of roof covering loss.
- ☒ B. No SWR.
- ☐ C. Unknown or undetermined.

Non SWR (Tar paper)

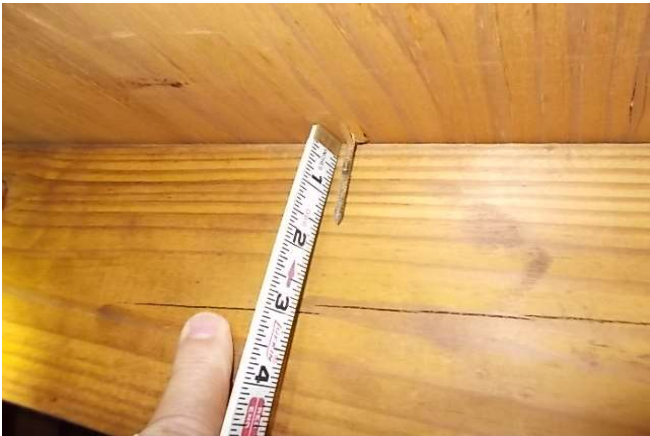
- ☒ C. Plywood/OSB roof sheathing with a minimum thickness of 7/16" attached to the roof truss/rafter (spaced a maximum of 24 inches o.c.) by 8d common nails spaced a maximum of 6" inches in the field. -OR- Dimensional lumber/Tongue & Groove decking with a minimum of 2 nails per board (or 1 nail per board if each board is equal to or less than 6 inches in width). -OR- Any system of screws, nails, adhesives, other deck fastening system or truss/rafter spacing that is shown to have an equivalent

8D nails
