# **Pineapple House Condominium**

1437 Pineapple Avenue  
Melbourne, Florida 32935

## **Walkways and Exterior Condition Survey Report**

**September 23, 2022**

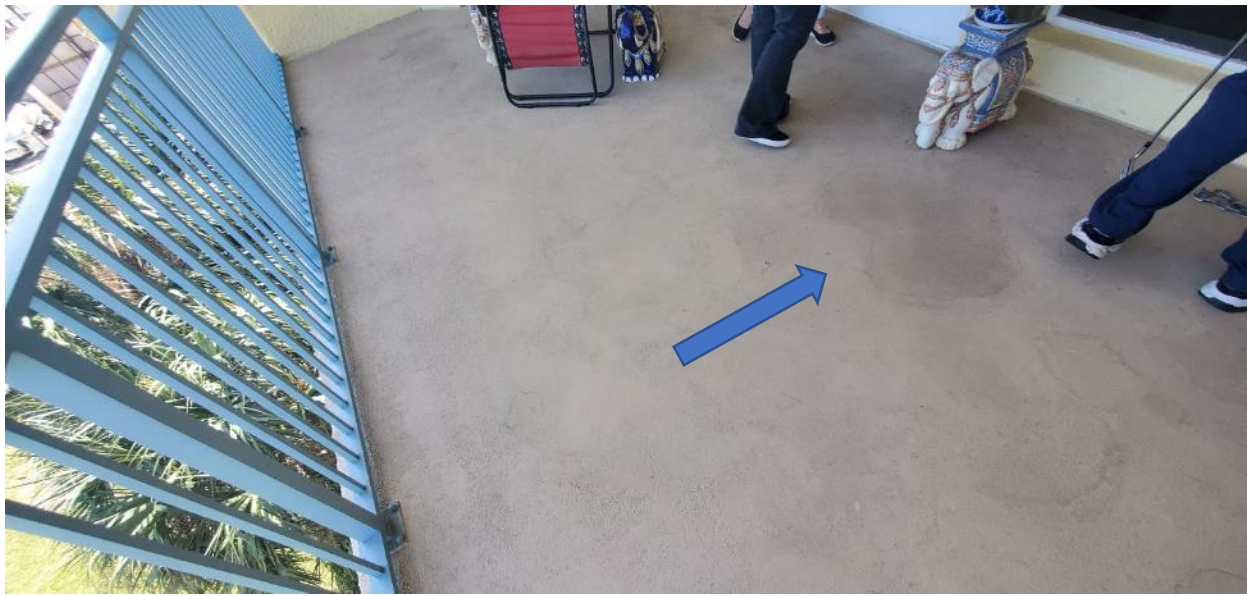
**Evidence of ponding water on the balcony surface. (Unit 407)**  
**Could be improved during a future restoration project**

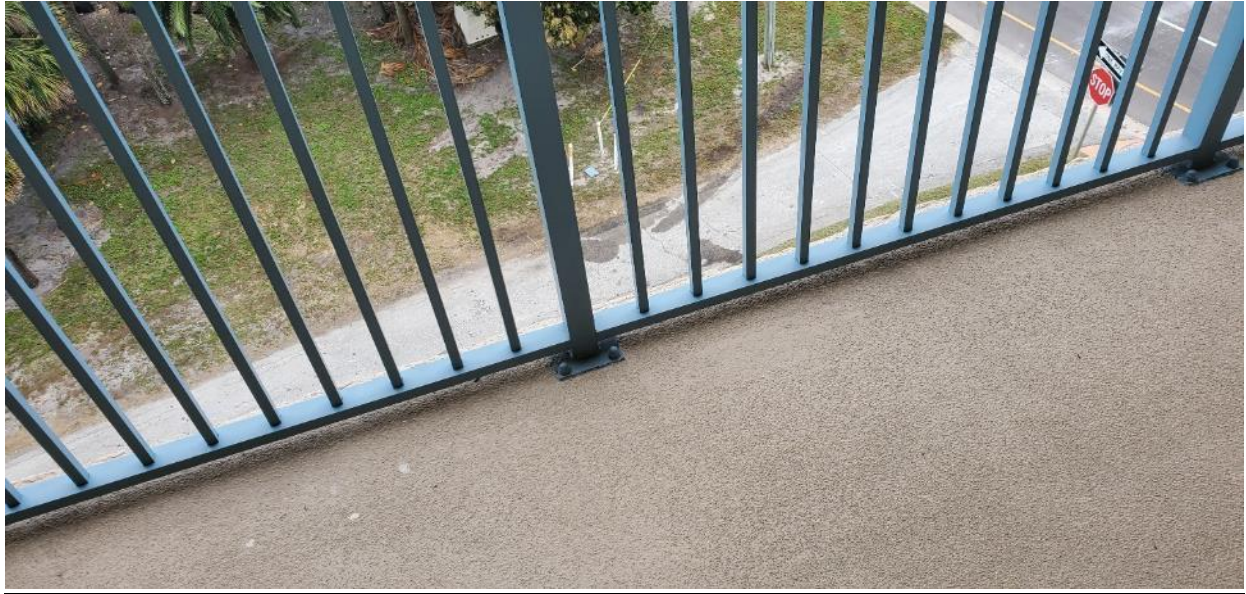
**Stained balcony surface. Possible candidate for cleaning and recoating as part of the next painting project. Drainage could be improved during a future restoration project.**

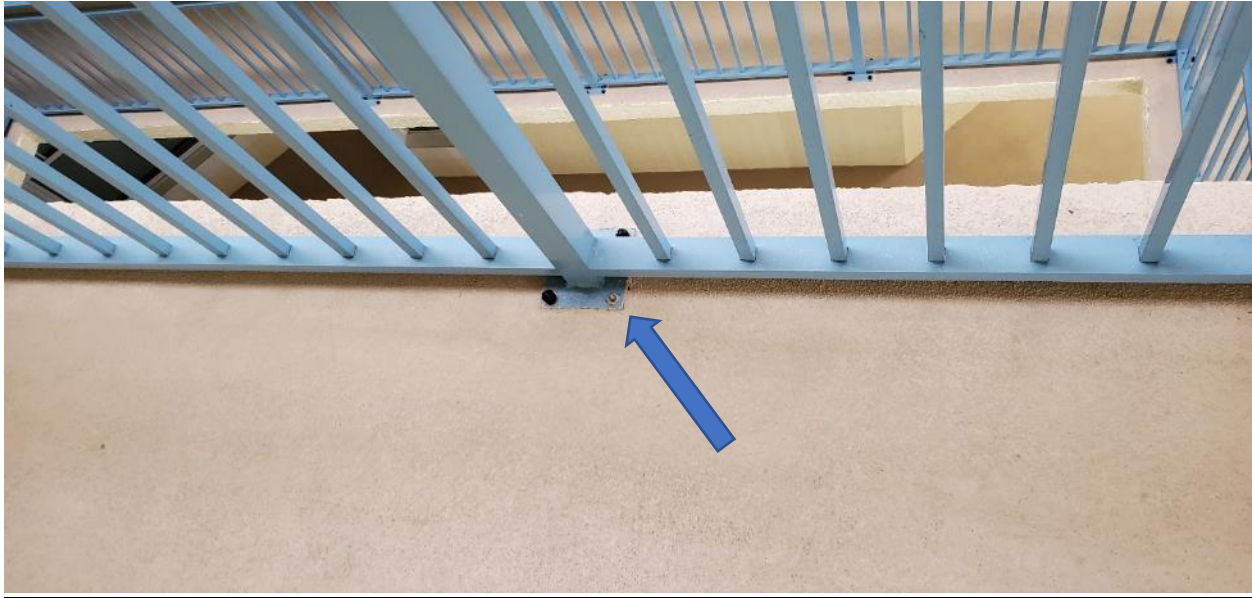
**Missing fastener cap on walkway railing (7<sup>th</sup> Floor)**  
**Consider repainting railings during next building painting project.**

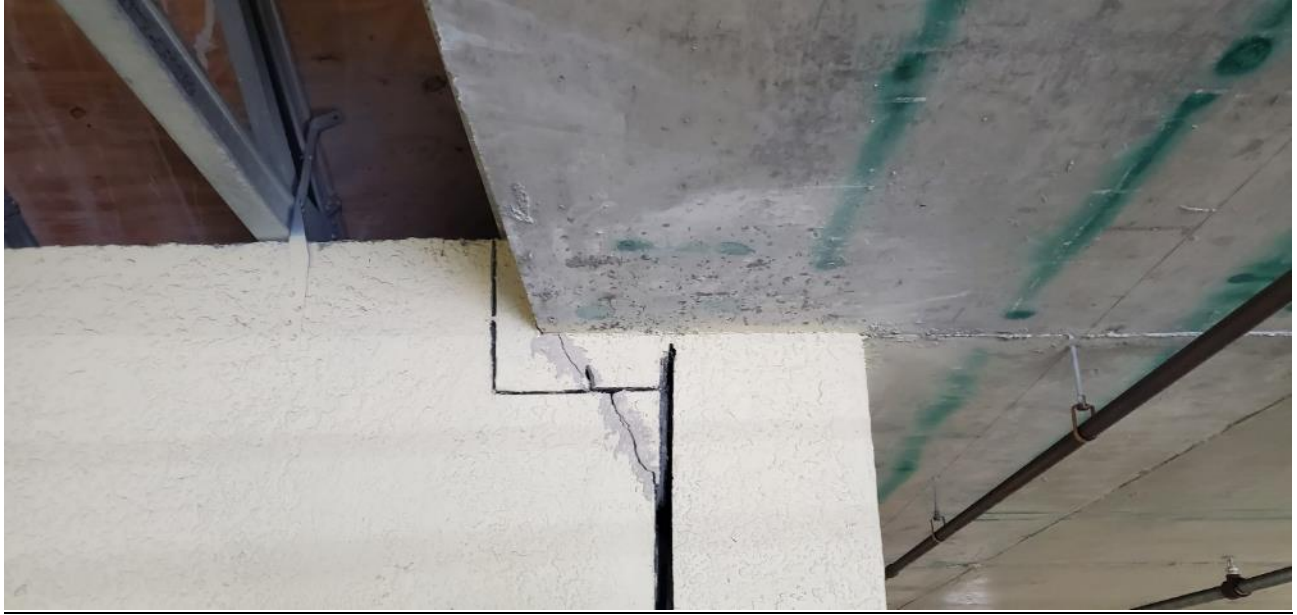
Concrete wall in garage with cracks  
Monitor for potential future concrete repair

**Garage Walls** – We noted some spalling on the top bearing surfaces of concrete walls. These areas that support concrete beams should be repaired by a qualified concrete contractor. There were also some cracks noted in some of the concrete masonry walls. These are not as critical by can be addressed at the same time as the bearing wall repairs.
