**Milestone Phase I Report**  
**R.P.O Condominium Association, Inc.**

Report Date: 10/21/2024

Inspection Date: 9/19/2024

1505 N Hwy A1A, Indialantic, FL, 32903

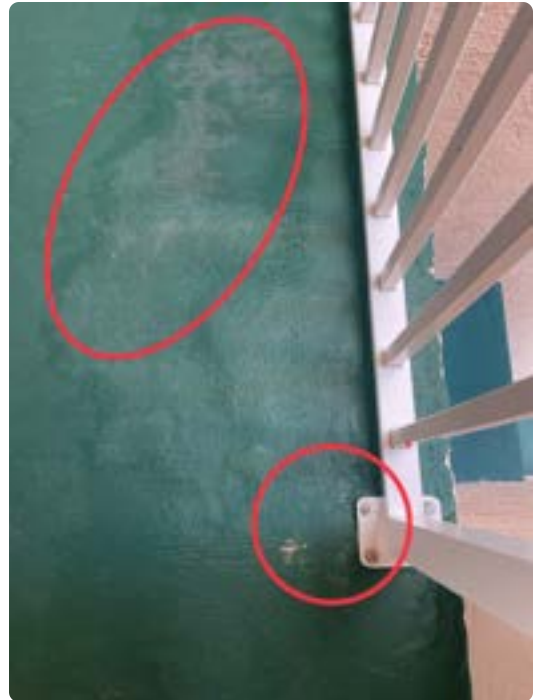
| Maintenance | <ul style="list-style-type: none"><li>Multiple hollow areas identified on walkways. Hollow areas are likely due to delaminated coating, as no signs of distress were identified on the underside of the slabs. Due to the high amount of areas with delaminated coating, it is recommended that the coating on the walkways be completely removed and a new coating applied during the next walkway painting cycle.</li><li>Rout and reseal crack at edge of walkway near Unit 502.</li></ul> |

Delaminated walkway paint near Unit 504

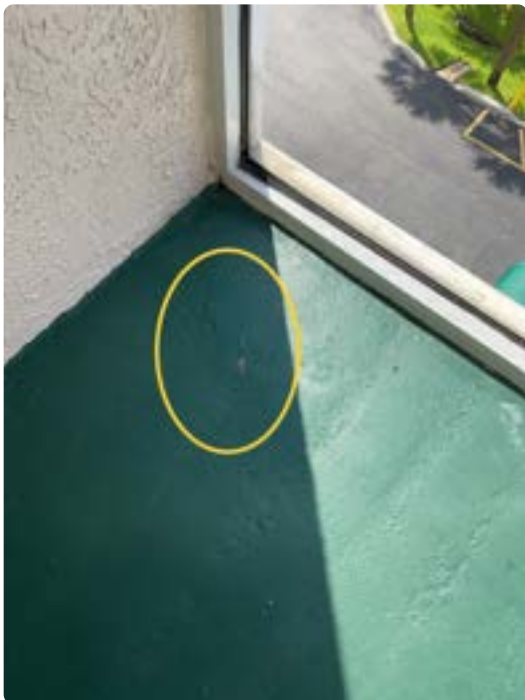
Hollow area near 5th floor elevator

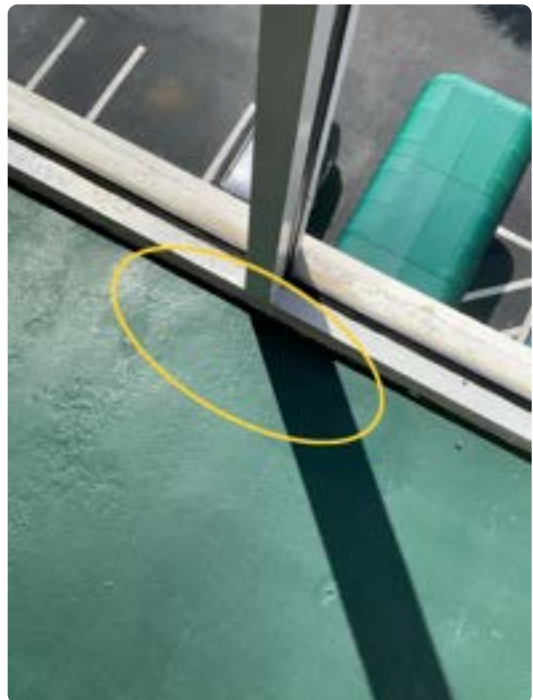
Hollow area near 5th floor elevator

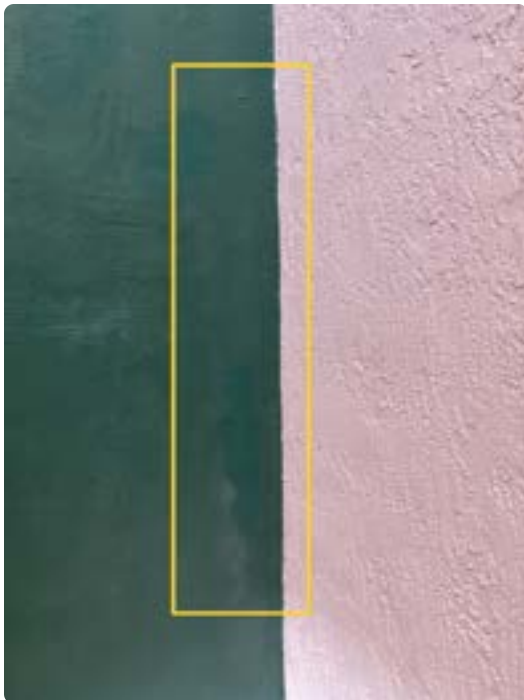
Hollow area near Unit 304

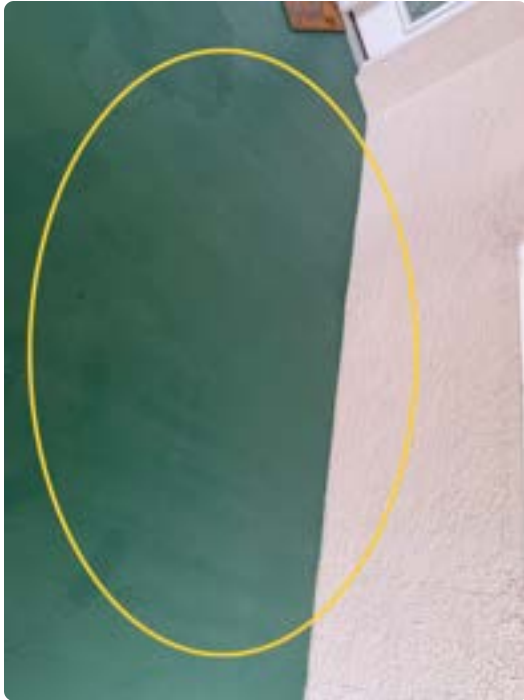
Hollow area near Unit 201. Area has had previous remediation.

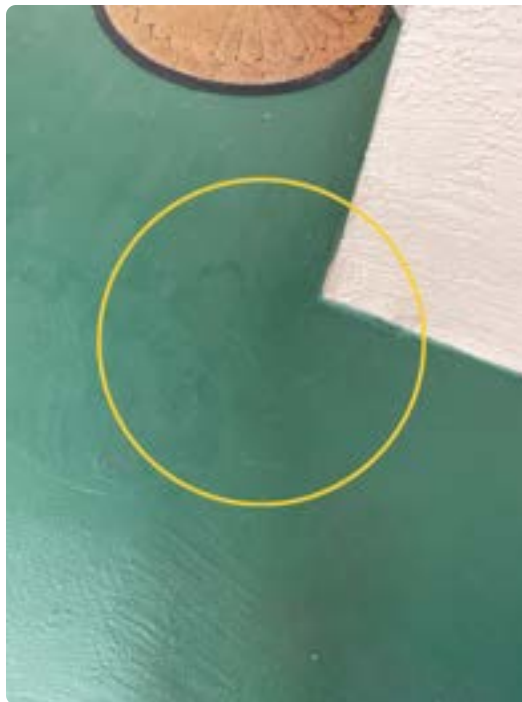
Hollow area near Unit 203
