# **Harbor Villa Townhouses**

Indian Harbour Beach, Florida

## **Exterior Building Balcony Structure Inspection Report**

**June 23, 2021**

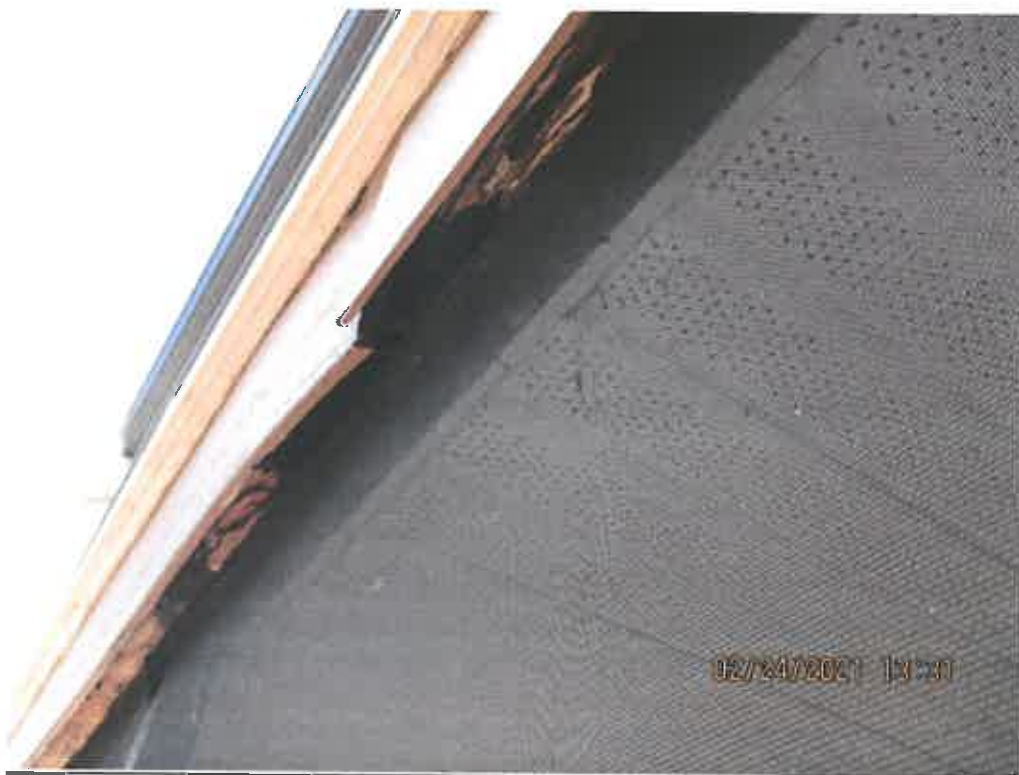
Example view of rotted wood fascia
