**AN APPRAISAL OF  
THE REPLACEMENT COST OF  
RIVERSIDE LANDING CONDOMINIUM  
LOCATED AT 29 RIVERSIDE DRIVE  
COCOA, FLORIDA  
W&Co FILE NO. 25 1615 RC**

**AS OF APRIL 14, 2025  
PREPARED BY  
BONNIE SUE BEDELL**

The Subject Property is Riverside Landing Condominium located at 29 Riverside Drive, Cocoa, Florida. It is comprised of one six-story condominium building and related site improvements.

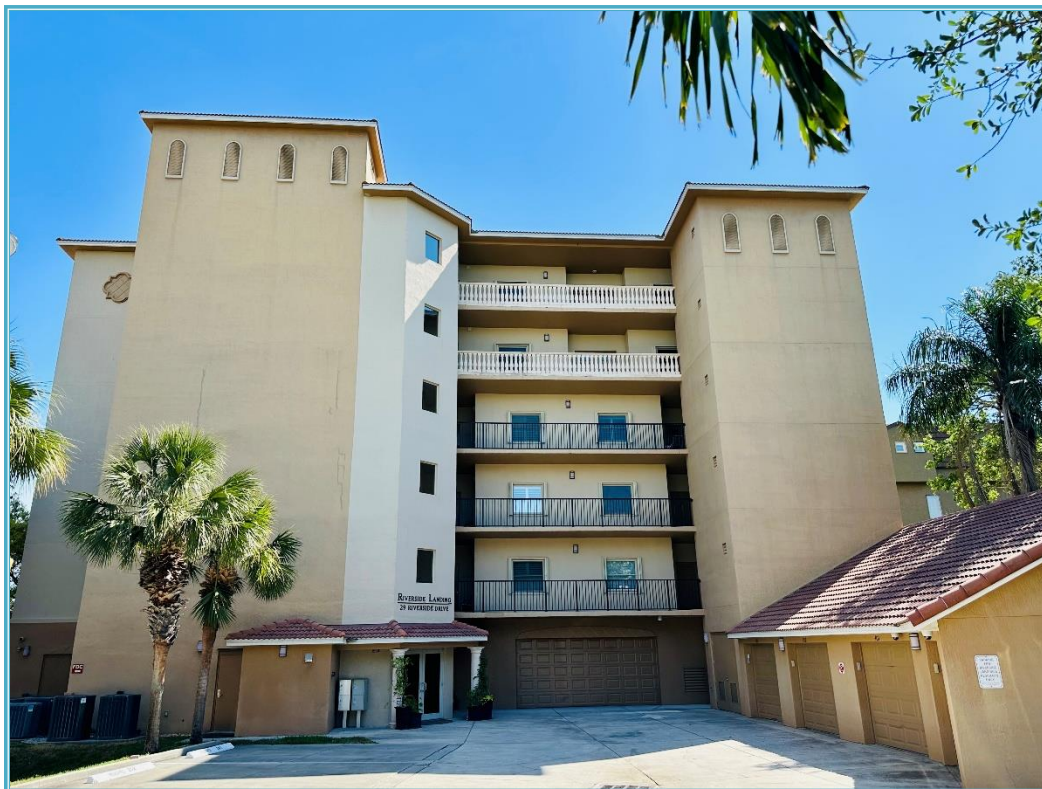
WEST ELEVATION

The condominium building was constructed in 2004 on a poured concrete slab with concrete footers. The exterior walls are comprised of reinforced concrete block with a painted stucco finish. Subfloors are poured concrete. The flat roof is poured concrete with a single-ply membrane roof covering with mansards all around covered with concrete barrel tile covering. The Construction Class of the condominium building is ISO 6, Fire Resistive.

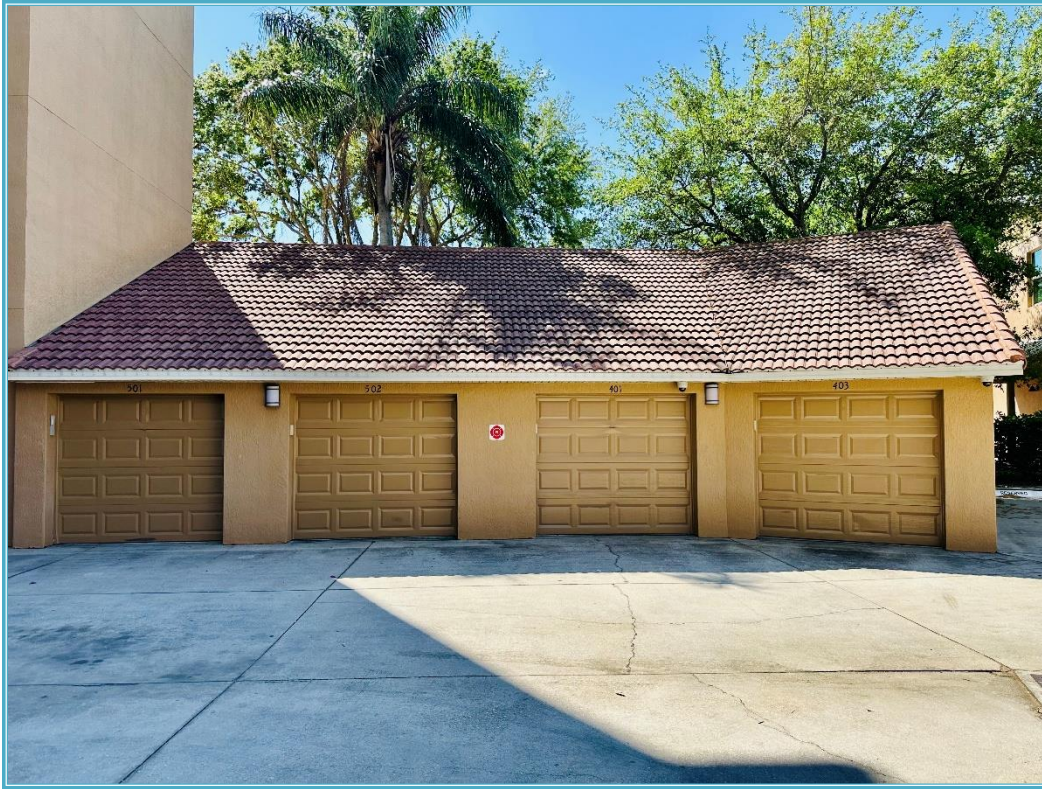
**NORTH ELEVATION OF ATTACHED GARAGE**

There is an attached garage building on the southwest corner of the condominium building, with four single car garage spaces. The construction appears to be wood frame with painted stucco on the exterior walls and concrete tile roof covering over a wood roof deck. This garage building will be treated as an addition to the main structure, and will not affect the selection of the appropriate Construction Class for the cost estimate.

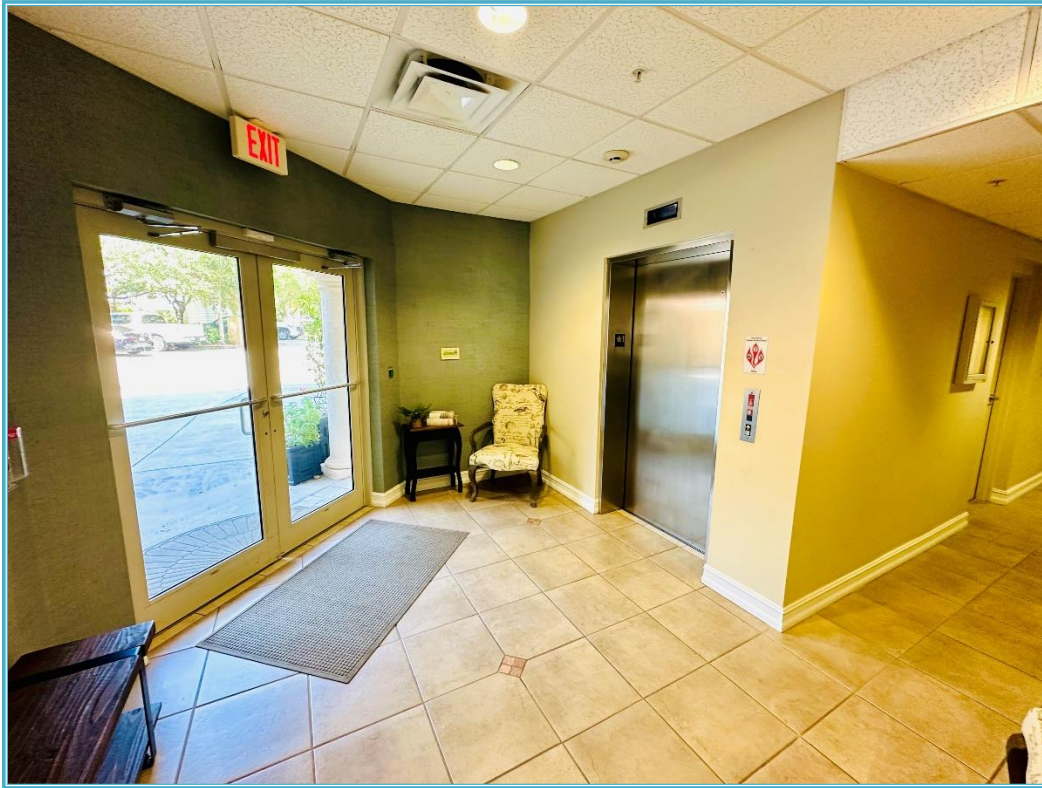
**LOBBY**

The interior finish in the common areas includes ceramic tile floor covering, painted drywall partitions, acoustic tile ceilings and recessed incandescent lighting. The club includes a meeting room and a kitchen with solid surface countertops over wood cabinets, a double stainless steel sink and a dishwasher. There is one restroom with two fixtures. Just outside the club is a pavilion (covered porch) next to the swimming pool.
