**Milestone Phase I Report**  
**R.P.O Condominium Association, Inc.**

Report Date: 10/21/2024

Inspection Date: 9/19/2024

1505 N Hwy A1A, Indialantic, FL, 32903

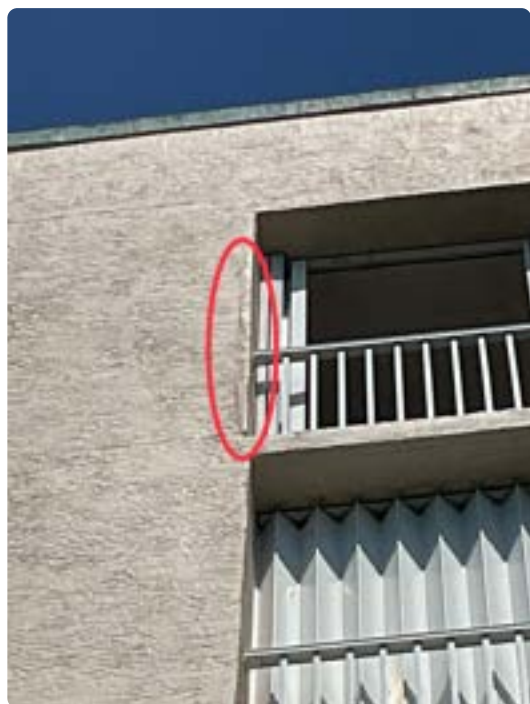
| Deficiencies | <p>Cracks were identified on the right elevation wall, near the balcony edges, for four out of the five floors. The cracks are occurring at a corner near where the CMU block exterior walls meet the metal stud-framed sliding glass door wall on the balconies. The building plans indicate that the CMU blocks in the area are filled with rebar. The fifth floor unit and the third floor unit were accessed to view the interior damage caused by the cracks. The fifth floor unit did not have an obvious crack on the exterior of the building, but had some drywall damage on the interior. The third floor unit did contain cracks on the exterior of the building and, when entering the unit, water damage was identified in the wood sheathing, metal studs, and carpet near the area. The unit owner removed the drywall and the area was still open during the inspection.</p> <p>The cracks on the exterior of the building appear to have had some previous remediation. This previous remediation was not sufficient as the cracks are resurfacing. Additionally, the unit owner in the third floor unit indicated to SIG during the inspection that water intrusion is still a current issue.</p> <p>A Phase II investigation with destructive testing is required to examine the mortar joints and condition of the CMU block at the areas with cracks.</p> |

Zoomed photo of 6th floor

On the right elevation, the stucco will be removed to observe the condition of the CMU block and mortar joints. A small area of stucco on the sliding glass door wall of each balcony will also be removed to observe the condition of the wood sheathing.

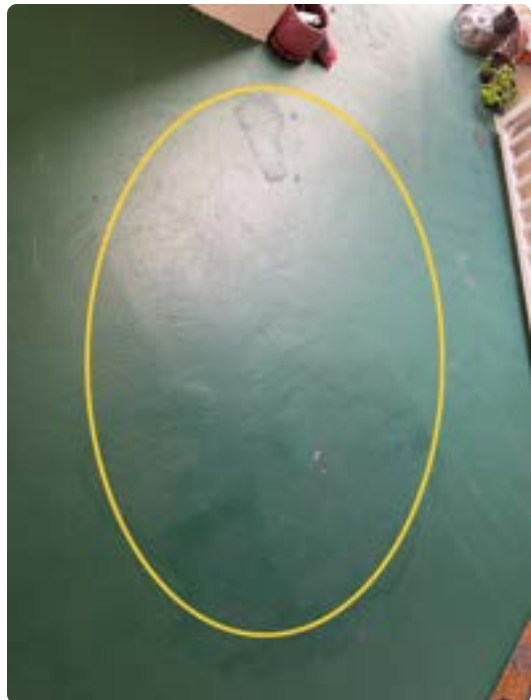
| Maintenance | <ul style="list-style-type: none"><li>Multiple hollow areas identified on walkways. Hollow areas are likely due to delaminated coating, as no signs of distress were identified on the underside of the slabs. Due to the high amount of areas with delaminated coating, it is recommended that the coating on the walkways be completely removed and a new coating applied during the next walkway painting cycle.</li><li>Rout and reseal crack at edge of walkway near Unit 502.</li></ul> |

Hollow area near Unit 201. Area has had previous remediation.
